APPENDIX B - BUILDING-BY-BUILDING ASSESSMENT (2020)

1 LOWER HIGH STREET SQUARE, ST.TYDFIL'S CHURCH & COURT STREET

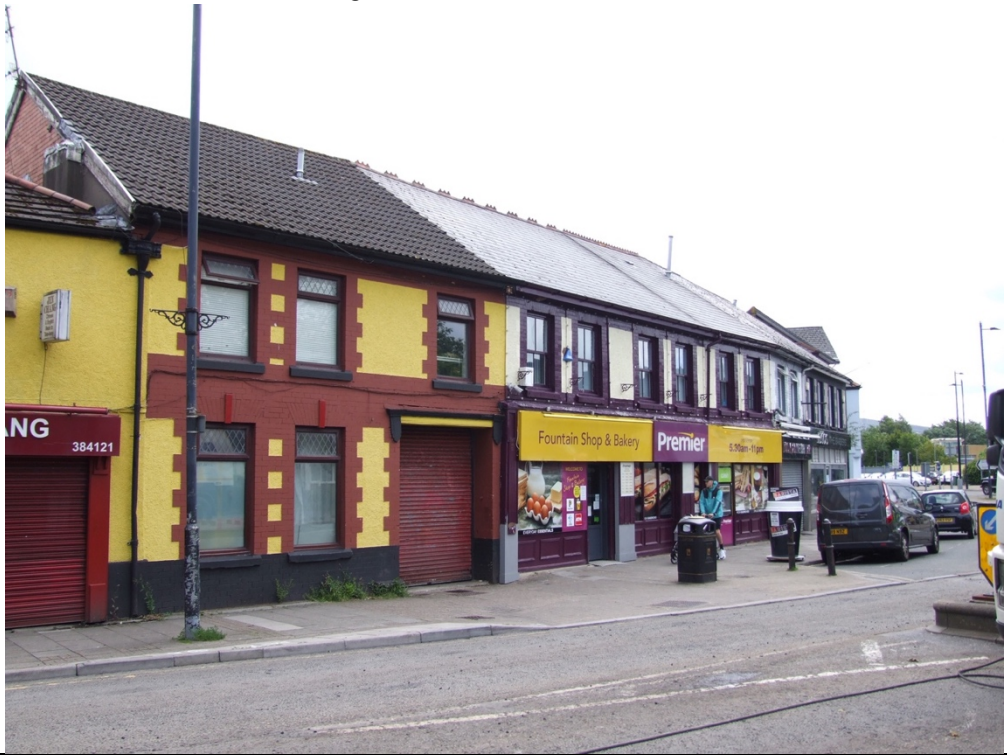
Address	13, 14, 14a, 14b & 14c Lower High Street

Current use	Shops (Premier supermarket, Barber & Fish bar)
Architectural Description & Condition	<p><u>Front</u></p> <p>Two-storeys, built following the curve of the street.</p> <p>Mostly fibre-cement slate roofs with clay ridge tiles, plastic rainwater goods, painted timber beaded / cot moulded fascia boards, and painted timber soffit boards.</p> <p>Modern metal flue extending up through the slating.</p> <p>Nos.14c and 13 have plastic windows to the first floor.</p> <p>Nicely proportioned first floor windows to most of the properties. Painted brickwork windows surrounds.</p> <p>Some old hard rendered panels between the windows.</p> <p>South, gable elevation of no.13 is an old unpainted hard render.</p> <p>Modern ground floor frontages.</p> <p>TV aerials, satellite dishes and heat pumps visible down the side lane to south of no.13.</p> <p>Premier shop has gloss painted brickwork surrounds to windows and what look like timber box sashes painted a dark purple colour.</p>

<p>Old stone windows cills to first floor windows except for no.13 where these have been replaced with what looks like concrete. All are paint finished.</p> <p>Nos. 14, 14a and 14b appear to have painted metal gutters and downpipes, although they are probably modern.</p> <p><u>Rear</u></p> <p>Nothing significant.</p> <p>Mostly plastic rainwater goods although there may be one length with a cast iron gutter and downpipe.</p> <p>Galvanised steel chimneys to the rear and lots of satellite dishes.</p> <p>Nos. 13-14 have clay ridge tiles, mostly red, some are crested. Some ridges have blue / black ridge tiles. None of these are particularly special.</p> <p>Nos. 14 to 13 have painted rendered walls. Rough-cast render but not old.</p> <p>A number of satellite dishes.</p> <p>Plastic rainwater goods.</p> <p>Some painted timber bargeboards and fascia boards.</p> <p>Some stainless-steel flues presumably from take away kitchens, extending at the gable of no. 14c.</p>

Summary Assessment of Building's Contribution / Significance to the Conservation Area	None or very low.

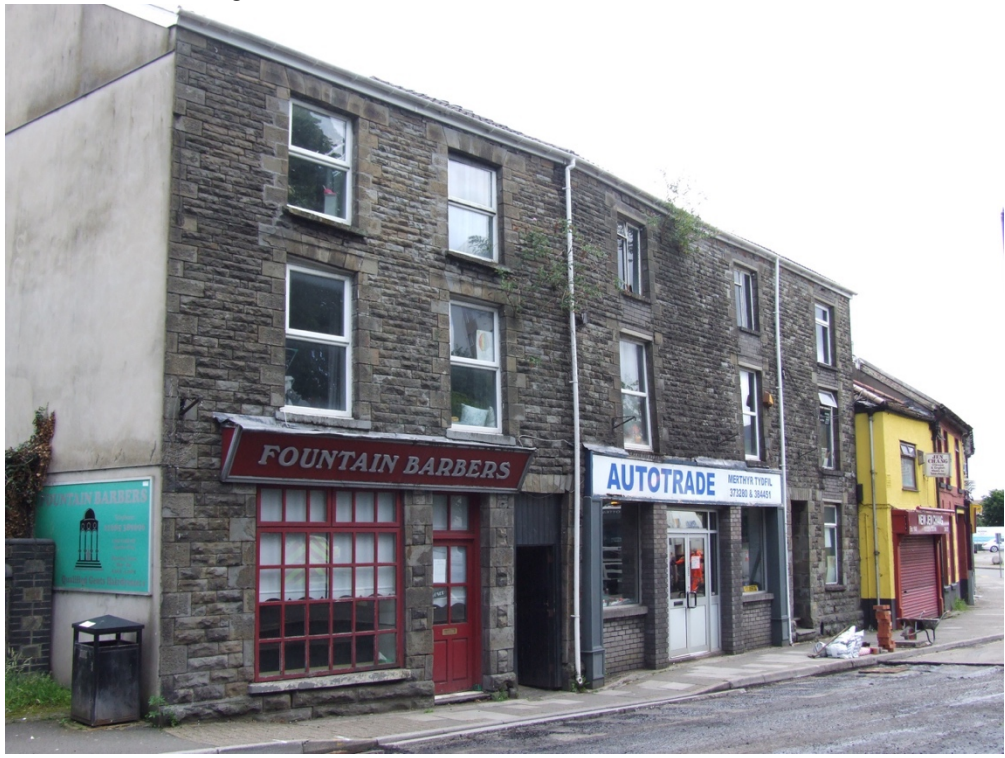
Address	<p>16, 17 & 18 Lower High Street</p>

Current use	Auto-trade Shop & Fountain Barbers
Architectural Description & Condition	<p>Not visible on 1851 Public Health Map.</p> <p>Shown on 1875 Ordnance Survey Map.</p> <p><u>Front</u></p> <p>Natural slate roof coverings.</p> <p>Three-storey block with coursed rock-faced pennant stonework, dressed stone reveals to the windows and doors and voussoirs over the old doorway. Some localised modern concrete brick infill areas and some modern concrete lintels, particularly to the southern openings. This suggests that the old stone voussoirs may have failed. The areas between first and second floor windows are infilled with concrete bricks.</p> <p>Use of stonework suggests this may have been an early to mid-19th century building.</p> <p>There is a chamfered stone plinth to the southernmost building, no. 16, and a set of old stone steps leading up to its doorway.</p> <p>Auto-trade shop frontage is all-modern, painted timber and concrete bricks.</p> <p>First and second floor window cills are all concrete bricks.</p>

<p>A buddleia is growing out of this building up at high level.</p> <p>Modern aluminium rainwater goods.</p> <p>No. 18 is of the same construction as nos. 16 and 17, although it is at a slightly different angle. Voussoirs appear to be failing to this building as well. Plastic modern windows to the ground floor. The large shop front opening looks to be an original opening even if the windows aren't.</p> <p>North elevation is cement rendered and has plastic barges, no overhang and highly visible plastic soil pipe so this is an unsightly elevation.</p> <p>This building has quite a sombre appearance.</p> <p>Historic photograph (visible online at www.alangeorge.co.uk) shows the historic frontage and fenestration. These opening have largely survived intact although the ground level shopfronts are all modern.</p> <p><u>Rear</u></p> <p>No. 15 has a single-storey mono pitched roof old extension to the rear with a small yard.</p> <p>No. 15 cement rendered walls, some of it is pebble-dashed.</p> <p>Concrete tiled roofs.</p> <p>The rears of nos. 16-18 are visible over the boundary wall from the pavement adjacent to TopLinePrint.</p> <p>Nos. 16-18 are all cement rendered. Concrete roof to outrigger.</p>

Summary Assessment of Building's Contribution / Significance to the Conservation Area	<p>Possibly some significance due to it possibly being of the mid / late-19th century phase of building. However, its condition is poor, with some structural issues visible (e.g. around stone voussoirs), and its original design is visually poor and sombre, affecting its significance. Also, it is far removed from and doesn't feel part of the town centre Conservation Area.</p> <p>Potential for restoration, although there needs to be discussion about whether this stays in the conservation area, and consideration of likely cost / benefit to the conservation area as a whole.</p>

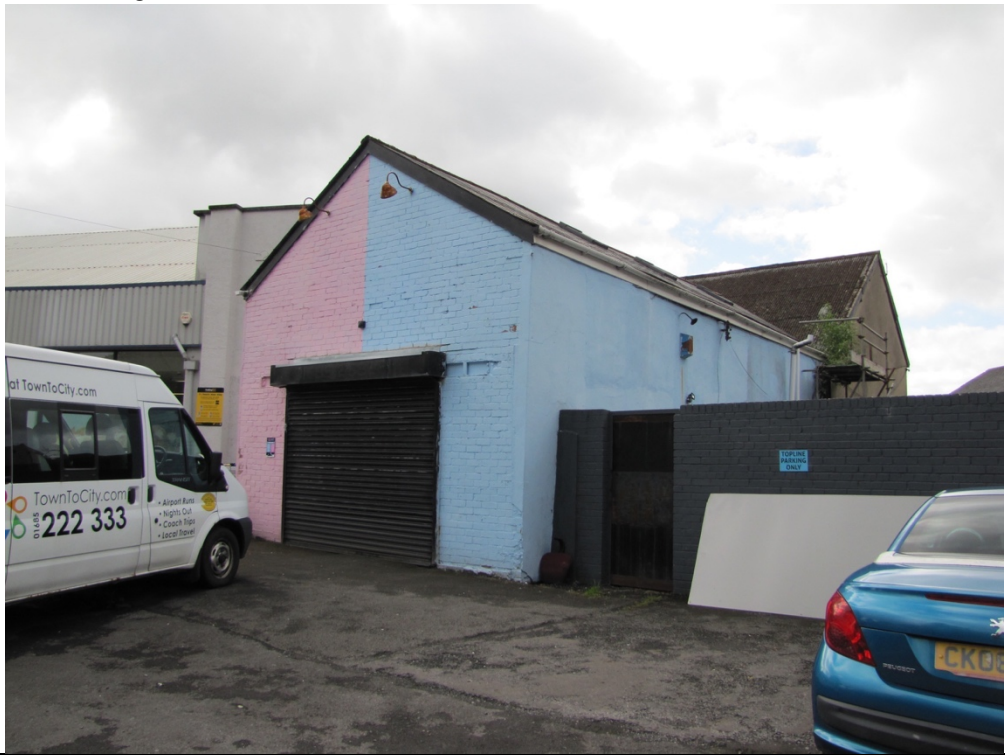
Address	<p>19 Lower High Street</p>

Current use	TopLinePrint (Printers)
Architectural Description & Condition	<p>Painted brick building, that looks like an old former industrial building.</p> <p>Roller shutter doors with modern windows / doors behind.</p> <p>Modern brick and painted render.</p>
Summary Assessment of Building's Contribution / Significance to the Conservation Area	None.

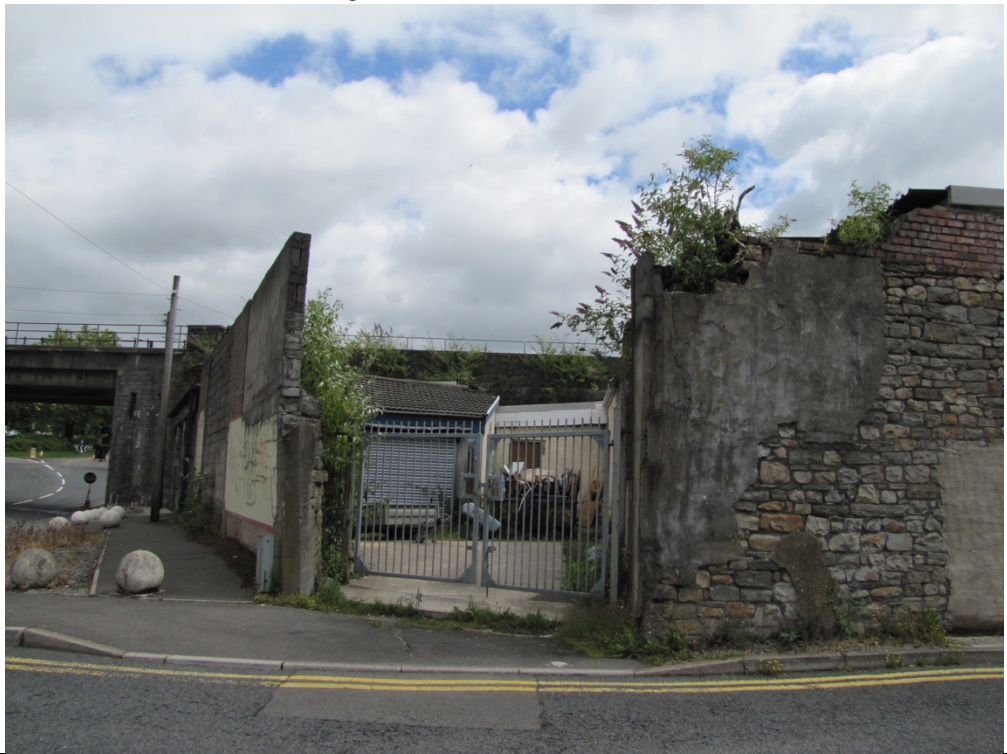
Address	<p>Car Care Auto Centre, Lower High Street</p>

Current use	Car Care Auto Centre (and former glass stockist yard)
Architectural Description & Condition	<p>Car care centre is a modern building with 'crinkly-tin' roof on top of modern brick walls.</p> <p>Galvanised gates to rear, just outside the Conservation Area.</p> <p>Northern two thirds is a much older building, stone built with brick extension on top, rendered over and with old openings infilled.</p> <p>Galvanised steel gates at the corner facing the town provide access into a small yard with roller-shuttered doors and a jumble of mono-pitched roofs, mostly finished with 'crinkly-tin'.</p> <p>Concrete hard standing to yard.</p> <p>Boundary wall overlooking Court Street is about 4-5m in height. It is a mixture of old stone with concrete blockwork laid on flat to the top 60% or so and with a large central section of concrete blocks. Nearly all rendered.</p> <p>This wall is unsightly and the stability of the wall is suspect, particularly at its western-most corner, at the gated opening.</p> <p><u>Harp Funeral Services</u></p> <p>Located to the north of the former glass stockist yard.</p> <p>Concrete tiled mono pitch roof.</p>

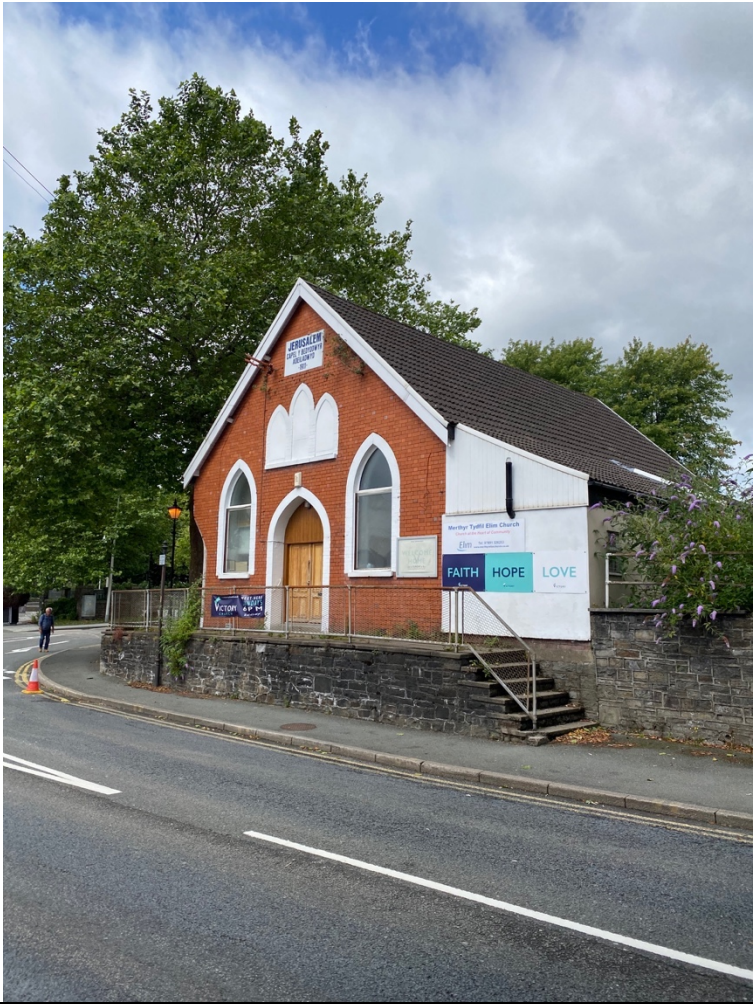
Address	<p>Elim Church, Court Street</p>

Current use	Elim Church
Architectural Description & Condition	<p>Not shown on 1875 Ordnance Survey Map.</p> <p><u>Front</u></p> <p>Red clay facing brickwork front elevation, cut back at the corner.</p> <p>Plastic clad catslide roof to the east side and modern rendered panel below that.</p> <p>Plastic bargeboards.</p> <p>Painted stone cills and lintels.</p> <p>Front door appears to be timber.</p> <p>The chapel is raised up above the street by about 4ft.</p>

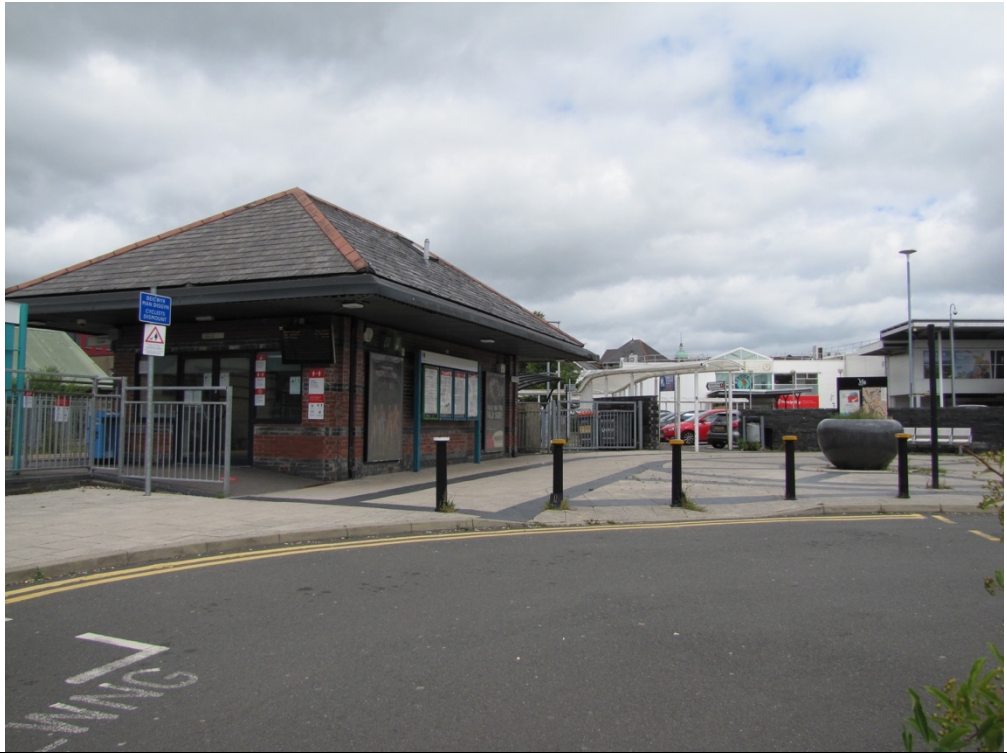
Current use	Train station (ticket office with waiting area inside)
Architectural Description & Condition	<p>A very plain modern functional building.</p> <p>Facing brick construction with fibre-cement slate roof, Velux-type rooflight, red clay hip and ridge tiles.</p> <p>Pressed metal fascia and soffits with paint finish.</p>
Summary Assessment of Building's Contribution / Significance to the Conservation Area	None.

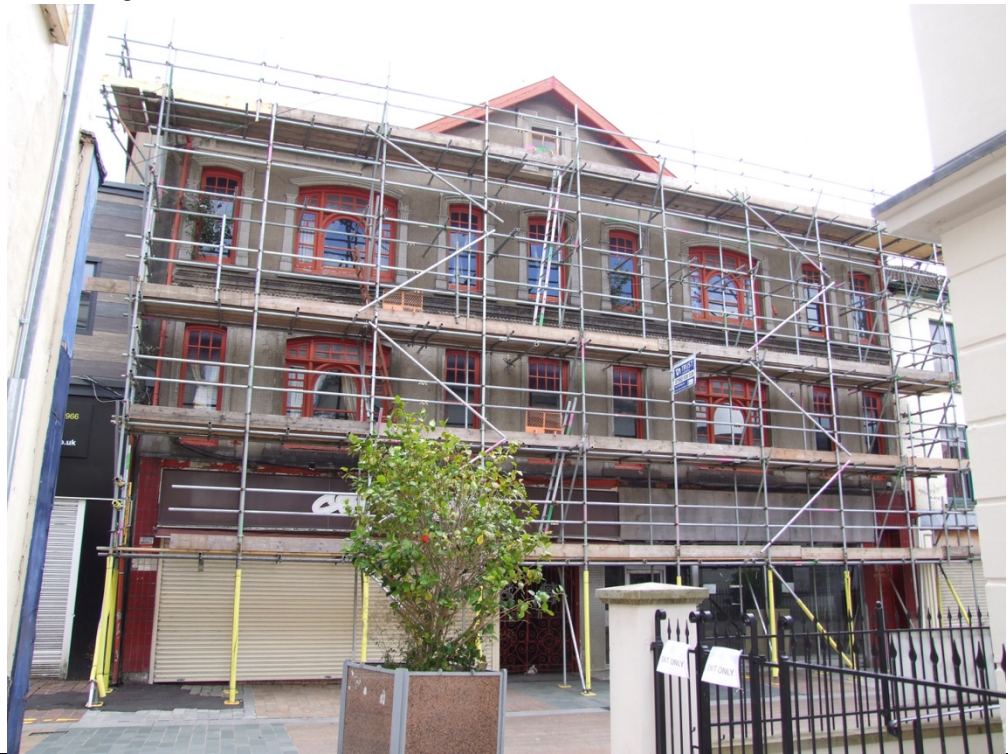
Current use	Café Njoy (café)
Architectural Description & Condition	<p><u>Front</u></p> <p>One of the dominant buildings in this part of High Street.</p> <p>Quite a sombre grey possibly natural-cement old render to 1st and 2nd floors. Probably original late 19th century render. I don't think this render was ever painted but it is quite sombre visually.</p> <p>Ground floor frontage is modern and visually poor. The best feature of the ground floor frontage is the pair of painted wrought iron gates to the central passage.</p> <p>The (almost) central gable bargeboards are probably modern painted timber, with very plain beaded / cot-moulded fascia boards each side.</p> <p>Deeply coved, rendered coving to eaves each side of central gable.</p> <p>Deeply run-moulded rendered window surrounds to 1st and 2nd floors probably in old natural-cement.</p> <p>Painted old timber windows. Painted red, although this was probably not the original colour. Quite an unusual (although not particularly attractive) arrangement to the glazing bars. These are mostly in the top half of the windows.</p> <p><u>Side (north elevation)</u></p>

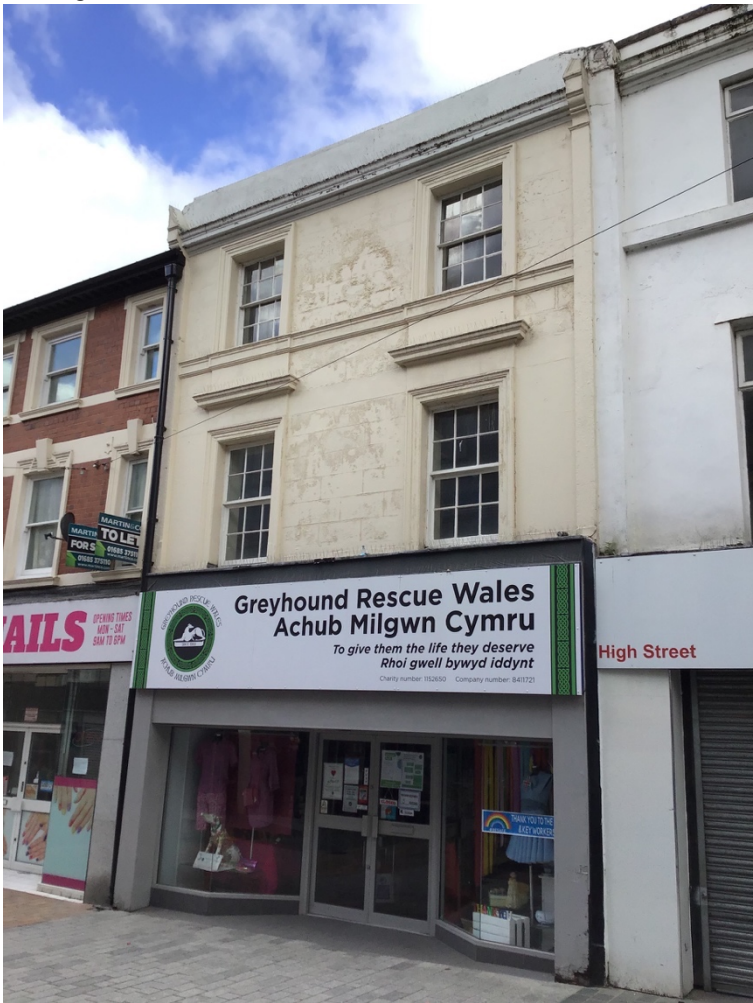
Current use	Greyhound Rescue (charity shop)
Architectural Description & Condition	<p>A visually positive elevation at 1st and 2nd floor levels. These have plain painted render but with stucco-lines struck. Some stone moulded hoodmoulds to 1st floor windows, moulded window surrounds and 6-over-6 painted sash windows with no horns. These look like good original details. Their condition looks good.</p> <p>Moulded cornice and then a plain parapet upstand.</p> <p>Street level shopfront is all modern aluminium framed and glazed.</p> <p>Scale matches 130 High Street.</p>
Summary Assessment of Building's Contribution / Significance to the	<p>Positive with the potential for improvement particularly to shopfront.</p> <p>1st and 2nd floor details are very good and visually positive.</p>

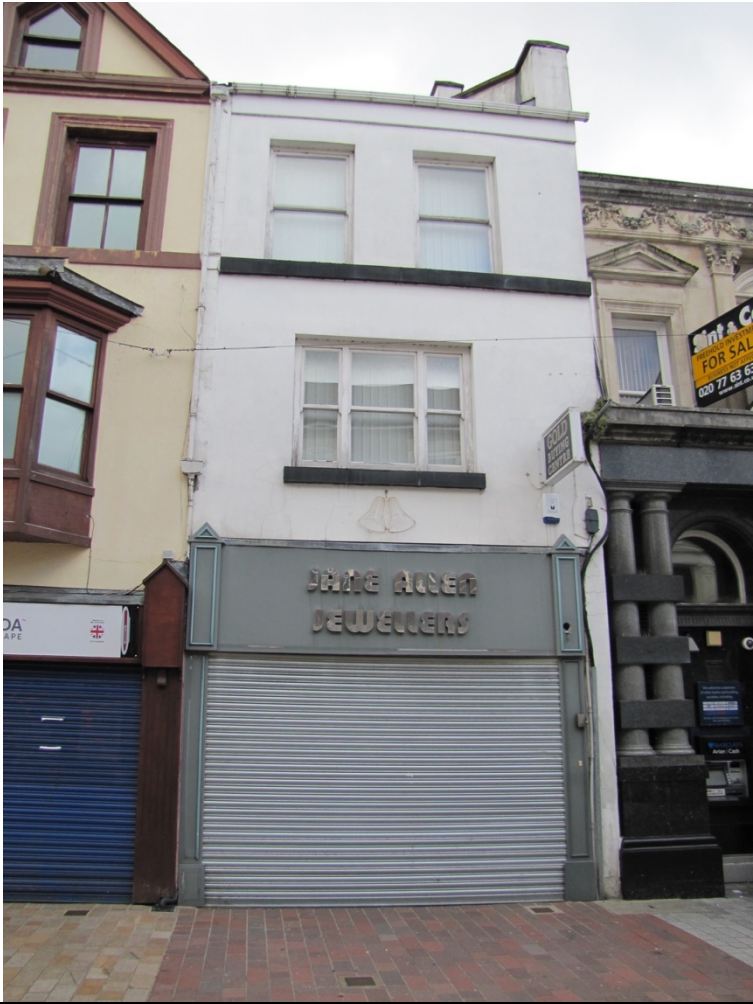
Current use	Jewellers
Architectural Description & Condition	<p><u>Front</u></p> <p>Built on the original street line, unlike the neighbouring Barclay's Bank that steps in at ground and 1st floor levels.</p> <p>No. 48 is a similar proportion to the buildings on the west side of High Street.</p> <p>Quite a high rendered raised parapet to its south gable.</p> <p>Roof is not visible from High Street itself as this is a three-storeys building. Roof is only visible from a distance from the market square. Looks like fibre-cement roof covering with a large Velux-type rooflight.</p> <p>Plastic rainwater goods.</p> <p>Street level has roller shutters, deeply recessed entrance, modern aluminium finishes and modern signage and modern pilasters.</p>

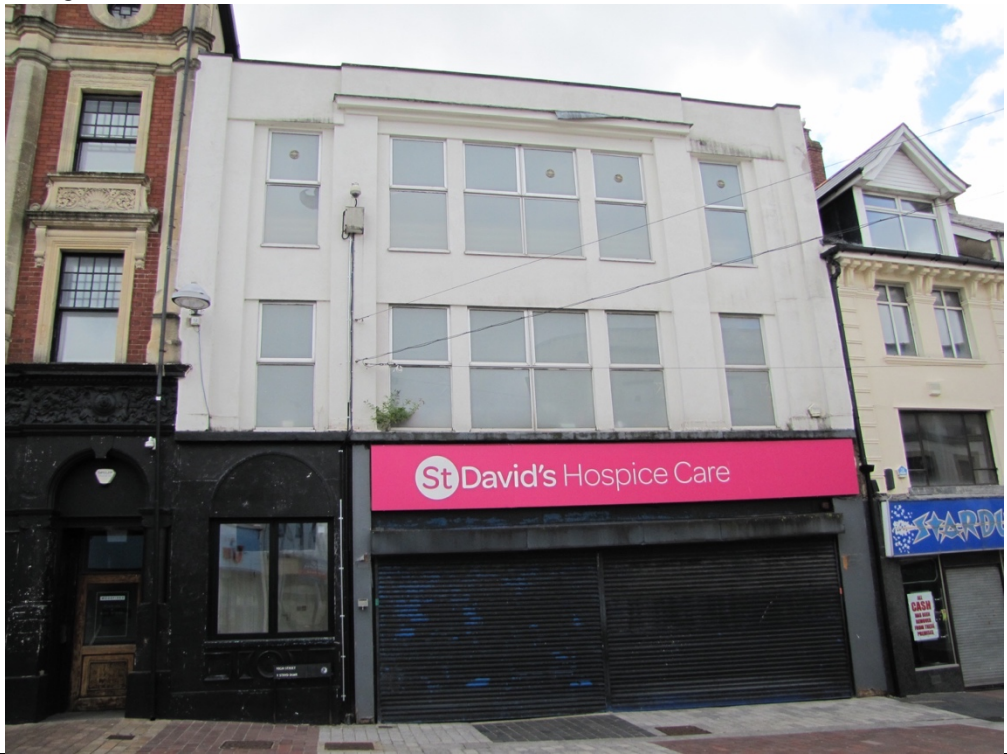
Current use	St. David's Hospice Care
Architectural Description & Condition	<p>Three-storeys.</p> <p>1st and 2nd floor windows look like aluminium frames with obscured glazing.</p> <p>Plain rendered pilasters to the outer edges and central portion of the front elevation. It has a low parapet and a hoodmould extending across the middle section and what looks like a stone stringcourse at cill level to the 1st floor windows.</p> <p>Very plain plinths to the pilasters.</p> <p>All modern render.</p> <p>I suspect this is an old building that's been heavily re-modelled, probably in the 1970s or 1980s.</p> <p>Ground floor frontage is all modern.</p> <p>I suspect there was small passageway to the north side, which has recently been infilled and taken on by the Wood Fired Pizzeria on the corner.</p>
Summary Assessment of Building's Contribution	Low.

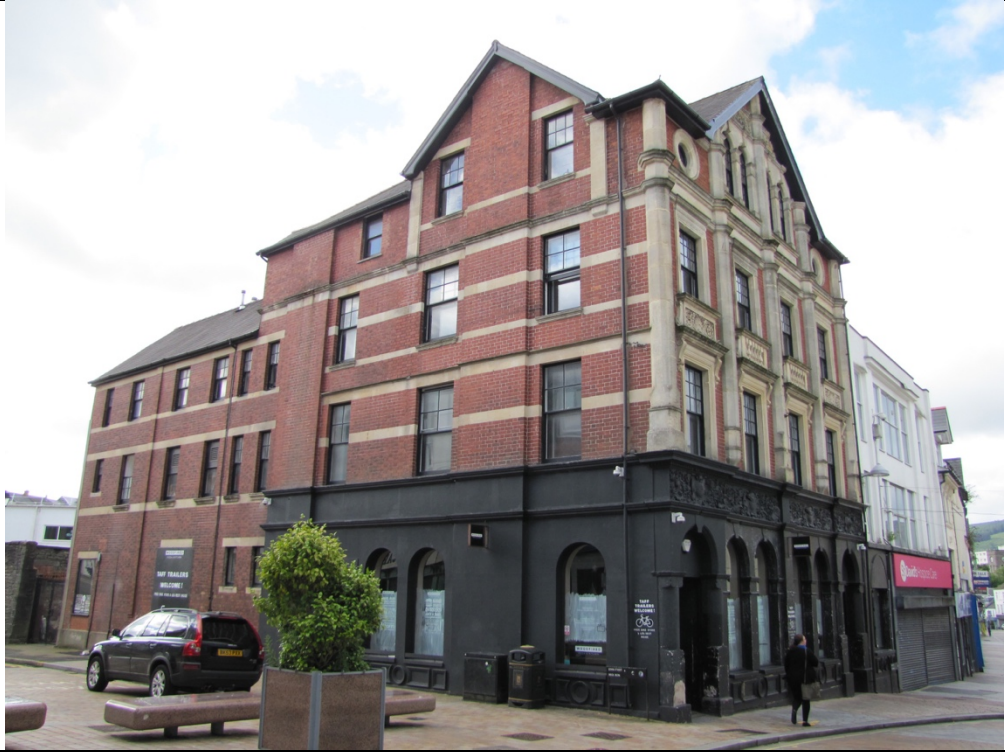
Current use	Wood Fired Pizza Restaurant
Architectural Description & Condition	<p>A four-storey corner building and so the most dominant building in this block.</p> <p>Large central gable on its High Street elevation.</p> <p>Street level is all black painted stonework with column pilasters. Oddly there is a central column and quite an ornate frieze.</p> <p>Painted window infills to the arch headed openings.</p> <p>Varnished, modern doors.</p> <p>2nd and 3rd floor have bathstone columns with an octagonal profile.</p> <p>Moulded cornice above 2nd floor windows.</p> <p>More carvings to the frieze above the 3rd floor windows.</p> <p>Moulded bathstone window surrounds and stone balusters and carved details below 2nd floor windows.</p> <p>1st, 2nd and 3rd floor windows are painted timber sash windows with horns. These I think are spiral balanced (rather than true box sashes) but they are not bad reproductions.</p> <p>Ground floor frontages, and 1st, 2nd and third floor windows are all painted black.</p> <p>1st, 2nd and 3rd floor wall panels are all red clay facing brickwork.</p>

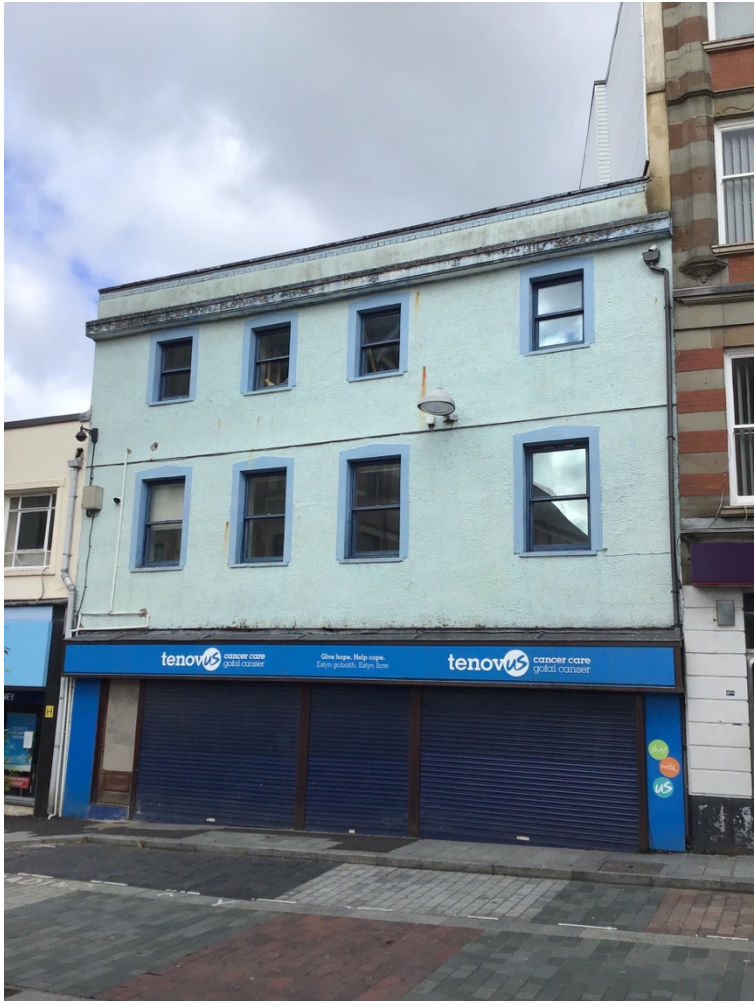
Current use	Tenovus (charity shop)
Architectural Description & Condition	<p>Three-storeys.</p> <p>Modern hardwood and glazed shopfront.</p> <p>1st and 2nd floors walls are finished with modern rough-cast render finish.</p> <p>Relatively deep run-moulded cornice with a plain rendered and brickwork parapet above and what look like concrete copings.</p> <p>Windows are of the usual taller proportions to the 1st floor and shorter to the 2nd floor.</p> <p>Windows have plain modern rendered surrounds and what look like concrete cills and painted modern timber sash windows.</p> <p>The arrangement of the windows makes me wonder whether this used to be two properties because the two northern-most windows are set slightly further away than the southern three.</p>

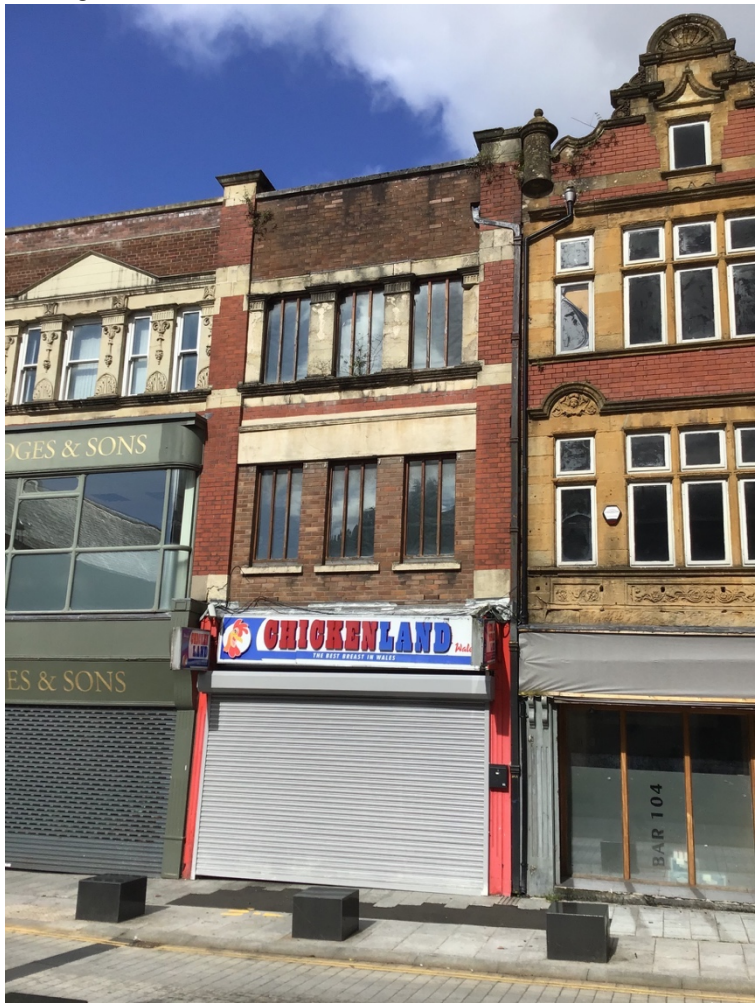
Current use	Chicken Land take away at ground floor level.
Architectural Description & Condition	<p>3 storey terraced building with plain flat parapet. Likely to have been constructed at the same time and in the same style as no. 106. This property has lost far more of its original features – refer also to no. 106.</p> <p><u>Roof</u> Roof believed to be of fibre cement slates, but only parapet visible from street views.</p> <p><u>Elevations</u> The ground floor generally is of a modern timber shopfront set between two poorly detailed modern reproduction painted timber pilasters. Modern lit and inappropriate signage over. External roller shutters to external face.</p> <p>Sections of original bathstone beneath and forming second floor windows (all embellishments lost). First floor windows have been formed in modern brickwork with matching modern brickwork panel at high level above second floor windows. All windows to upper storeys are of inappropriate modern stained timber fixed lights.</p>

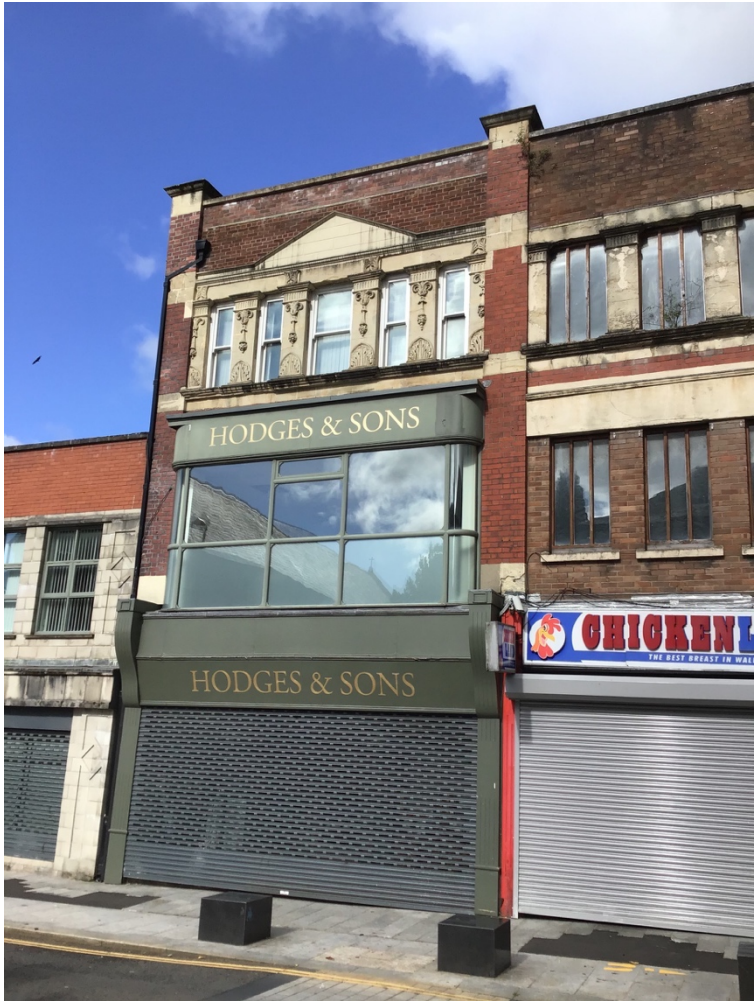
Current use	Known as Hodges & Sons – currently used by Tydfil Training.
Architectural Description & Condition	<p>Fine 3 storey terraced building with plain flat parapet. Likely to have been constructed at the same time and in the same style as no. 105. This property retains many of its original features.</p> <p><u>Roof</u> Roof believed to be of fibre cement slates, but only parapet visible from street views.</p> <p><u>Elevations</u> The ground floor generally is of a generally well detailed replacement timber shopfront set between two painted timber pilasters with deep inset entrance door and curved shopfronts each side. Decorative pilaster cappings would be beneficial. Plain painted signage to shop fascia.</p> <p>First floor comprises a substantial projecting curved window with further first floor shop sign fascia above.</p> <p>Second floor of decorative bathstone embellished pilasters and replacement painted timber sliding sash windows beneath bathstone pediment. Modern brick panel and parapet over.</p>

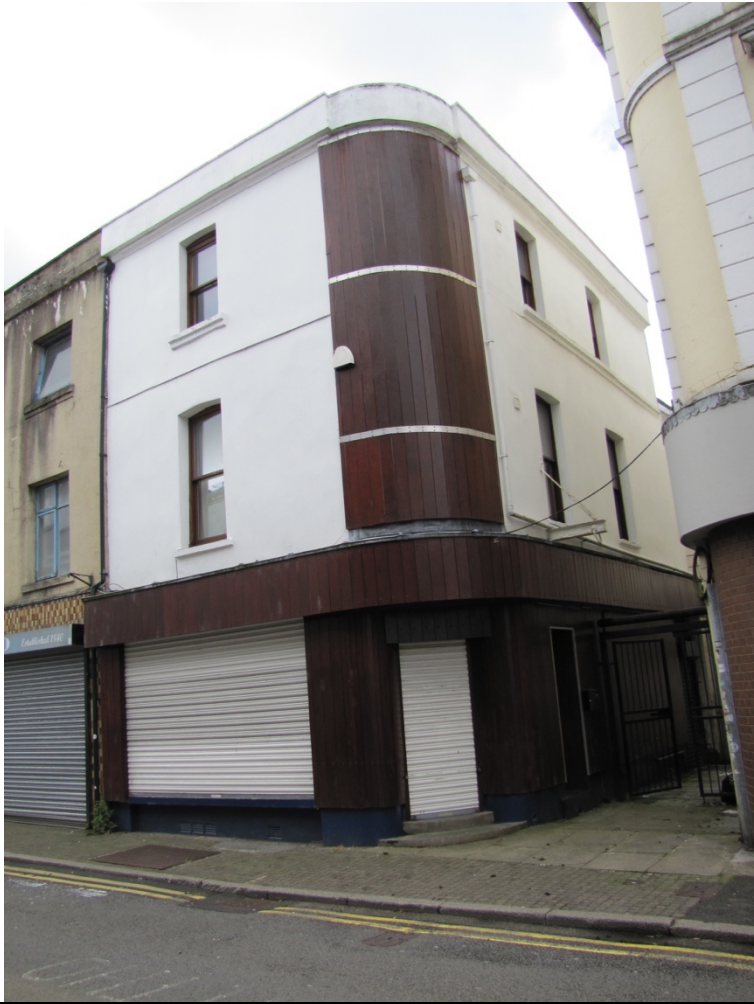
Current use	Weekender (clothes shop)
Architectural Description & Condition	<p>Again, a parapeted three-storeys building with a curved corner.</p> <p>Ground level has a painted stone plinth, modern timber cladding, modern glazing and a modern timber door.</p> <p>The timber cladding has been continued around the curved corner at 1st and 2nd floor levels.</p> <p>1st and 2nd floor windows are stained timber, probably hardwood sashes.</p> <p>Painted stone cills to the windows.</p> <p>Slightly projecting parapet with a run-rendered cornice below this.</p> <p>A gate is alongside this to the end of the lane.</p>

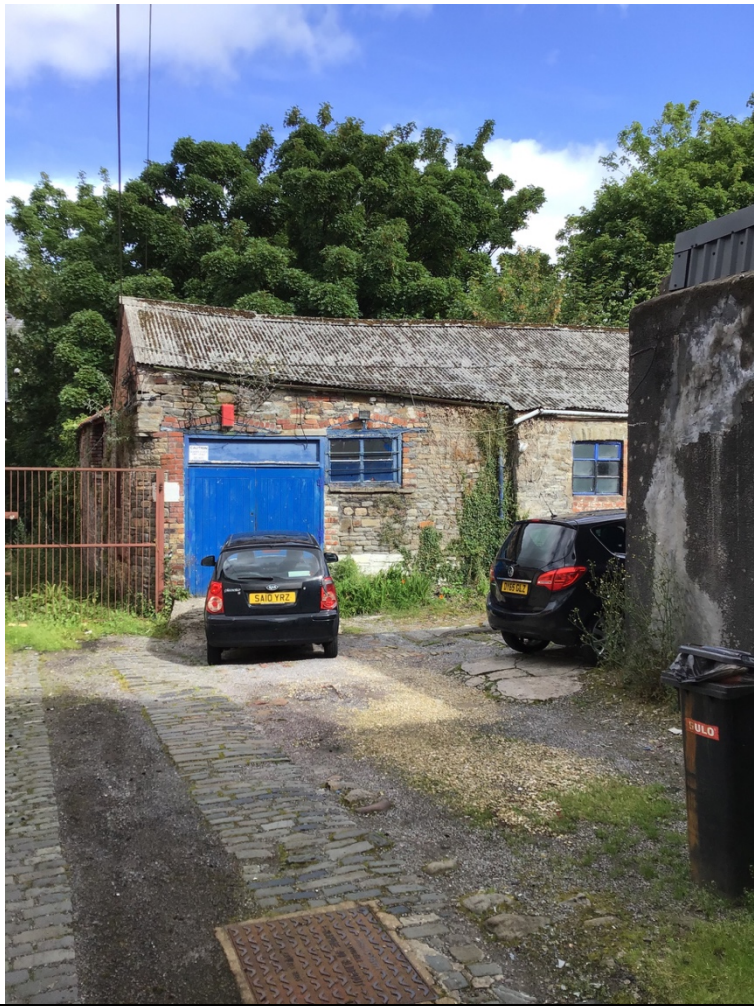
Current use	Unknown, formerly 'The Sweet Factory'
Architectural Description & Condition	<p>Simple single-storey brick and stone detached duo-pitched building.</p> <p>Poor condition.</p> <p>Building in this location on 1851 Public Health Map described as 'Grist Mill' (flour mill).</p>
Summary Assessment of Building's Contribution / Significance to the Conservation Area	<p>Slight significance for its history as a survival of one of the small backyard industries in Pontmorlais, although it isn't really in the public realm and feels quite private.</p>

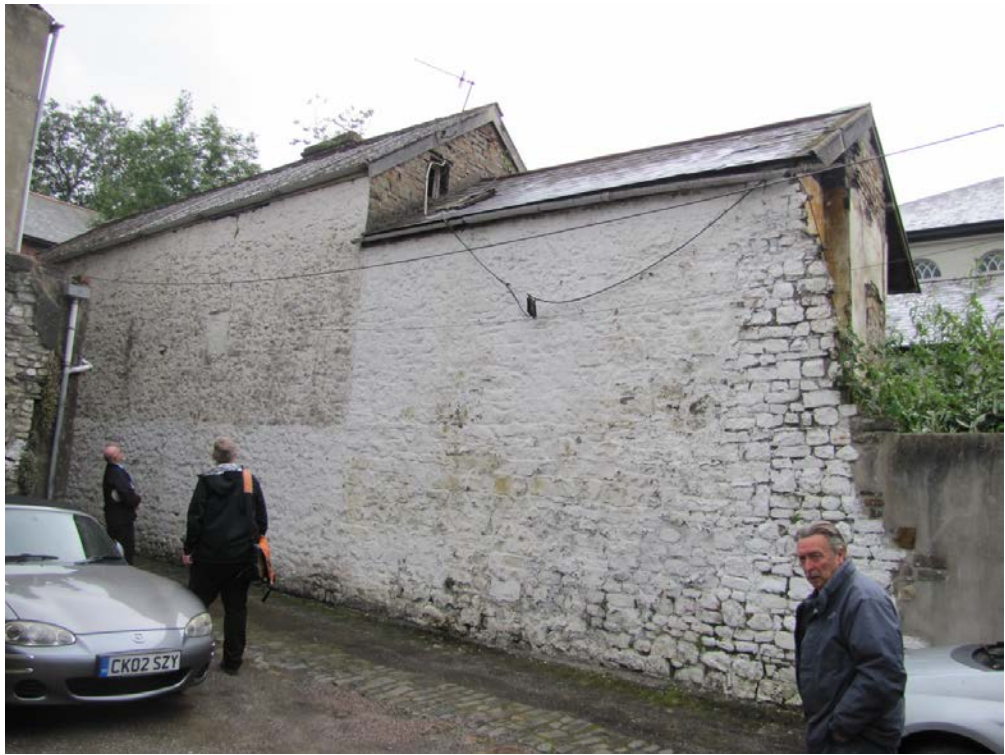
<p>Photograph taken 2016</p>
Current use	Presumed former dwellings. Both vacant & dilapidated.
Architectural Description & Condition	<p>Visible on John Woods' 1836 town map and in more detail on 1851 Public Health Map. Bowen's Court would have been open to High Street alongside 8 Pontmorlais where there is currently a modern wall infilling the gap.</p> <p>Formerly small (low-two storeys) duo-pitch roofed stone cottages.</p> <p>No.3 Bowens Court linked to No.8 Pontmorlais.</p>
Summary Assessment of Building's Contribution / Significance to the Conservation Area	As one of the few survivals of the early 19 th century worker's dwellings that once proliferated behind the western side of High Street these should have a high significance.

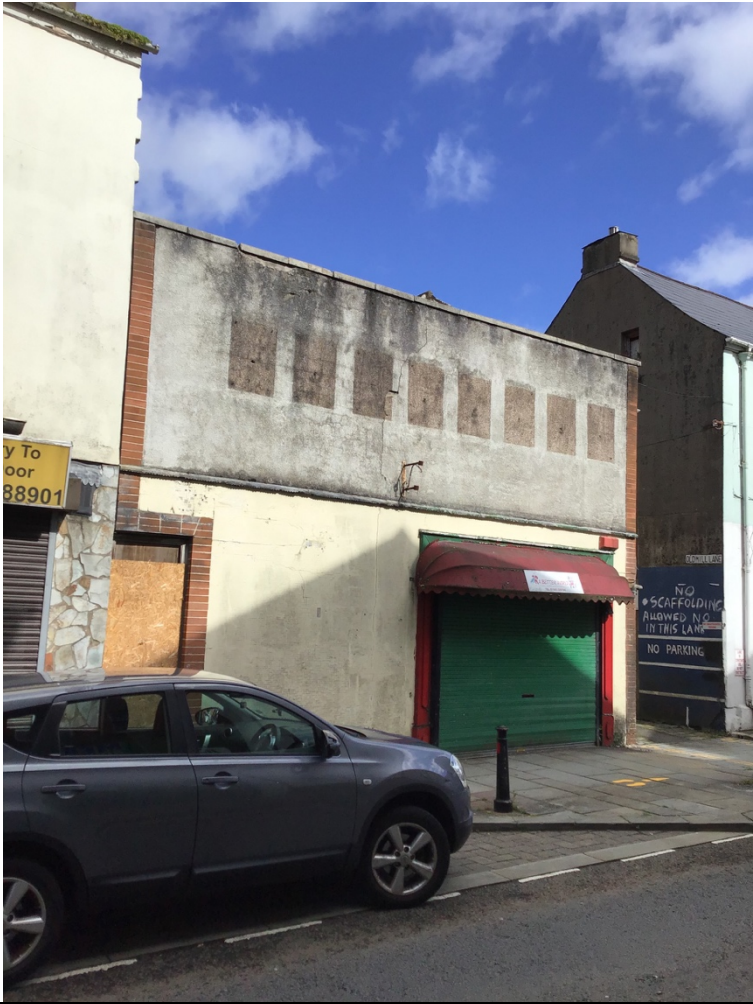
Current use	Former comic shop (looks unoccupied at present)
Architectural Description & Condition	An old low building hidden behind poor remodelled front elevation with modern rendered parapet and wall to yard behind.
Summary Assessment of Building's Contribution / Significance to the Conservation Area	Some significance since it retains historic fabric behind the modern finishes that are visually very poor, although there is potential for its significance to be increased if it could be returned properly to its historic form and appearance.
