Storm Bert Recovery Update

Pentrebach

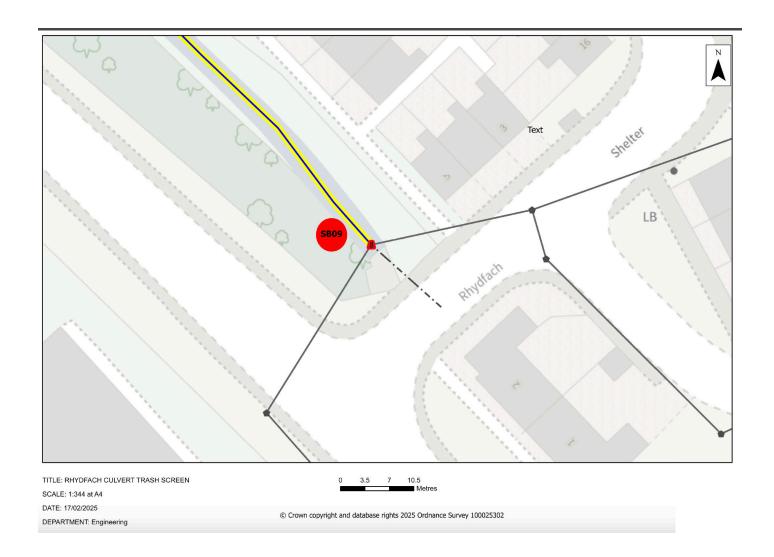
Scheme No.	Location	Works
SB09	Rhydfach	Replacement of trash screen at Rhydfach lower culvert inlet.

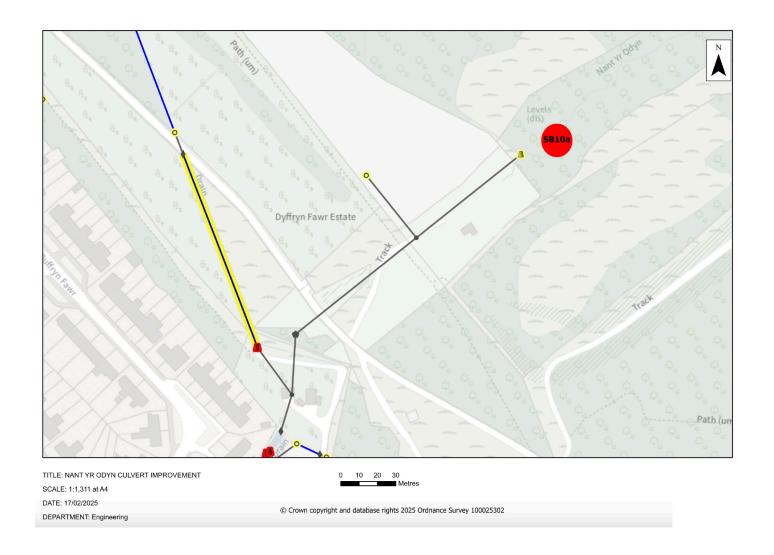
Scheme No: SB10a

Scheme No.	Location	Works
SB10a	Nant-Yr-Odyn watercourse	Improve headwall structure and trash screen. Install lined channel to overflow structure to protect against future overtopping.

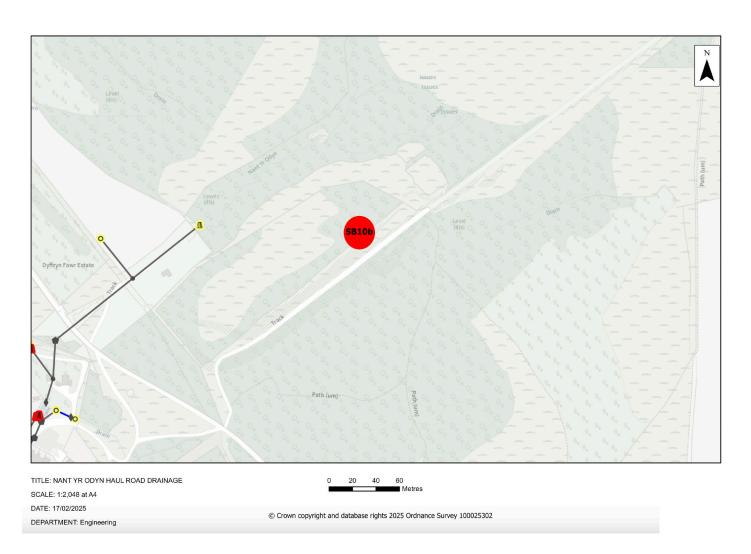
Scheme No: SB10b

Scheme No.	Location	Works
SB10b	Nant-Yr-Odyn incline	Formalise haul road surface, install drainage grips to divert surface water to new drainage ditches near Trevithick Trail. Install new 600mm pipe at Trevithick Trail and construct lined channel to outfall chamber at General Dynamics channel.

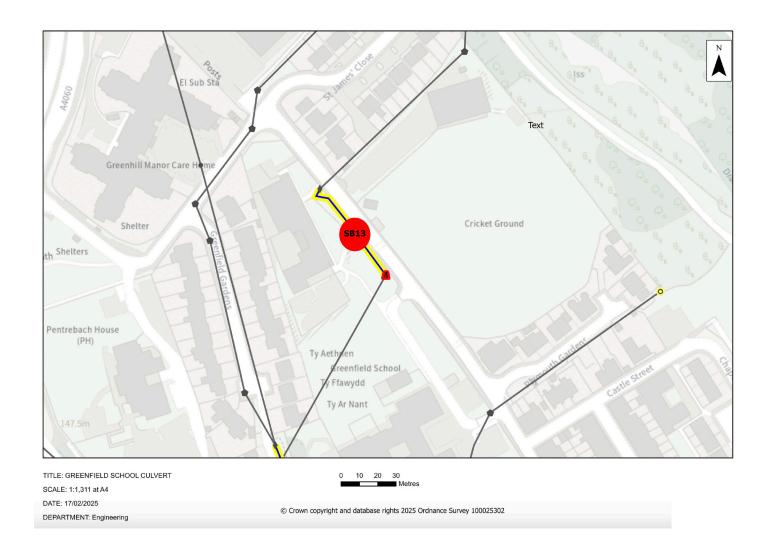
Scheme No.	Location	Works
SB13	Greenfield School	Install 50m of new 1.2m diameter culvert to seal watercourse.

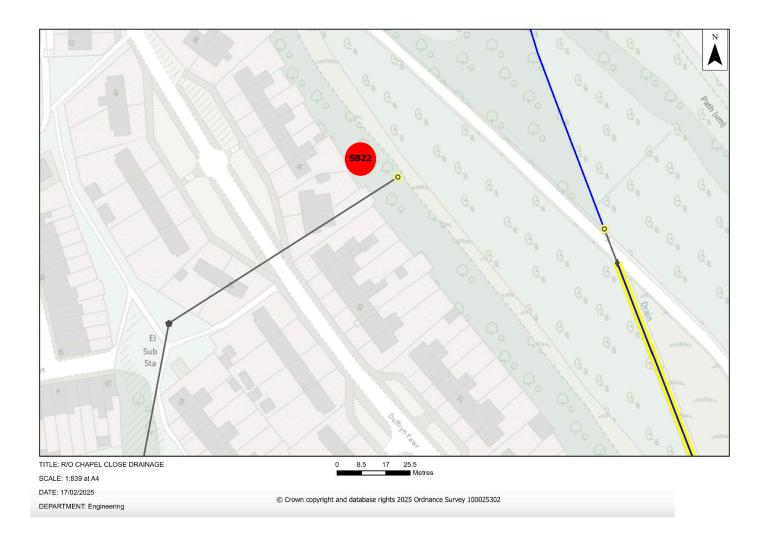
Scheme No.	Location	Works
SB22	Land to north of Chapel Close	Expose existing masonry culvert. Install new culvert to existing culvert.
		Construct 2m retaining wall.

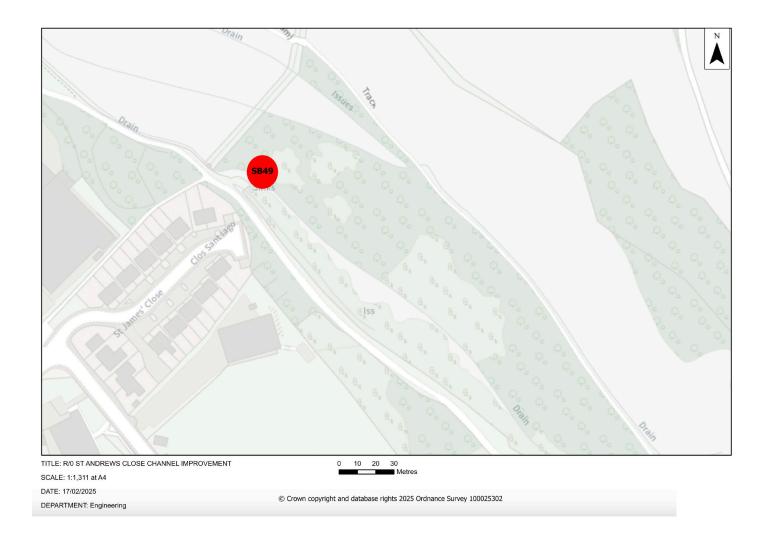
Scheme No.	Location	Works
		Re-profile and line 100m of existing watercourse with Concrete Canvas.
