# Storm Bert Flood Scheme Updates Pentrebach

Cyngor Bwrdeistref Sirol  
**MERTHYR TUDFUL**  
**MERTHYR TYDFIL**  
County Borough Council

**May 2025**

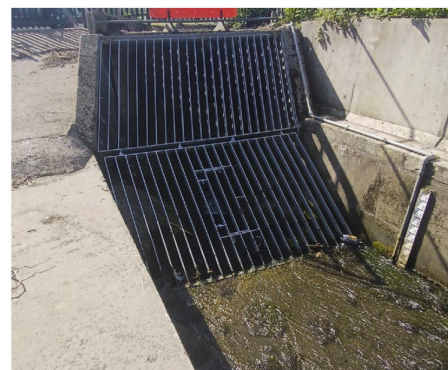
*New trash screen at Rhydfach Lower*

Scheme No.	Location	Works
SB09	Rhydfach	Replacement of trash screen at Rhydfach lower culvert inlet.

The replacement culvert trash screen has now been completed reducing the risk of future blockage within the culvert.

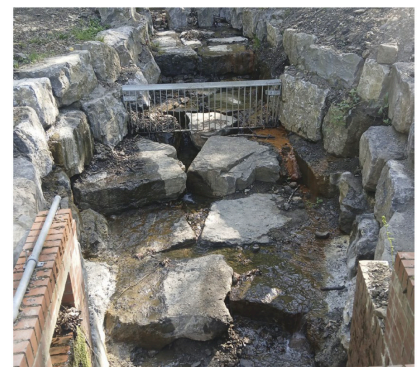
Improvement to headwall structure

Scheme No.	Location	Works
SB10a	Nant-Yr-Odyn watercourse	Improve headwall structure and trash screen. Install lined channel to overflow structure to protect against future overtopping.

Scour to the land immediately to the south of the culvert has now been reinstated with compacted type 1 aggregate, land regraded and maintenance track constructed. The culvert inlet structure has now been replaced with an improved block stone structure to increase storm flow capacity. A new culvert trash screen with increased surface area to reduce the risk of blockage is due to be installed at the end of the overall culvert work programme.

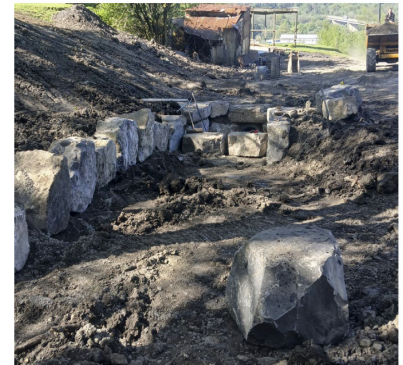
Culvert overflow structure under construction

Work is currently ongoing to install a blockstone overflow structure from the culvert inlet to a new headwall 30m downstream of the main culvert headwall. The overflow structure will ensure, any excess flows are captured and diverted back in to the culvert and help to prevent flood flows to the Rhydfach residential area immediately to the south.

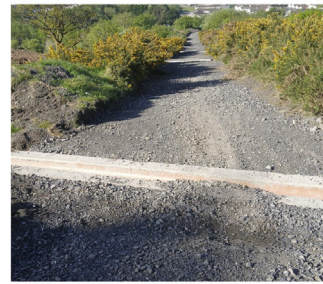
Haul road drainage grips

Haul road surfacing has now been formalised with type 1 material and drainage grips installed at 20m intervals to divert surface water away from the gated entrance to the track and on to land immediately to the east of the haul road.

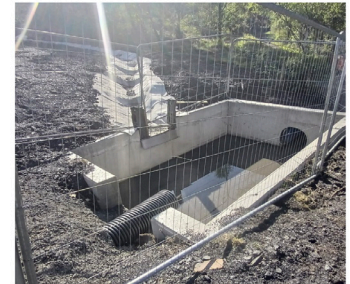
Culvert inlet structure

A series of lined channels have been installed to manage surface water from the haul road, directing water to an improved concrete headwall adjacent to the Trevethick trail.

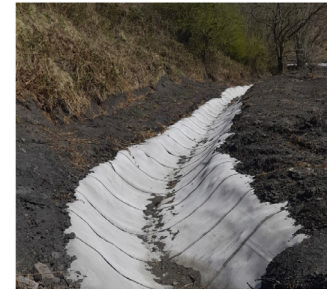
Concrete canvas channel

A new 600mm pipe has been installed under the Trevithick Trail directing surface water to a new Concrete Canvas drainage ditch that is connected to the existing drainage channel to the rear of General Dynamics.

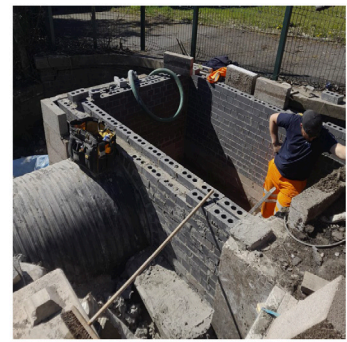
Inspection chamber under construction

Tree and root removal along the watercourse embankment has been undertaken. The 50m installation of a 1.2m diameter culvert and construction of two access chambers at the connection points is now complete.

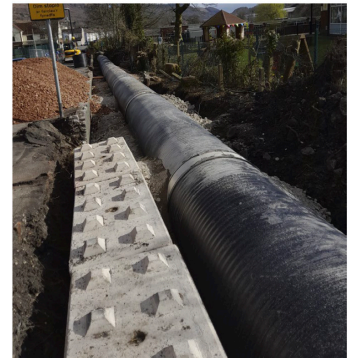
Culvert installation

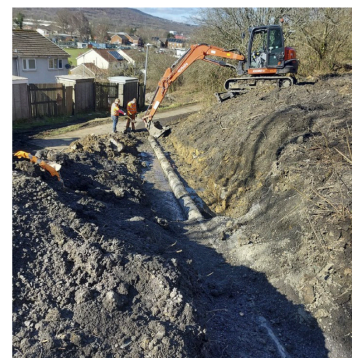
*Culvert installation*

Culvert outlet adjacent to Trevithick trail located and new section of connecting 225mm pipe installed to existing chamber. 3.5m high retaining wall installed to secure excavated embankment. 80m of new 225mm pipework installed to replace collapsed culvert.

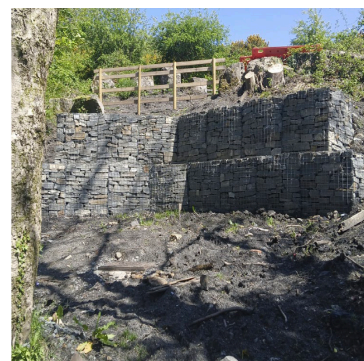
*Retaining wall above culvert outlet*

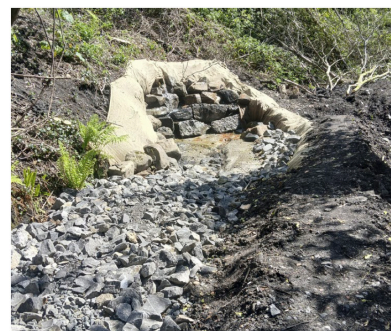
*Culvert outlet structure*

Improvement to the outfall structure with the construction of a blockstone headwall have been completed. Vegetation clearance of the "Dragons Teeth" cascade and ditch reprofiling to cut of drains have been carried out to divert runoff back to the culvert inlet.

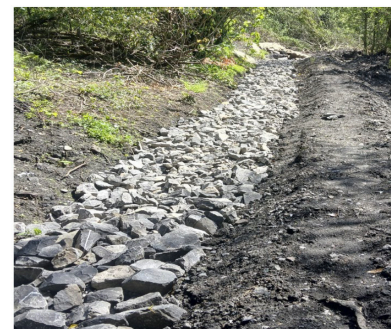
*Stone lined trench*

Vegetation clearance and channel clearance/reprofiling completed. 100m installation of impermeable liner and 225mm perforated pipe to help prevent seepage through the embankment and placement of 80 tonnes of ballast stone undertaken.
