Merthyr Tydfil County Borough Council

Flood and Water Management Act 2010

Section 19 Flood Investigation Report

This Section 19 report provides a factual review of Storm Dennis, the storm event that occurred from 13 to 19 February 2020, reaching the UK on 15 February 2020. The report specifically focusses on the impact that Storm Dennis had on those areas found within the Merthyr Tydfil County area where more than twenty properties experienced internal flooding. Those areas have been identified as Troedyrhiw and Pentrebach.

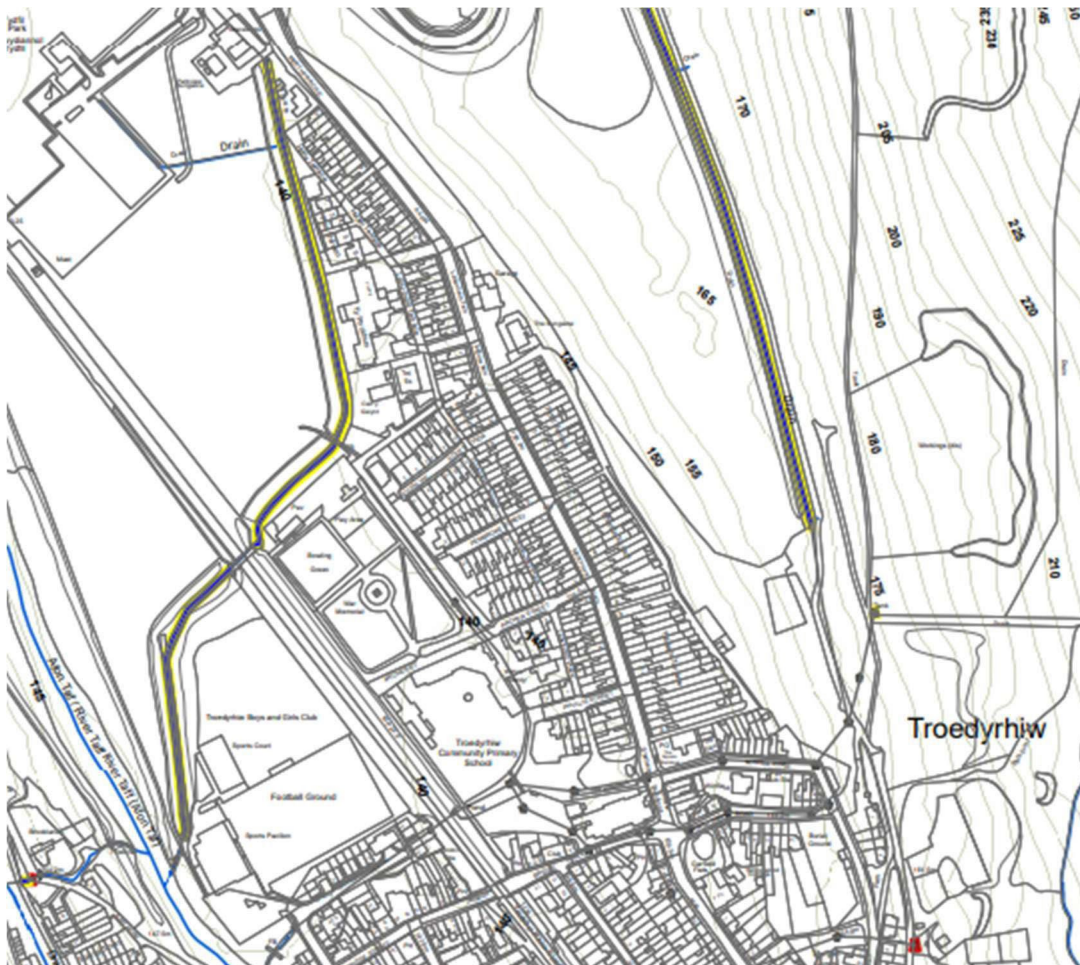
Troedyrhiw also has two significant watercourses around it, with one to the north east and another to the south west of the village. The watercourse to the south west is the Plymouth Feeder Channel, which feeds directly into the River Taff to the west of Troedyrhiw. It is this channel that became overwhelmed with the volume of water draining into it, that caused the flooding of the Troedyrhiw estate.

Image 4 – A map of Troedyrhiw and the surrounding watercourses

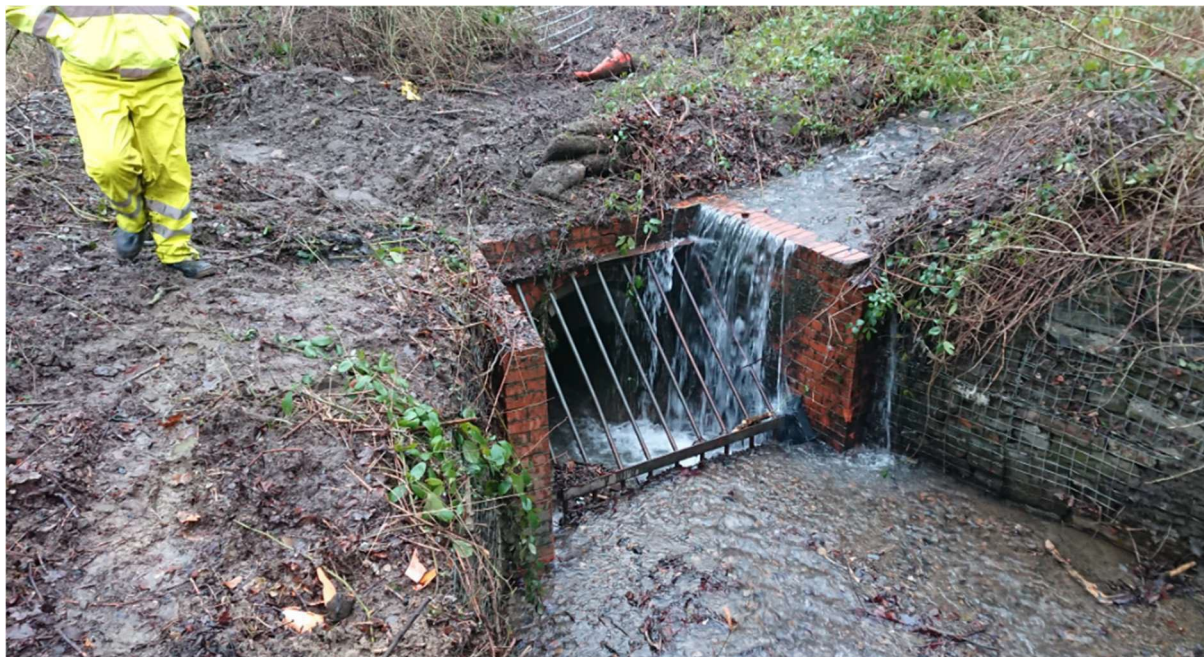
A blocked culvert was found to be the cause of the flooding event at Pentrebach, with debris and surface material from the land above entering the channel and being unable to travel further once it reached the culvert.

Image 8: Culvert no.4 at Pentrebach, cleared following the flooding incident.

Currently, MTCBC operate a programmed maintenance schedule on watercourses and associated culverts, clearing any debris (such as a fallen tree or branches) or fly tipped material that is reported to the local authority by the public. In addition, MTCBC has flood monitoring stations on 14 of its culverts at highest risk. During storm events, MTCBC operate a cleansing schedule on those assets at highest risk, and where it is identified that attention needs to be focussed for that specific storm event.

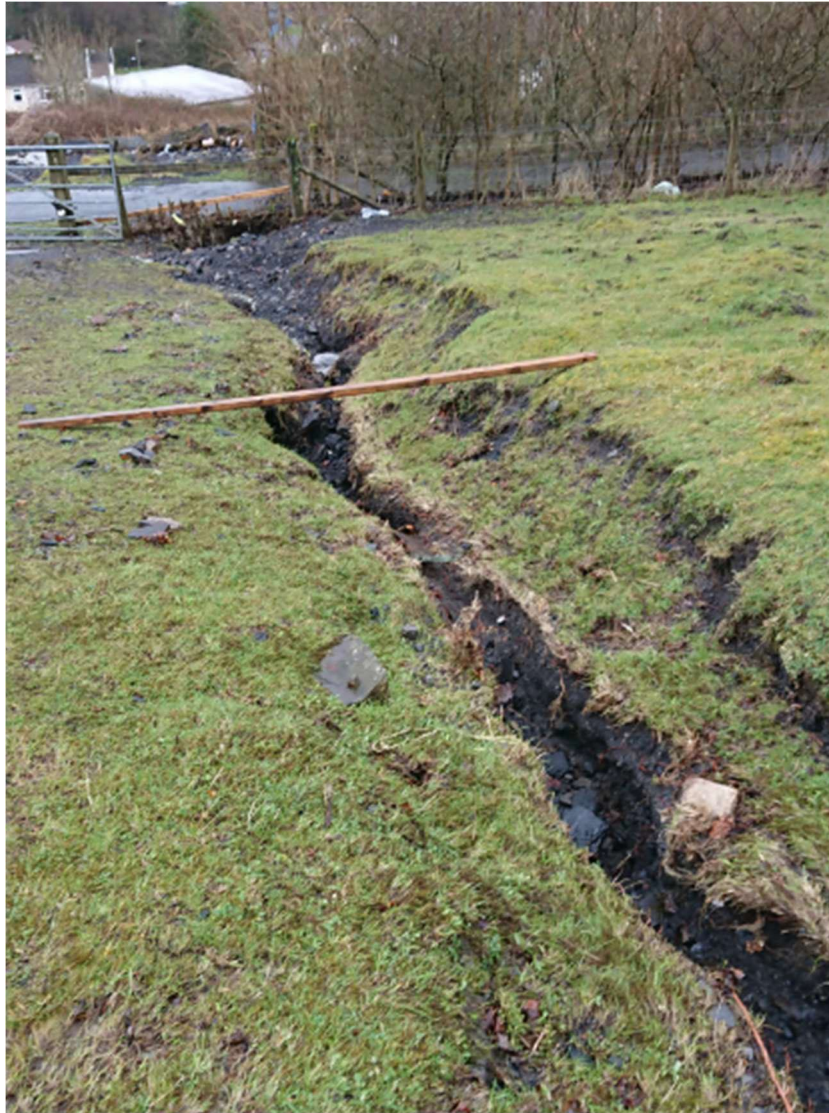
Image 10: Downhill view of the damage caused by debris and loose material at Pentrebach.

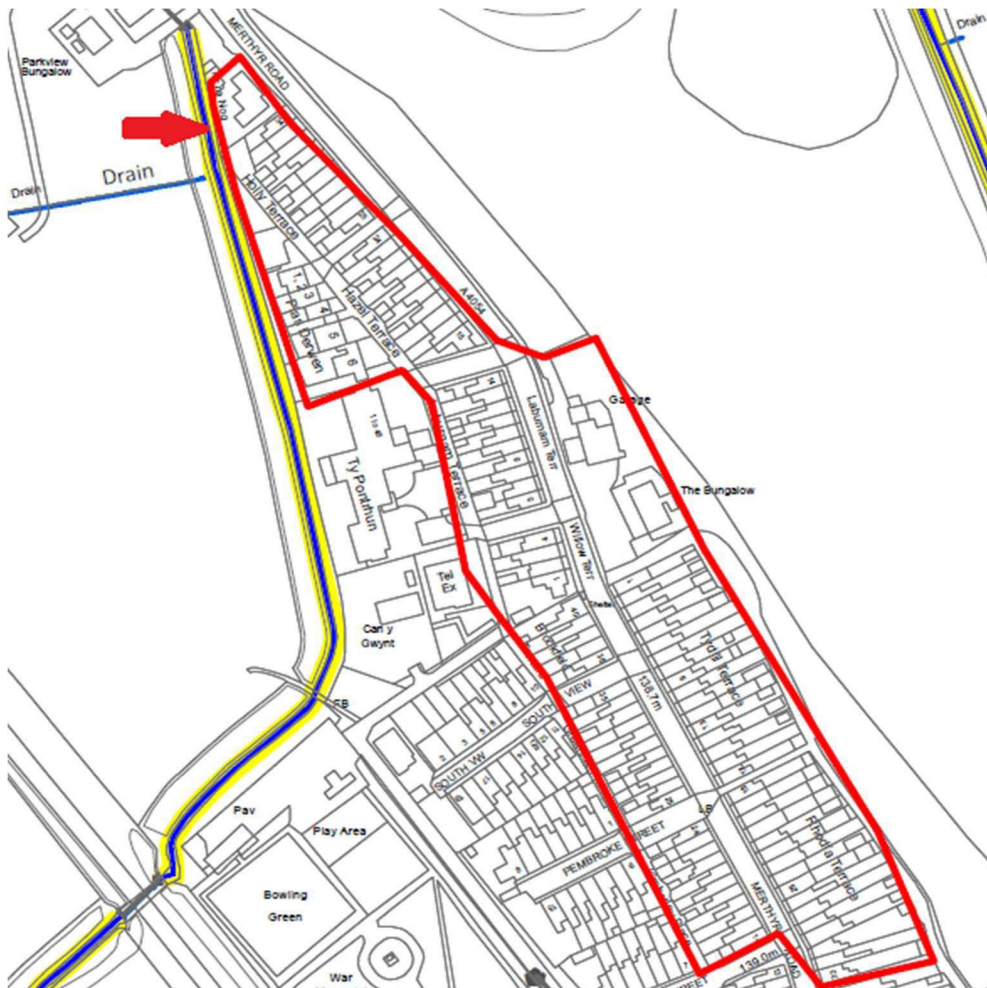
The map below identifies the channel in question (highlighted in yellow), as well as the area that was flooded by the watercourse (outlined in red). The arrow at the top left of the map shows the point of the channel at which the flooding occurred.

Image 11: Map showing the point at which the Plymouth Feeder Channel breached the embankment, and the area of Troedyrhiw subsequently flooded

As a flood defence measure, a flood bund 2.5-3m in height had previously been built along the residential side of the water channel. There is a low point in this bund, situated at the same place the arrow is pointing on the map. It is at this low point that the watercourse breached the flood defences, flooding the nearby properties.

sacrificial trash screen in section of watercourse under A470
Nant y Coed	Drainage and reinstatement work to a landslide
Fernhill Close	Replace 200m of undersized culvert along Chapel Road. Re-profiling and lining of existing channel to the rear of Fernhill Close
Plymouth Feeder, Troedyrhiw	Dredging of feeder to remove silt. Installation of 2.5m high flood defence to the Transport for Wales culvert. Installation of new footbridge to southern section at the higher level, to remove an identified pinch point.. Installation of flood monitoring devices at both ends of the feeder channel. Installation of non-return valve.
Plymouth Feeder, Troedyrhiw	Flood modelling to determine cause of flooding and type of flood defence required to protect Troedyrhiw (completed)

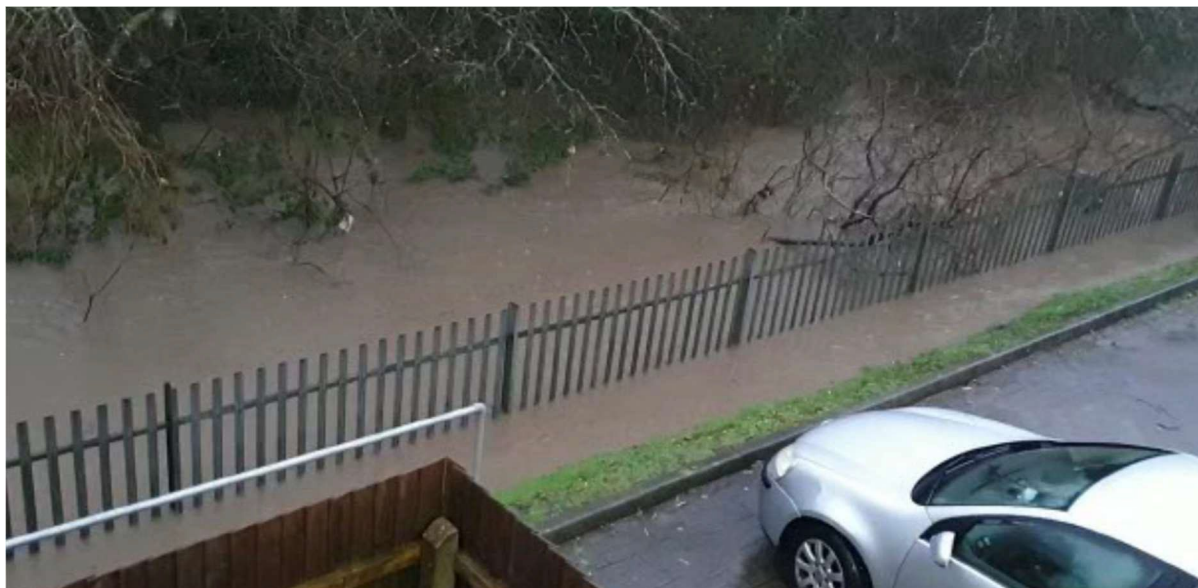
An over-loaded watercourse was found to be the cause of the flooding event at Troedyrhiw. Water levels in the River Taff were running high due to the increased rainfall from Storm Dennis, and Storm Ciara the previous week. This backed up into the Plymouth Feeder Channel, which could not cope with the volume of water.

Image 12: View of the Plymouth Feeder Channel with rising water levels during the day of 15 February 2020

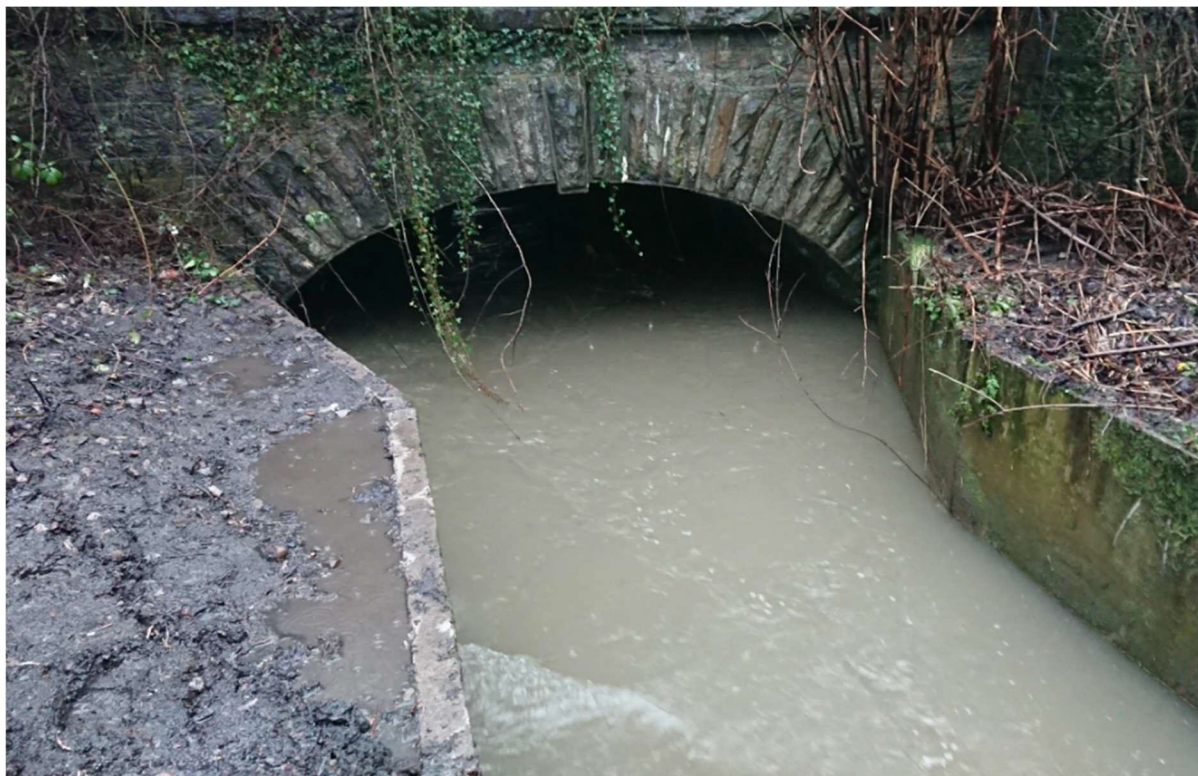
There are a number of highway drainage gully systems in the area connected to the Plymouth Feeder Channel. As a result of the feeder channel being overwhelmed and running at capacity, these drainage systems were unable to drain effectively.

Image 14: Rising water levels at a railway culvert at the Plymouth Feeder Channel

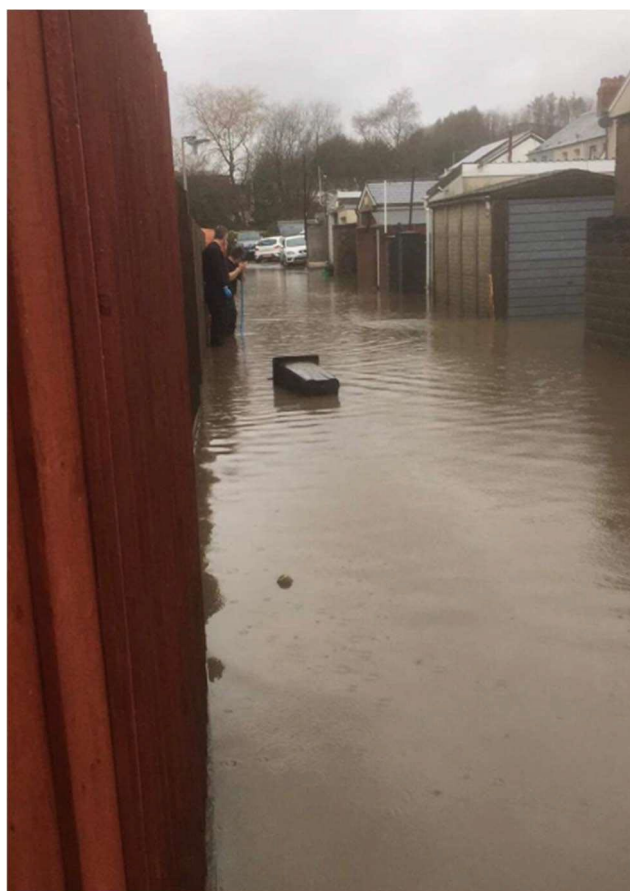
The Plymouth Feeder Channel has been identified as the watercourse where a culvert overloaded, ultimately leading to the flooding of 129 properties on the nearby Troedyrhiw housing estate.

Image 15: Flood damage to properties on the Troedyrhiw estate following the overspill of the Plymouth Feeder Channel

Image 16: Flood damage to properties on the Troedyrhiw estate following the overspill of the Plymouth Feeder Channel

In Troedyrhiw, 129 properties experienced internal flooding, when the Plymouth Feeder Channel could no longer contain the volume of water flowing through it. Investigation has found that water levels of the River Taff were significantly higher than normal, with Storm Dennis being recorded as a 1 in 200-year event for the river catchment. This resulted in water in feeder channels, and the Plymouth Feeder Channel at Troedyrhiw specifically, becoming backlogged and unable to cope with the demand. It has been noted that future severe storm events in the River Taff catchment are highly likely to cause repeat flooding of the Plymouth Feeder Channel at Troedyrhiw. A number of prevention/alleviation measures are being put in place at the feeder channel to reduce the potential of future flooding events. As well as the installation of additional flood defences and a higher foot bridge, a non-return valve is also being installed, as well as flood monitoring devices at either end of the channel.
