APPENDIX B - BUILDING-BY-BUILDING ASSESSMENT (2020)

1 LOWER HIGH STREET SQUARE, ST.TYDFIL'S CHURCH & COURT STREET

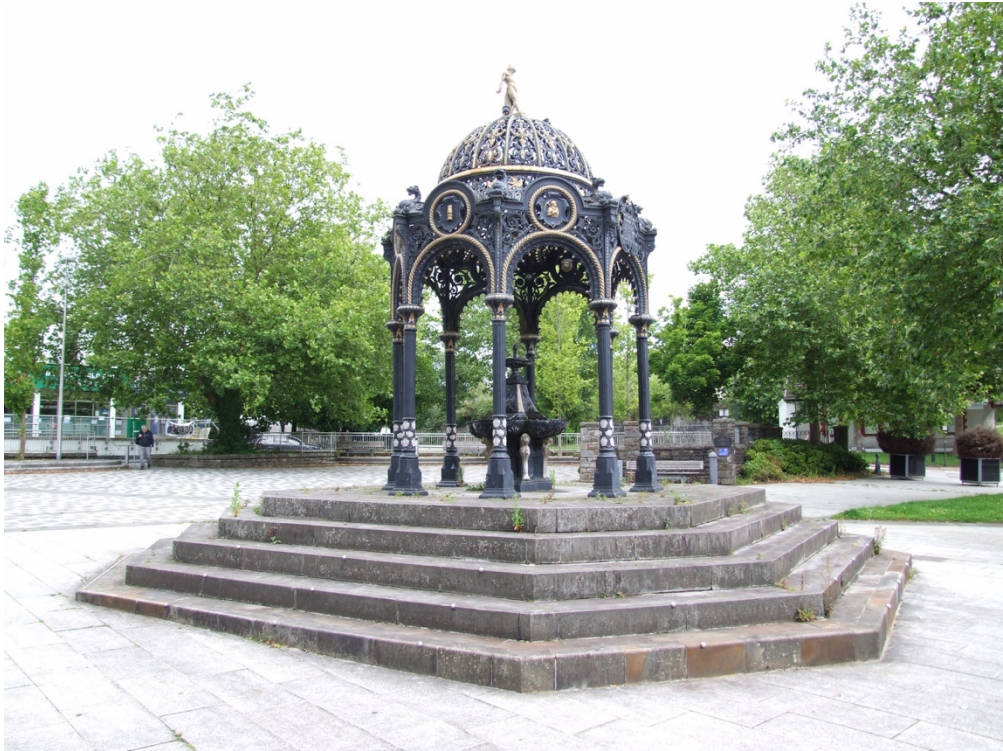
Address	<p>Monument / water drinking fountain located towards the southern end of the square at the southern end of the Conservation Area.</p>

Current use	Disused water drinking fountain
Architectural Description & Condition	<p>Completely made of painted finish cast iron elements cast by W MacFarlane & Co. of Glasgow.</p> <p>An octagonal construction on columns, with a domed fret-like roof and at the centre is a four-sided drinking fountain.</p> <p>Modern metal grilles have been added over the basins. There is a lot of rubbish collected in these basins / bowls.</p> <p>There's a lot of broken glass on the ground and this area looks unkempt.</p> <p>The ironwork is mostly painted black with some imitation gold paint to some of the details.</p> <p>The monument is raised up on a plinth formed by five modern stone steps. Historic photograph (visible online at www.alangeorge.co.uk) shows that the fountain had a similar plinth arrangement (albeit 4no. steps) when it was in its original location at the centre of road to the south of St.Tydfil's churchyard.</p> <p>A galvanised steel Aco-type drainage channel runs around the base of the water fountain. I can't see any water coming out of it currently and there is just some stagnant water in the bowls.</p> <p>There is a lot of lighting cabling hanging up inside the roof structure and I can see some spotlights at higher level above the columns.</p>

<p>The monument helps to mark the end of the current town centre.</p> <p>It would be good if the water fountain could be restored and brought into use.</p>
<p>Summary Assessment of Building's Contribution / Significance to the Conservation Area</p>	<p>Highest / most positive, although it could be much improved.</p> <p>Grade II listed.</p>

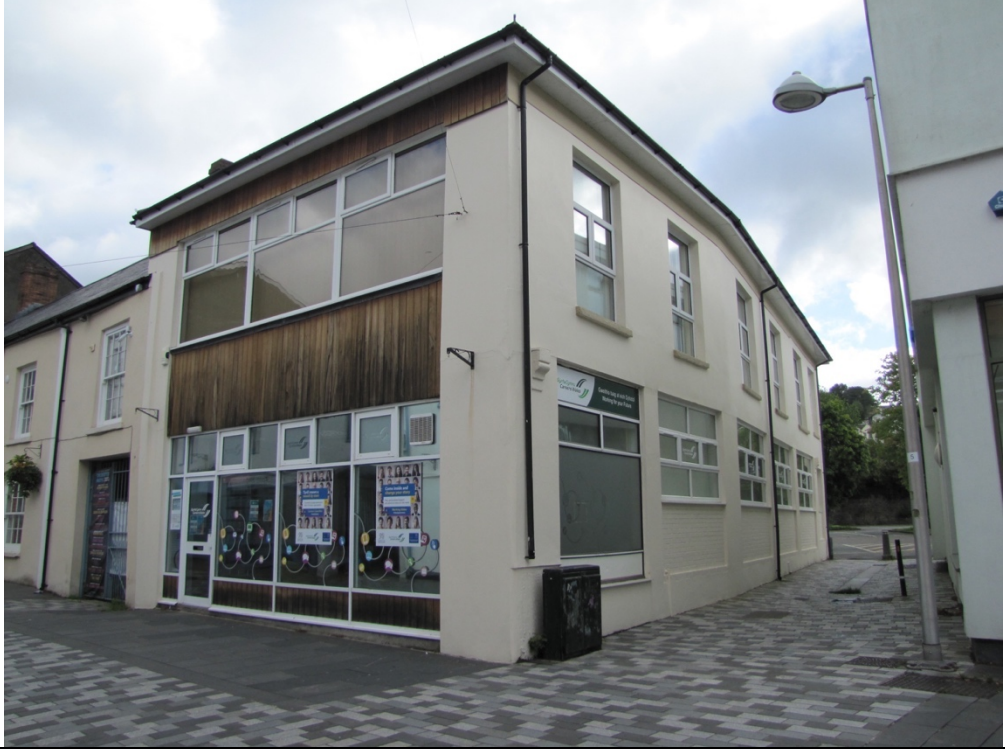
Address	27 High Street

Current use	Careers Wales (offices)
Architectural Description & Condition	<p><u>Front</u></p> <p>Modern two-storey building with hipped roof construction.</p> <p>Fibre-cement slating with concrete hip tiles, plastic fascia, plastic soffits and plastic rainwater goods.</p> <p>Plastic rainwater goods.</p> <p>Timber cladding to the two-storeys High Street elevation.</p> <p>Aluminium windows and door.</p> <p>Good visibility helps to 'police' the street.</p> <p><u>Rear</u></p> <p>Modern render to walls.</p>

<p>Plastic windows and aluminium door at the centre of its east elevation.</p> <p>Heat pumps on the side of the building.</p> <p>Painted metal external escape stair.</p>
Summary Assessment of Building's Contribution / Significance to the Conservation Area	<p>None, although the form and roof of the building 'fit' fairly well within the Conservation Area.</p>

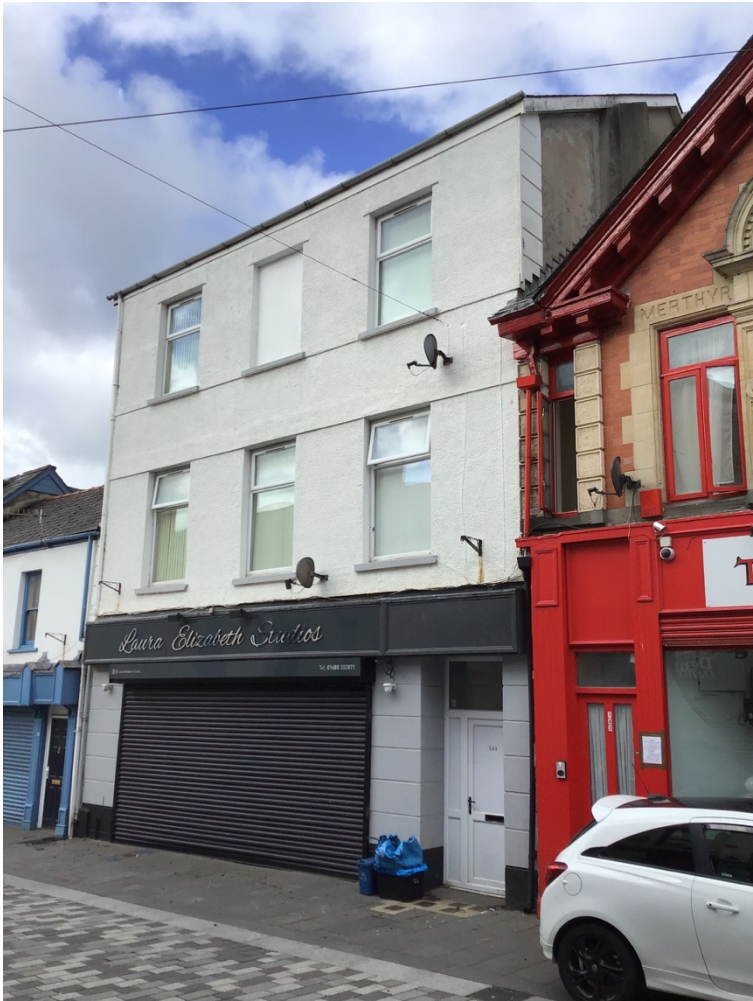
Address	144 High Street

Current use	Laura Elizabeth Studios (hair salon)
Architectural Description & Condition	<p><u>Front</u></p> <p>Three-storeys building.</p> <p>Windows are partly obscured (probably a film applied).</p> <p>Modern rough-cast rendered walls to 1st and 2nd floors with modern bell-cast detailing.</p> <p>Plastic rainwater goods, painted stone cills, and plastic windows.</p> <p>Some rusticated render either side of the shop frontage.</p> <p>Plastic front door.</p> <p>Roller shutter and lead weatherings.</p> <p>Wall mounted satellite dishes.</p>

<p><u>Side (north elevation visible above roof level of no. 143 High Street)</u></p> <p>Modern cement-based render with some remnants of rusticated render at its eastern-most end.</p> <p><u>Side (south elevation visible above roof level of no. 145 High Street)</u></p> <p>Modern cement-based render with bell-cast details.</p> <p>Chimneystack has been removed.</p> <p>Some plastic windows visible.</p> <p>Some remnants of rusticated render at junction between the two buildings. This does not match the rustication to no. 143.</p>
Summary Assessment of Building's Contribution / Significance to the Conservation Area	<p>Highly positive as a survival of a likely mid-19th century building with potential for further detailing and finishes improvements.</p> <p>Its three-storeys scale is a little at odds with most other buildings along this length of High Street, and so less human in scale and slightly detrimental to the scale of the street. However, this seems likely to have been the historic arrangement.</p>

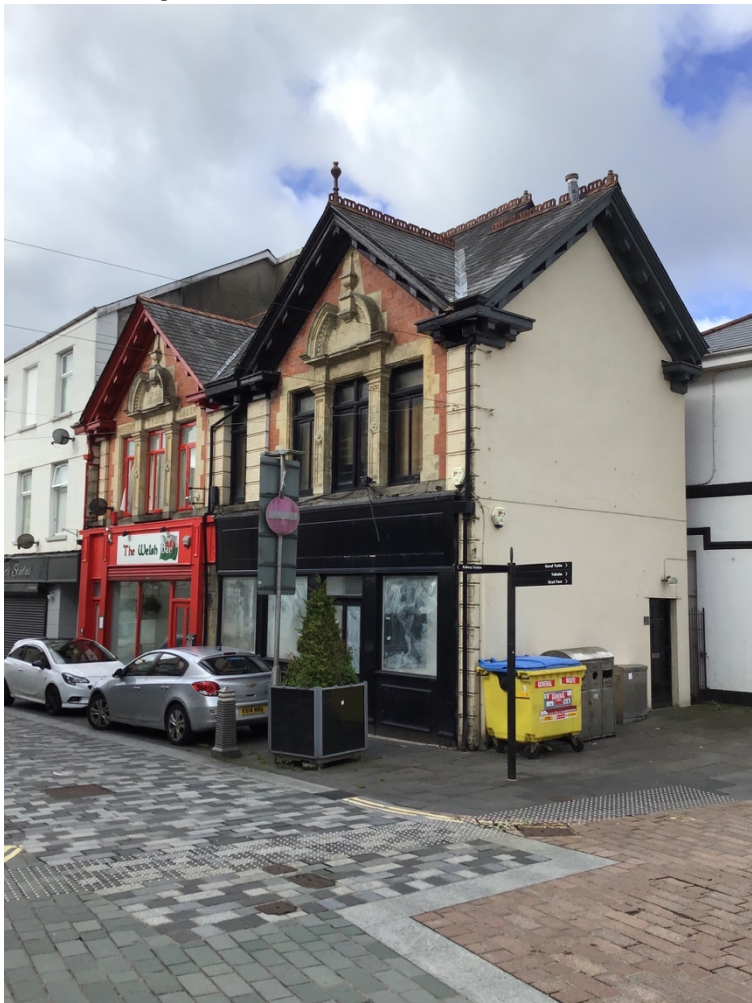
Address	143a & 143 High Street

Current use	143a (disused, lastly Napoleon's Restaurant and Pizzeria) & 143 (The Welsh Bar) – both originally the Merthyr Tydfil Gas Company building
Architectural Description & Condition	<p>Bold deeply dentilled set of gables with painted timber mouldings. The steeply pitched roofs and projecting gable roofs are dominant features.</p> <p>Beneath each gable is a bathstone window surround with nicely proportioned window openings and bathstone detailing. Deeply rusticated pilasters to 1st floor.</p> <p>An inscription within the bathstone-work to no. 143 reads 'MERTHYR TYDFIL GAS COY' and 'Est 1836 ... 1868'.</p> <p>Built as a pair.</p> <p>There's a small 'heritage-trail' plaque, badly faded and illegible, on the pilaster between the two buildings.</p> <p>Since the 'Merthyr Tydfil Gas Company' carving is on the southern-most gable I had wonder whether there was actually a third matching section to the south of this. It seems a bit odd</p>

<p>just to have two. However, the form and detailing of no. 144 suggests it may pre-date nos. 143a and 143 so maybe they were simply built as a pair.</p> <p><u>No. 143 (The Welsh Bar)</u></p> <p><u>Front</u></p> <p>Modern painted timber casement windows of a nice proportion but the windows are modern. Painted red.</p> <p>Natural slate roof covering with clay capped modern ridge tiles.</p> <p>The lofty ground floor has red painted roller shutters, modern timber pilasters and frontage.</p> <p><u>No. 143a (disused, lastly Napoleon's Restaurant and Pizzeria)</u></p> <p><u>Front</u></p> <p>Painted timber casement windows more traditional, possibly original detailing, with dentils along the top transom.</p> <p>Natural slate roof covering with old (likely original) crested decorative clay ridge tiles with semi-circular headed 'hole' details. Original clay finials to gable and northern apexes of roof, although those to the roof apexes are missing their top halves.</p> <p>Painted timber work to the ground floor of no. 143a is more nicely detailed than to no. 143.</p> <p>No. 143a appears to be undergoing renovation.</p> <p>The timberwork looks to be in fairly good condition.</p> <p>2-over-2 panelled front door.</p> <p>Joinery is black painted.</p> <p>The panels of the Gas Company Building are clay facing brickwork, very fine joints.</p> <p><u>Side (north elevation)</u></p> <p>Painted deeply overhanging dentilled bargeboards and painted timber mouldings.</p> <p>Painted rendered gable wall.</p> <p>Stainless steel rubbish bins set against the northern gable of 143 are very poor visually.</p>

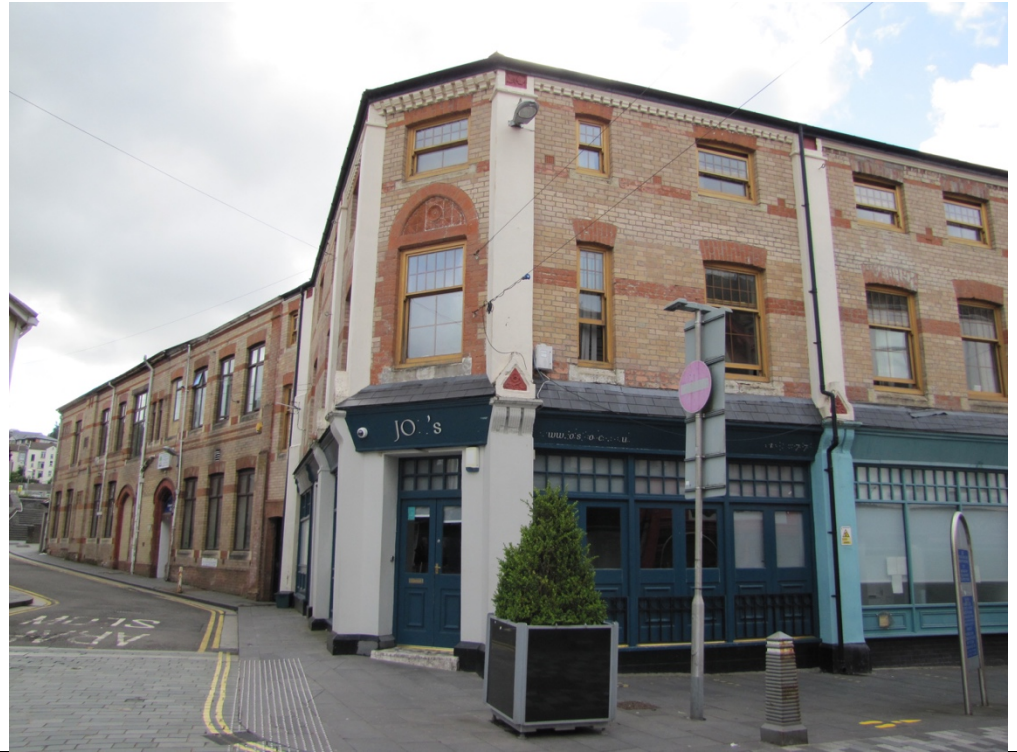
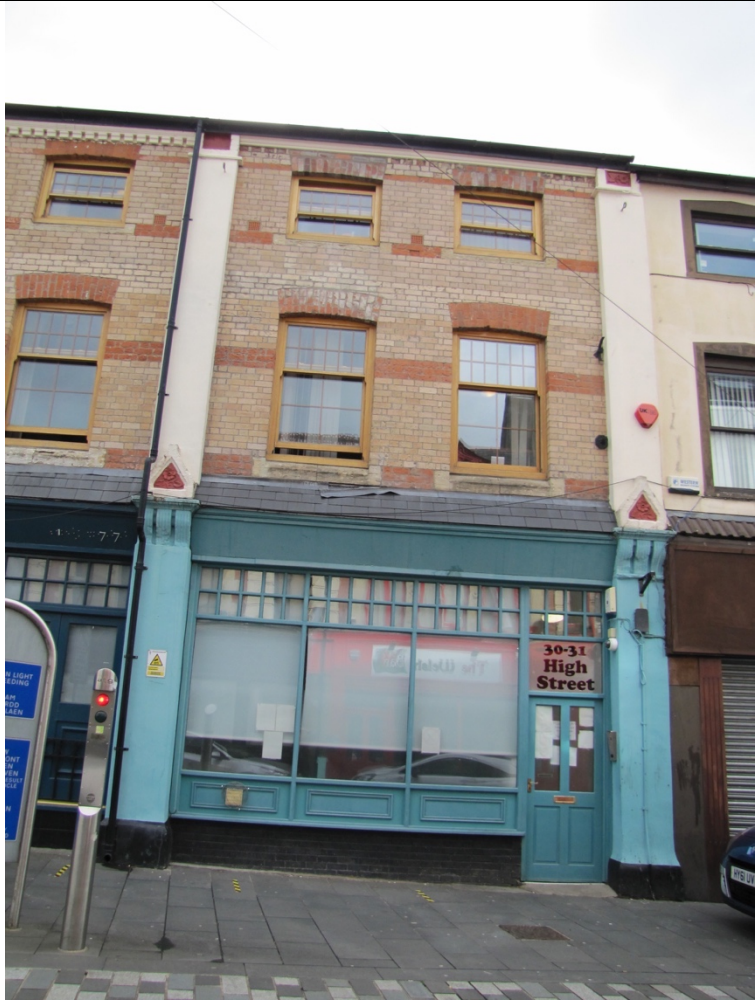
30 & 31 High Street

Current use	JOL's (restaurant)	
Architectural Description & Condition	<p><u>Front</u></p> <p>Parts of three-storeys building probably built as part of the Conservative Club building and adjacent no. 29 High Street.</p> <p>Nos. 30 and 31 appear to be running as one tenancy currently, although historically it was probably two separate tenants / shops.</p> <p>Detailing is very similar to the façade of the Conservative Club on Masonic Street. Largely buff clay facing brickwork to 1st and 2nd floor levels with red clay facing brickwork banding / courses, bathstone window cills and red clay brick voussoirs.</p> <p>Painted dentilled brickwork or stonework running along the head of the wall at eaves level to no. 31 may have been removed to no. 30, but a moulded string course remains. The remaining stringcourse might be painted render or stone.</p> <p>Full height pilasters each side of nos. 30 and 31 may be painted render. These have red clay moulded 'rose' inserts to the capitals.</p>

<p>The pilasters at street level also have capitals with red clay moulded inserts. The glazed shop frontage projects beneath a narrow fibre-cement slated canopy. Joinery to shop frontage painted turquoise.</p> <p>The dentilled eaves stringcourse remains at the head of the chamfered corner of the building. This is slightly more elaborate and deeper than the others. The chamfered corner wall panel has a larger window with a terracotta arched detail above it.</p> <p>The partly glazed restaurant frontage incorporates a door at the corner and doors opening onto High Street. This has been well done. This is all modern painted timber.</p> <p>The roofs of these three-storey buildings are not particularly dominant since they are of a shallow pitch and the eaves stringcourse detailing draws the eye.</p> <p><u>Rear</u></p> <p>Modern painted plain rendered walls extended up to the ridge level of the adjacent short terrace, perhaps to support a mono-pitched roof beyond.</p> <p>Modern sash windows with a stained or painted finish.</p> <p>Galvanised steel fire escape stair with a galvanised kitchen flue and a painted flush fire escape door.</p>

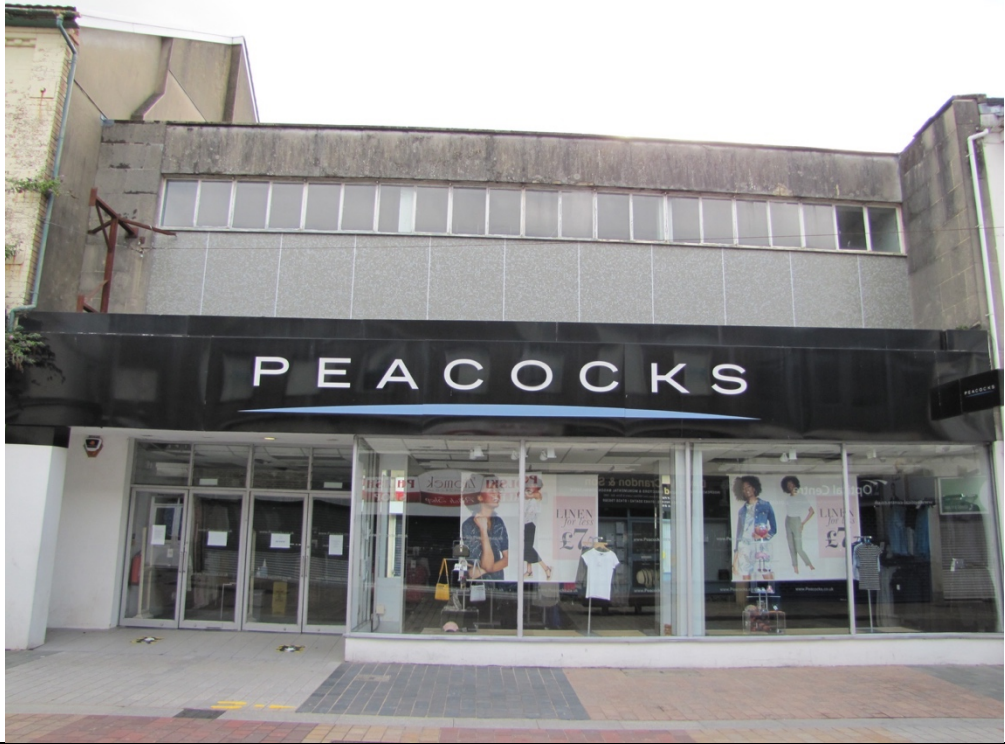
Address	<p>37 High Street</p>

Current use	Peacock's (clothes shop)
Architectural Description & Condition	<p>1st floor deeply set back from the street line with Crittal-type metal windows running the full width. Rendered and mosaic 1st floor walls.</p> <p>The street level is of all modern aluminium framed windows.</p>
Summary Assessment of Building's Contribution / Significance to the Conservation Area	None.

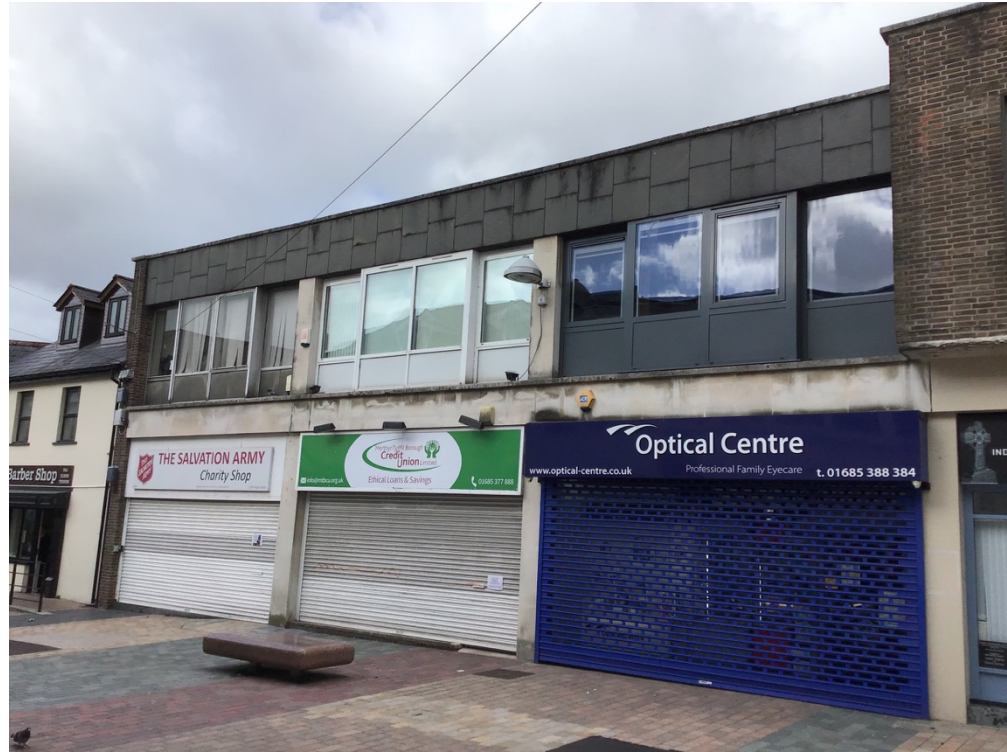
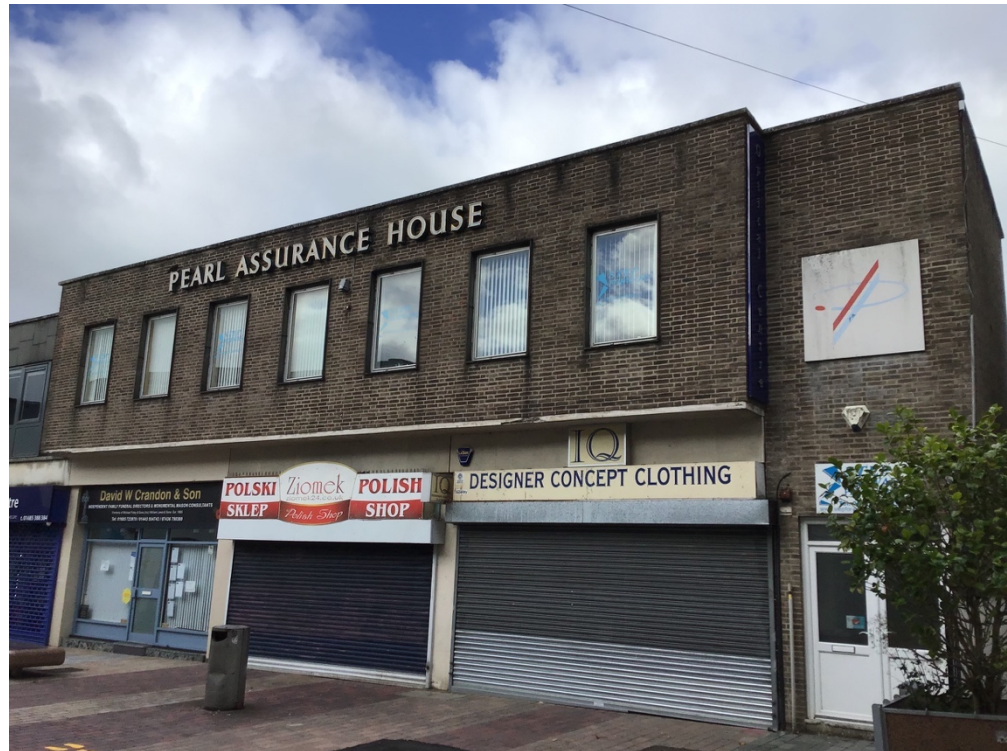
136 to 139 High Street (Pearl Insurance House)

<p>Architectural Description & Condition</p>	<p><u>Front</u></p> <p>Forms a block between no. 140 Hugh Street (barber shop) and High Street Chapel.</p> <p>Probably mid-20th century construction.</p> <p>Although this building is slightly taller than no. 140 High Street, the two-storeys scale of this block visually fits / is appropriate within this length of High Street. However, its parapet form is clearly modern and so doesn't fit visually.</p> <p>Bathstone cladding around the shopfronts and between ground and 1st floor.</p> <p>Northern half of the block has a projecting 1st floor with brown facing brickwork whilst the southern half is set back and has glazed infill panels.</p> <p><u>Rear</u></p> <p>Visually poor.</p> <p>Flat roofed, modern brick and rendered walls.</p> <p>Security shutters to windows.</p>
<p>Summary Assessment of Building's Contribution / Significance to the Conservation Area</p>	<p>None, although its scale does fit this part of the Conservation Area.</p>

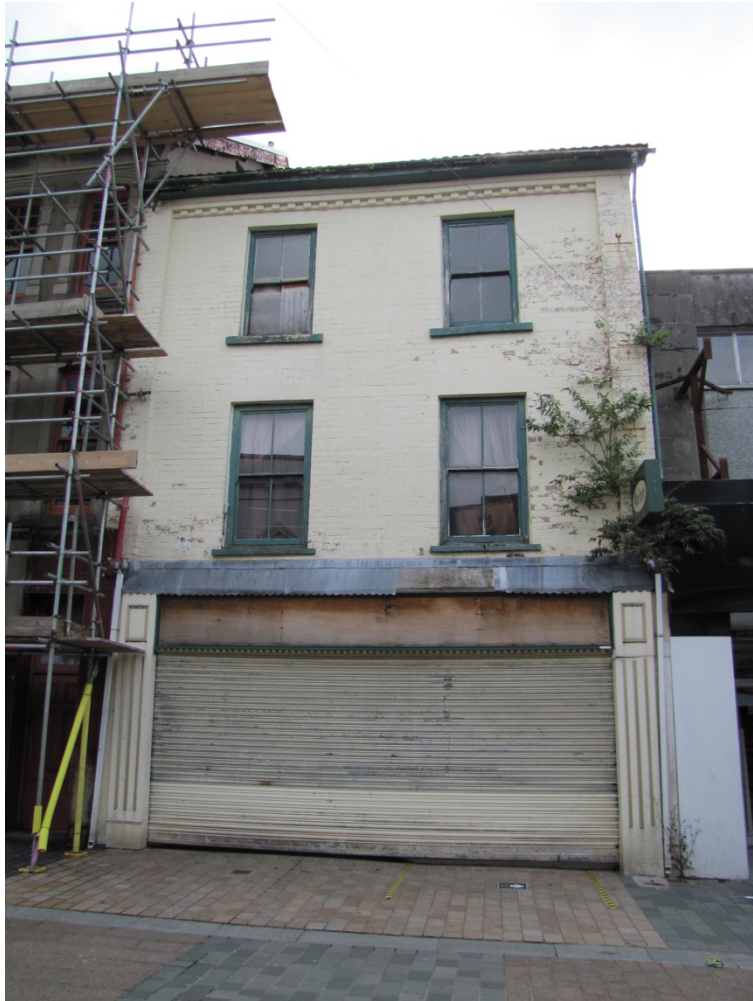
Address	<p>38 High Street</p>

Current use	Looks like a disused shop
Architectural Description & Condition	<p><u>Front</u></p> <p>Simple traditionally proportioned likely late-19th century commercial building.</p> <p>Buff facing brickwork walls to 1st and 2nd floors. These have been painted.</p> <p>The building is in a poor state of repair / maintenance is long overdue. For example, large Buddleia are growing out of it.</p> <p>2-over-2 pairs of sash windows to 1st and 2nd floors. Stone window cills to 2nd floor, probably concrete to the 1st floor.</p> <p>Ground floor is a mess, all closed / shuttered-up with roller shutters. Modern pilasters either side. Brick pilasters to 1st and 2nd floors.</p> <p>Painted timber fascia and bargeboards. The timber eaves soffit is collapsing.</p>

Looks like a concrete tiled roof.
Summary Assessment of Building's Contribution / Significance to the Conservation Area	Positive as a survival of a likely late-19 th century town centre building. Opportunity for repair and refurbishment to traditional details.

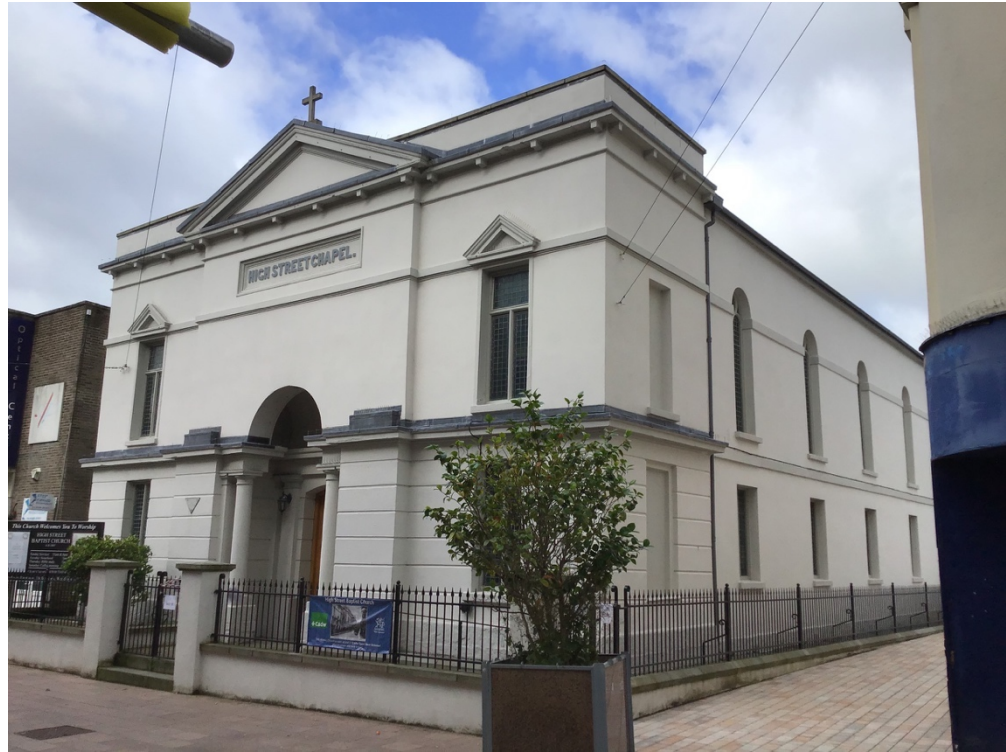
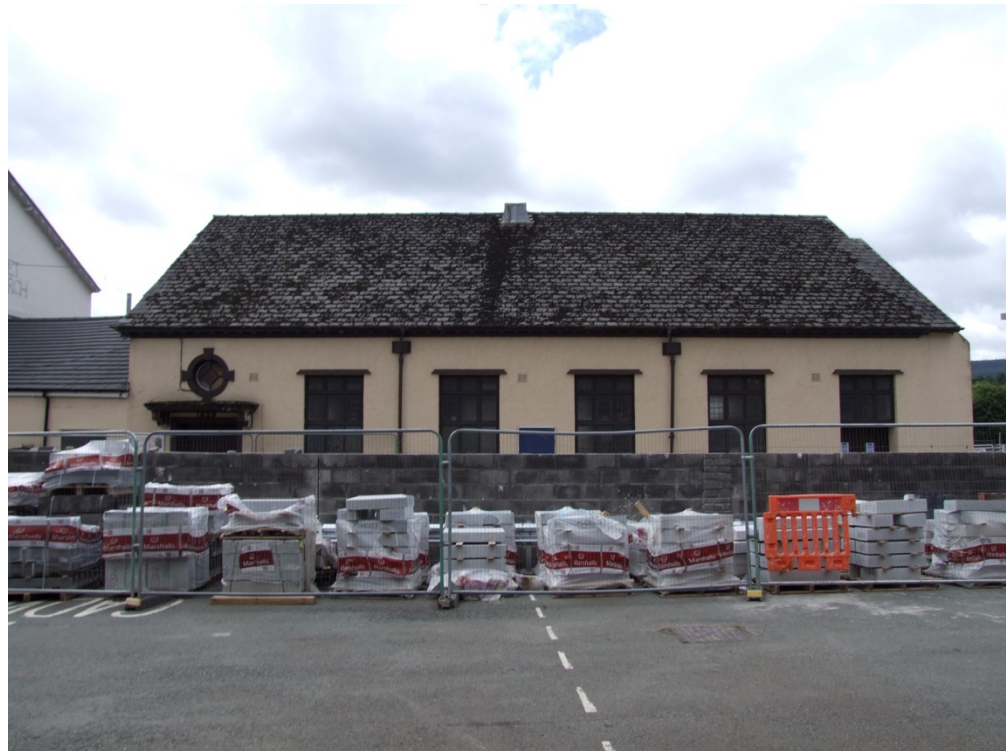
High Street Chapel, High Street (and former church hall to rear)

<p>Architectural Description & Condition</p>	<p><u>High Street Chapel</u></p> <p>Built 1840.</p> <p>The has been well renovated recently with modern gates and railings to the forecourt.</p> <p>The building is all painted render, rusticated to the lower half.</p> <p>The recent work all looks very well done.</p> <p>Recently installed Penrhyn heather blue natural Welsh slate roof coverings, only visible from a distance.</p> <p><u>Former Church Hall (High Street Friendship Centre and Café)</u></p> <p>Dated 1929.</p> <p>Deeply dentilled eaves.</p> <p>Painted cast iron rainwater goods and painted timber windows.</p> <p>Hard (likely cementitious render) rendered walls.</p> <p>Stained timber doors.</p> <p>Penrhyn heather blue natural Welsh slate roof coverings with concrete tiled duo-pitched lower roof linking the two buildings.</p>
<p>Summary Assessment of Building's Contribution / Significance to the Conservation Area</p>	<p><u>High Street Chapel</u></p> <p>Highly positive.</p> <p>Listed Grade II.</p> <p><u>Former Church Hall (High Street Friendship Centre and Café)</u></p> <p>Positive, although not part of the reason for the Conservation Area.</p> <p>Probably regarded by Cadw as falling within the curtilage of the Chapel.</p>

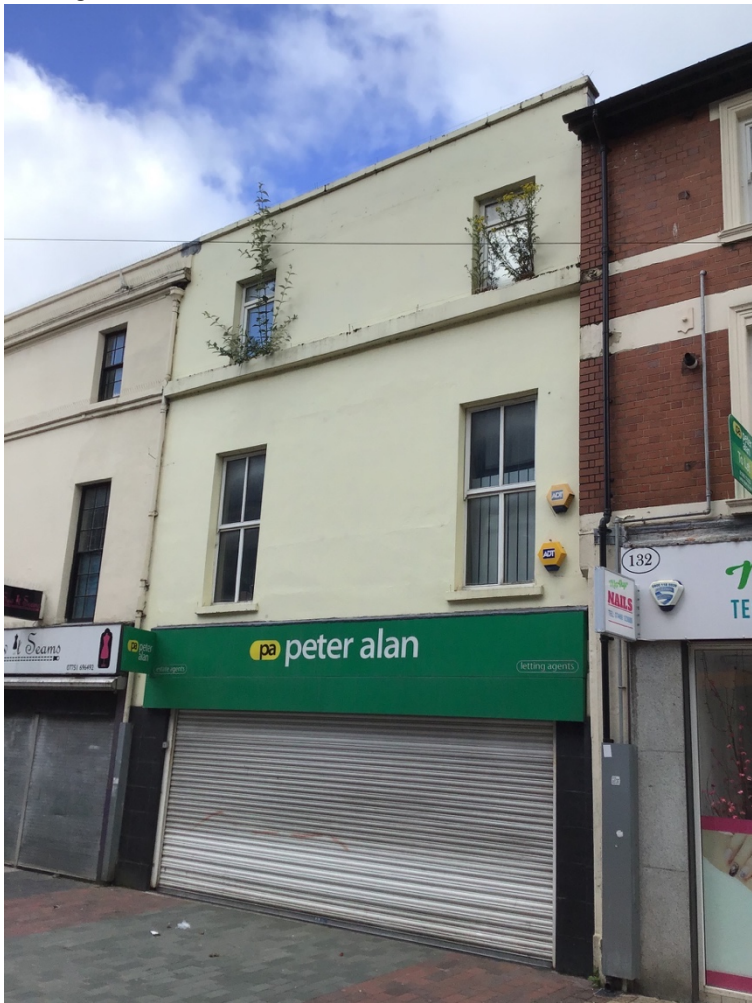
Address	133 High Street

Current use	Peter Allen (estate agents)
Architectural Description & Condition	<p>1st and 2nd floor windows similarly well-proportioned as those to nos. 134 and 135 High Street.</p> <p>Plastic 2nd floor windows. Look like modern timber 1st floor windows.</p> <p>Modern glazed aluminium framed shopfront. Plastic signage.</p> <p>Plain painted render to upper stories and a very plain, modern, square (likely) rendered stringcourse at the same level as to nos. 134 and 135 High Street.</p> <p>The height of this building is consistent for the rest of this block running northwards (except for 132 High Street).</p> <p>Rainwater downpipe(s) have galvanised steel guarding around. This is visually poor. It's difficult to tell whether these downpipes are metal or plastic, although they are probably plastic.</p>
Summary Assessment of	Positive as a survival of likely early to mid-19 th century town centre building.

Building's Contribution / Significance to the Conservation Area	Whilst the proportions of the 1 st and 2 nd floor windows are a positive, the modern detailing of the windows themselves are visually poor and the shopfront is poor as well.
---	---

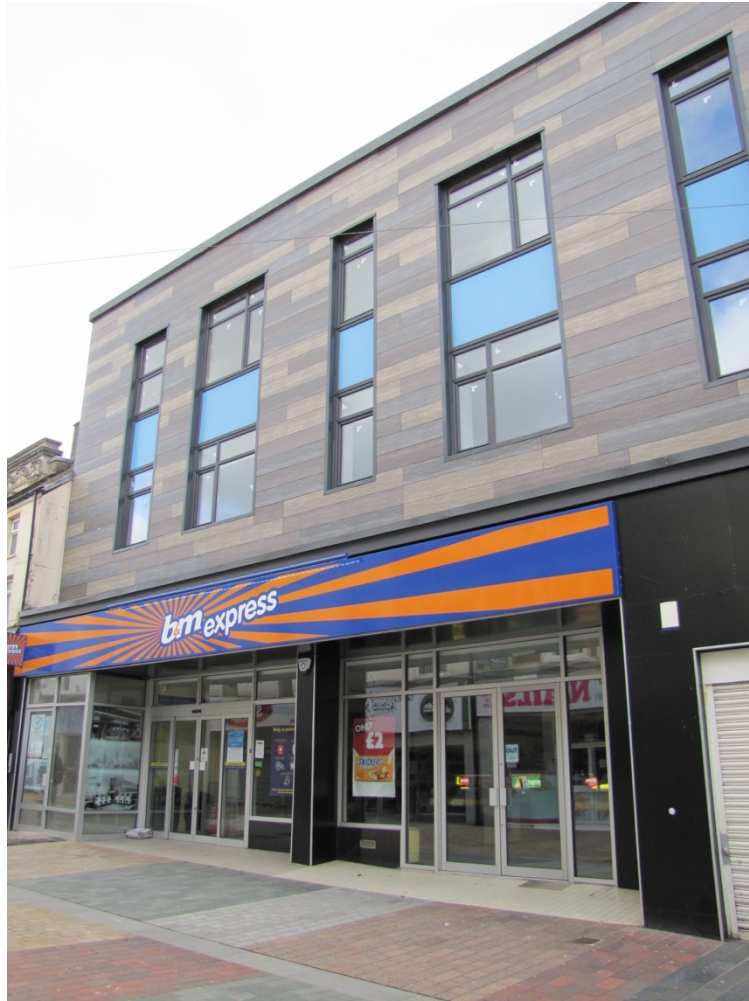
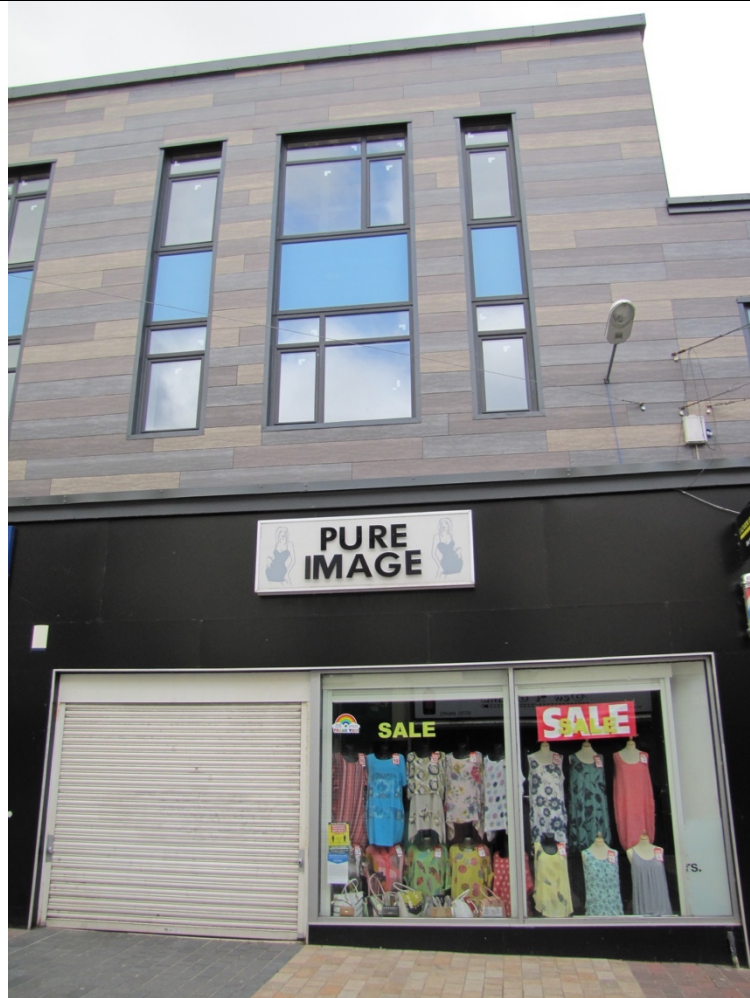
41 to 45 High Street

Current use	B&M Bargains (43 to 45), Pure Image Clothes (42), Barber (41)
Architectural Description & Condition	<p><u>Front</u></p> <p>All clad recently with timber effect horizontal cladding panels to 1st and 2nd floors.</p> <p>Aluminium windows to 1st and 2nd floor panels.</p> <p>Pressed metal cappings to parapet.</p> <p>Shopfronts are all modern, possibly 1970s / 1980s, although some cladding at street level is recent.</p> <p>Barbers has a shuttered shopfront. Painted timber and chamfered barges to match those on the gable on the street side. These look like replacements. The paint is peeling.</p> <p><u>Rear (43 to 45)</u></p> <p>Modern red brick walls.</p> <p>Crittall type windows with galvanised steel guards over them.</p>

Flat roofs with modern pressed metal copings and a parapet.
Summary Assessment of Building's Contribution / Significance to the Conservation Area	None.

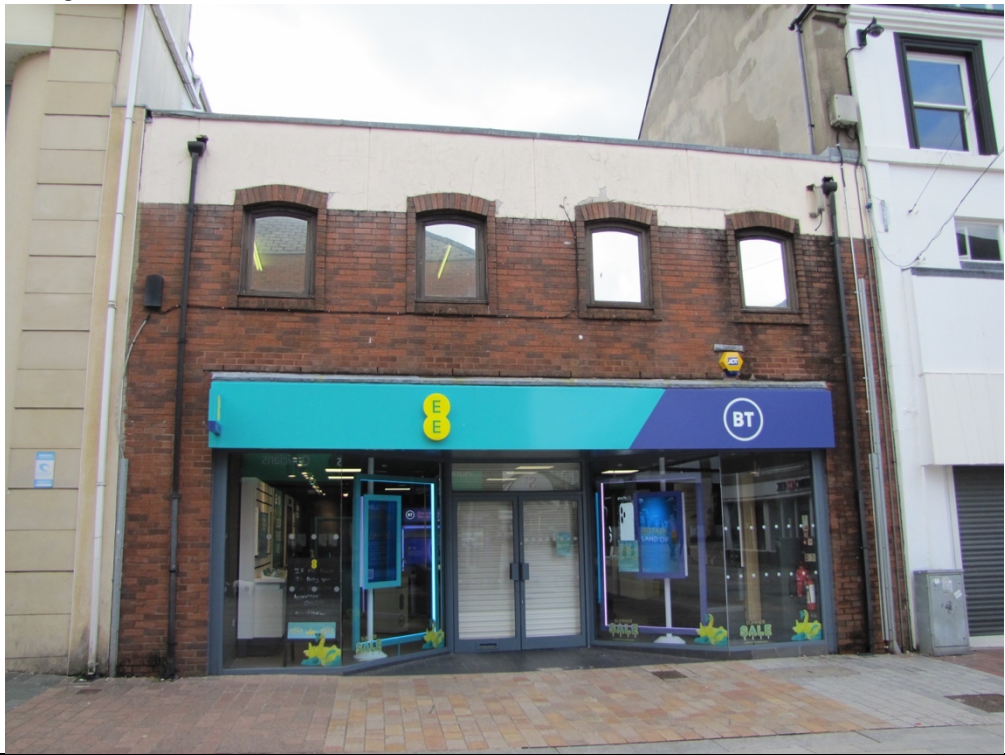
Address	<p>51 High Street</p>

Current use	EE (phone shop)
Architectural Description & Condition	<p>All modern, two-storeys, with parapet with lead weatherings.</p> <p>Brown facing brickwork to the ground floor's pilasters and 1st floor, although the top of the 1st floor looks like its render with paint finish.</p> <p>Windows are centre pivoting, metal framed.</p>
Summary Assessment of Building's Contribution / Significance to the Conservation Area	None.

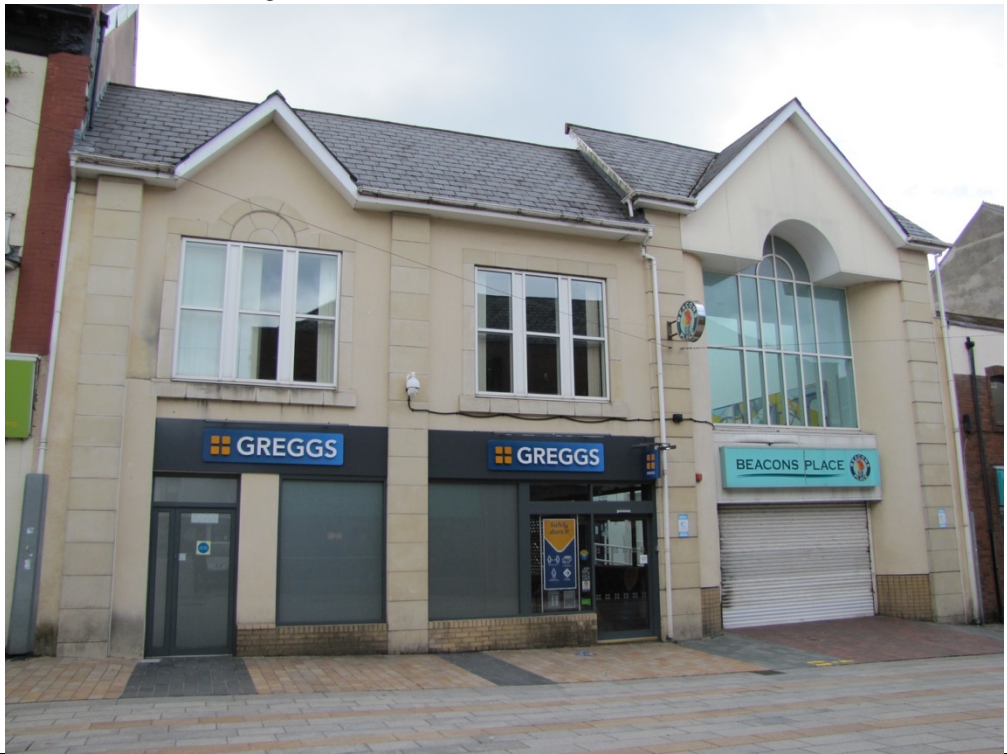
Address	Beacons Place, 52-55 High Street

Current use	Beacons Place (shopping arcade) entrance & Greggs (takeaway)
Architectural Description & Condition	<p><u>Front</u></p> <p>All modern aluminium framed and glazed two-storeys height entrance with rendered panels and modern 'rusticated' pillars each side. Large gable over main shopping centre entrance and then a smaller gable at its northern end over the Greggs. Fibre-cement slate roof and plastic rainwater goods. Buff facing brickwork plinth.</p> <p><u>Rear</u></p> <p>Upper two storeys clad with what look like metal panels with galvanised steel guarding around the top. This conceals almost completely the east elevation of the original 50 High Street.</p>
Summary Assessment of Building's Contribution / Significance to the Conservation Area	None.

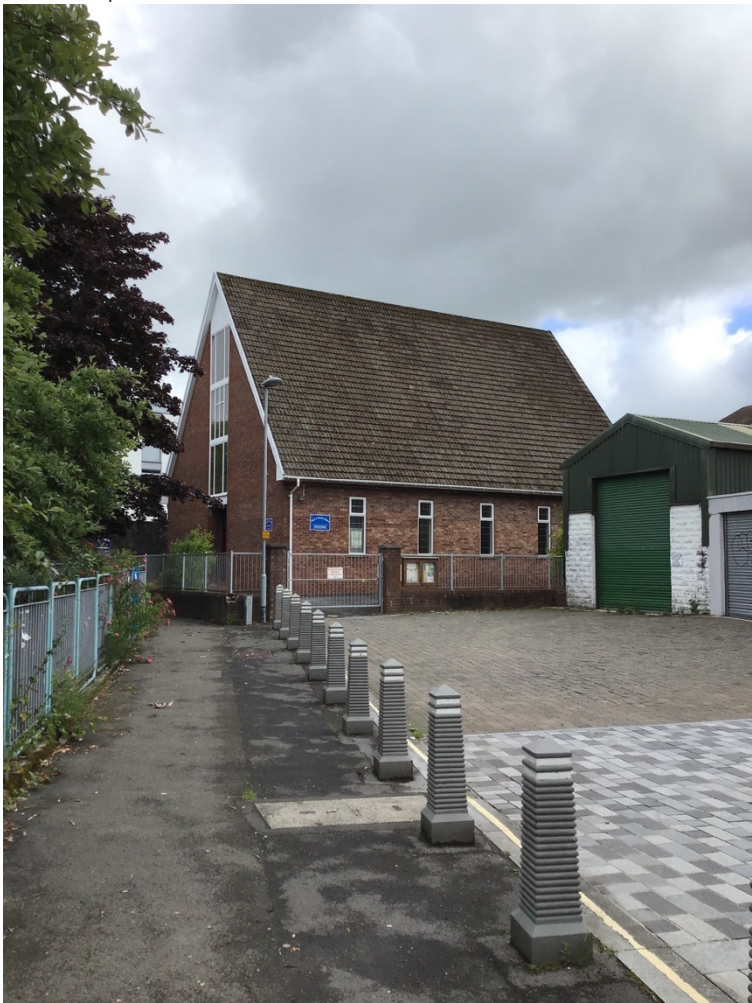
Address	<p>Market Square United Church</p>

Current use	Market Square United Church
Architectural Description & Condition	<p>Concrete tiled steeply duo-pitched roof.</p> <p>Modern building, probably 1960s or 1970s, with plastic windows, fascia, bargeboards and rainwater goods.</p> <p>Galvanised steel railings around modern brickwork walls and a small parking forecourt.</p>
Summary Assessment of Building's Contribution / Significance to the Conservation Area	None.

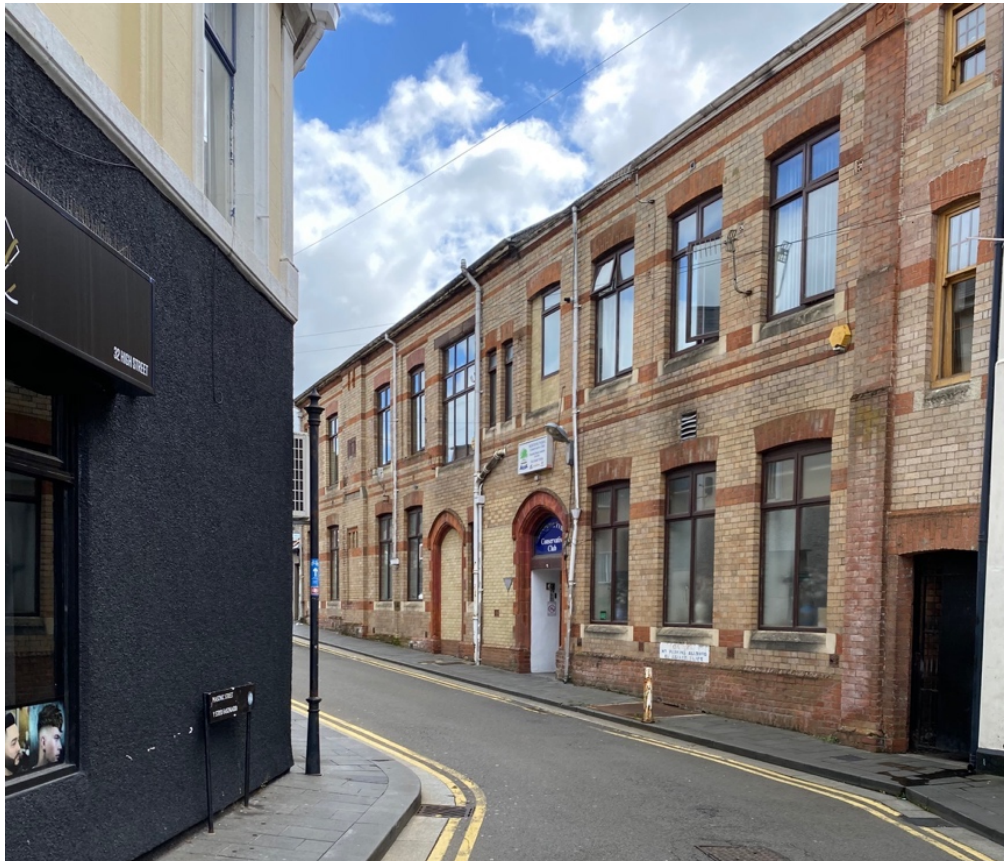
Address	<p>Conservative Club, Masonic Street</p>

Current use	Conservative Club
Architectural Description & Condition	<p>Built late 19th century.</p> <p><u>Rear</u></p> <p>Walls predominantly painted modern render.</p> <p>Two-storey gabled entrance and alongside this a single-storey flat and mono-pitched roofed extension.</p> <p>There is a small yard visible behind the sign advertising the club.</p> <p>Old painted fire escape stair.</p> <p>Mono pitched roof appears to be fibre-cement slate with Velux rooflight.</p> <p>Plastic ground floor windows.</p> <p>Modern timber front doors.</p> <p>Plastic rainwater goods and timber barges and fascia.</p> <p>These lower buildings on the southern side of the Conservative Club, all appear modern.</p> <p>The hall one would expect in a Conservative Club building is probably within its eastern two-thirds. This has quite a shallow pitched roof, and what look like timber windows although they are of a modern design.</p>

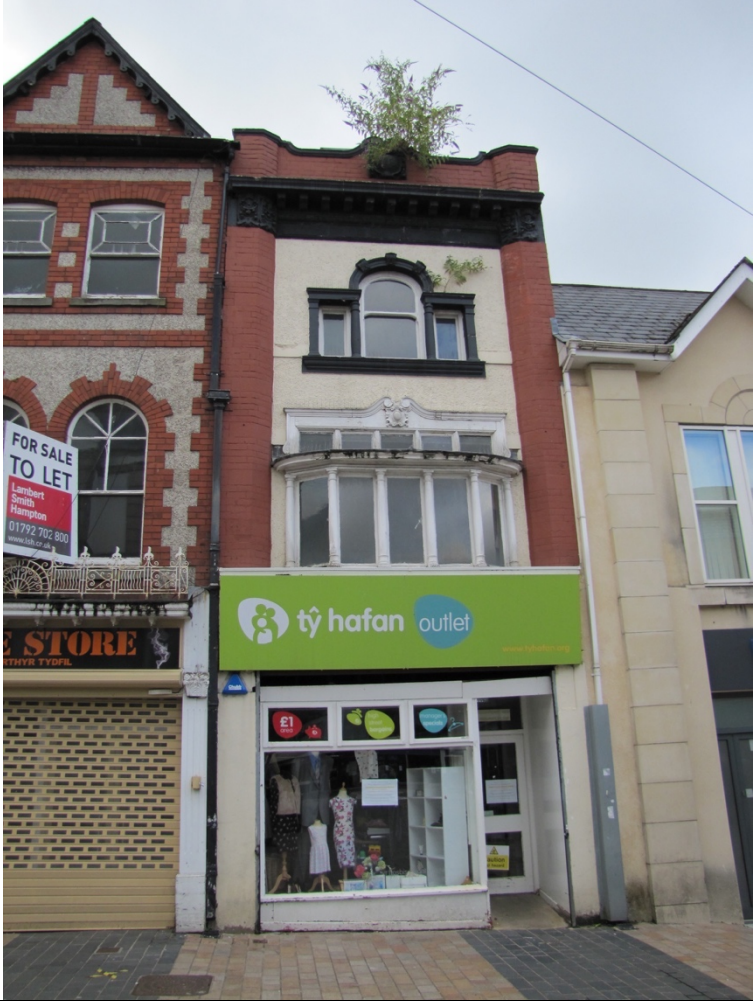
Address	<p>56 High Street</p>

Current use	Ty Hafan (charity shop)
Architectural Description & Condition	<p>All modern at street level with rendered pilasters each side, no decoration.</p> <p>1st floor has an interesting columned projecting bay window with clerestory lights above this. The columns and mouldings add a central ornate detail to the frieze above the clear storey lights.</p> <p>2nd floor has a Venetian-style window. This has three windows, a central semi-circular headed timber sash window and a pair of windows each side and columns.</p> <p>Deeply projecting cornice to this elevation with brackets and elaborate capitals to the painted brickwork chamfered pilasters each side. Bands of stone within this have also been painted out.</p> <p>Rendered panels around the windows are roughcast with a paint finish.</p> <p>Plain rendered stringcourse just above 2nd floor cill level.</p>

<p>Brick parapet wall with a detail dated 1902 at the centre of the parapet. Buddleia growing out of this.</p> <p>Standing back in Market Square I can see a small flat roofed dormer window behind the parapet. This dormer has plastic fascia, plastic cladding and plastic windows. The roof covering is only just visible and appears to be fibre-cement with plastic barges.</p>
Summary Assessment of Building's Contribution / Significance to the Conservation Area	<p>Very positive, mainly for its 1st and 2nd floor historic details and for its fit / scale.</p> <p>Potential for improvement, particularly its street frontage.</p>

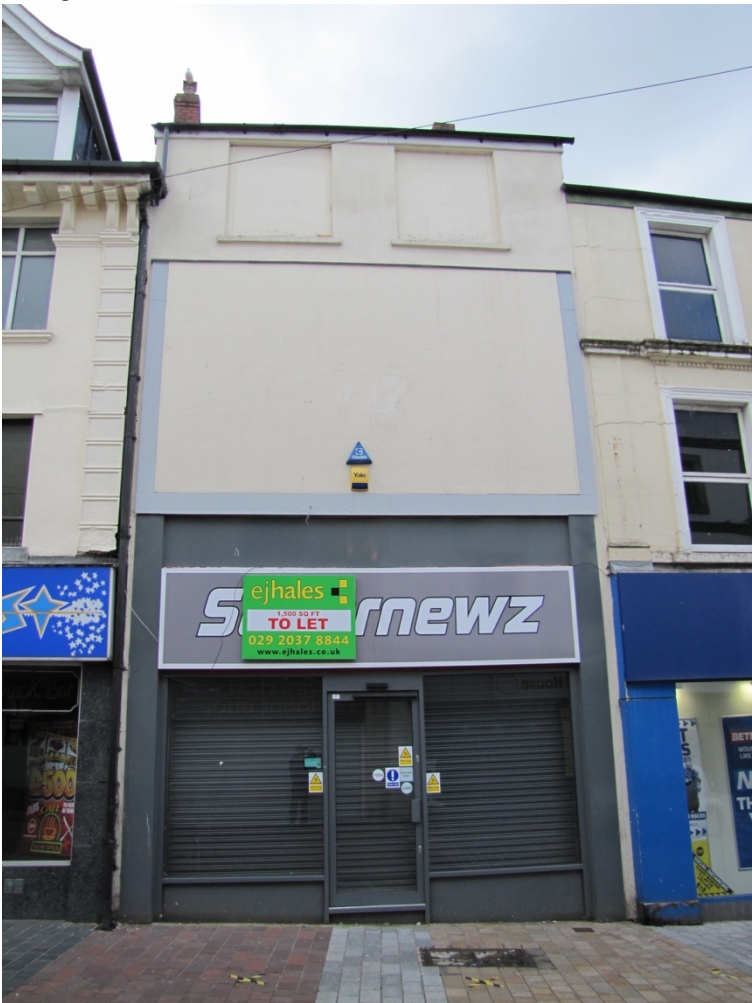
Address	59 High Street

Current use	Super News (newsagent)
Architectural Description & Condition	<p>Plain three-storey building, slightly loftier than 58 High Street.</p> <p>All modern at street level.</p> <p>1st floor has been overclad or infilled with blockwork.</p> <p>Painted render, I suspect, some timber trims possibly.</p> <p>2nd floor has what look like concrete cills in large window openings perhaps up to the plastic fascia rainwater goods.</p> <p>Brick chimneystack at northern-most roof apex probably belongs to no. 60 (Stardust).</p> <p>No. 59 has a brick chimneystack to its southern-most roof apex.</p> <p>Plastic bargeboards.</p>

Historic photograph (visible online at www.alangeorge.co.uk) of Volunteer Inn shows part of the historic façade of 59 High Street as a highly decorative gable frontage. It is possible that some of this historic fabric / infilled fenestration remains behind modern render although nothing is visible.
Summary Assessment of Building's Contribution / Significance to the Conservation Area	Low, due to losses, although potential for improvement.
