APPENDIX B - BUILDING-BY-BUILDING ASSESSMENT (2020)

1 LOWER HIGH STREET SQUARE, ST.TYDFIL'S CHURCH & COURT STREET

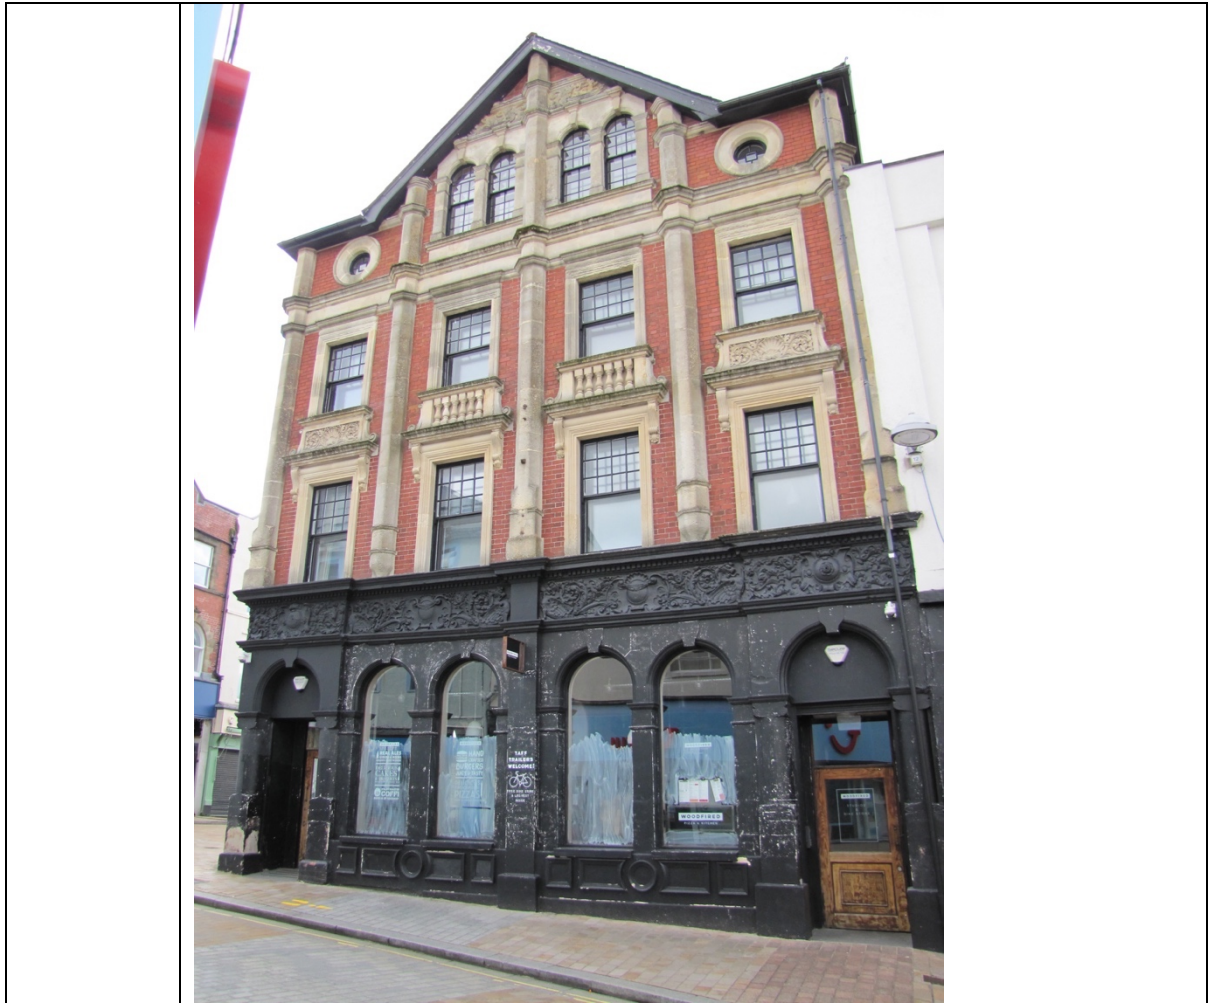
Address	62 High Street
---------	----------------

Current use	Wood Fired Pizza Restaurant
Architectural Description & Condition	<p>A four-storey corner building and so the most dominant building in this block.</p> <p>Large central gable on its High Street elevation.</p> <p>Street level is all black painted stonework with column pilasters. Oddly there is a central column and quite an ornate frieze.</p> <p>Painted window infills to the arch headed openings.</p> <p>Varnished, modern doors.</p> <p>2nd and 3rd floor have bathstone columns with an octagonal profile.</p> <p>Moulded cornice above 2nd floor windows.</p> <p>More carvings to the frieze above the 3rd floor windows.</p> <p>Moulded bathstone window surrounds and stone balusters and carved details below 2nd floor windows.</p> <p>1st, 2nd and 3rd floor windows are painted timber sash windows with horns. These I think are spiral balanced (rather than true box sashes) but they are not bad reproductions.</p> <p>Ground floor frontages, and 1st, 2nd and third floor windows are all painted black.</p> <p>1st, 2nd and 3rd floor wall panels are all red clay facing brickwork.</p>

<p>Bargeboards are painted timber, chamfered and with swept ends.</p> <p>Look like plastic rainwater goods.</p> <p>The north elevation of the Pizzeria is much less ornate although the stringcourses continue around with Bathstone banding in the facing brickwork.</p> <p>The street level rendered panels stop half-way along this elevation.</p> <p>There is a missing chimneystack. To the east of this there are numerous smaller sash window openings mostly at 1st and 2nd floor, and the roof steps down here so it's only three storey at this point.</p>
Summary Assessment of Building's Contribution / Significance to the Conservation Area	<p>Highly positive.</p> <p>Locally listed.</p>

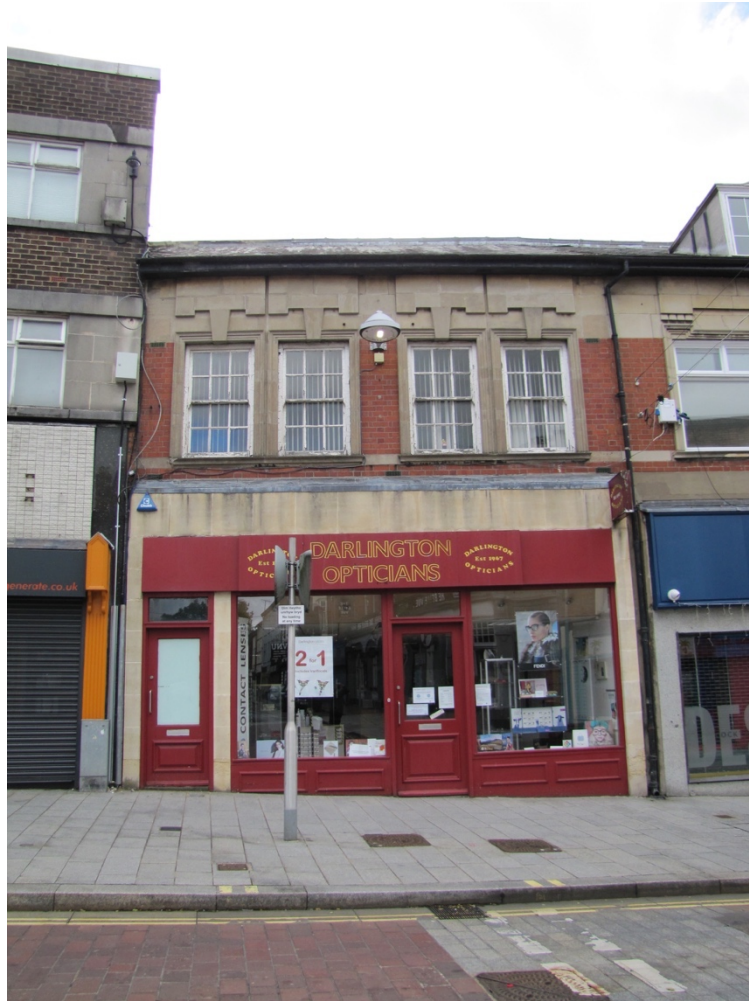
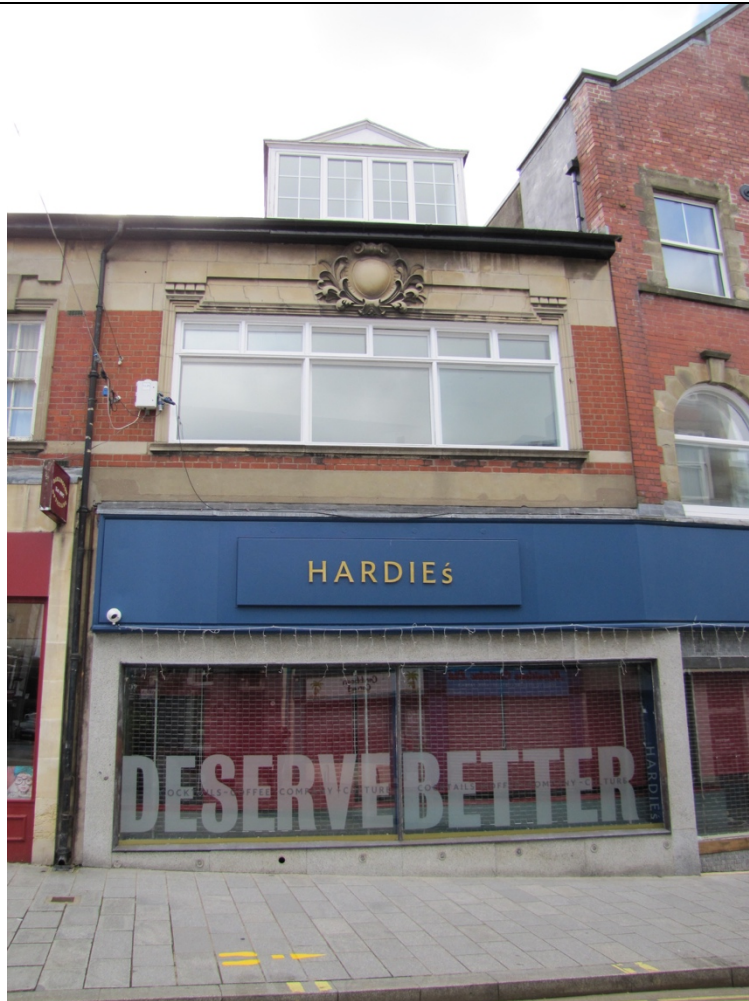
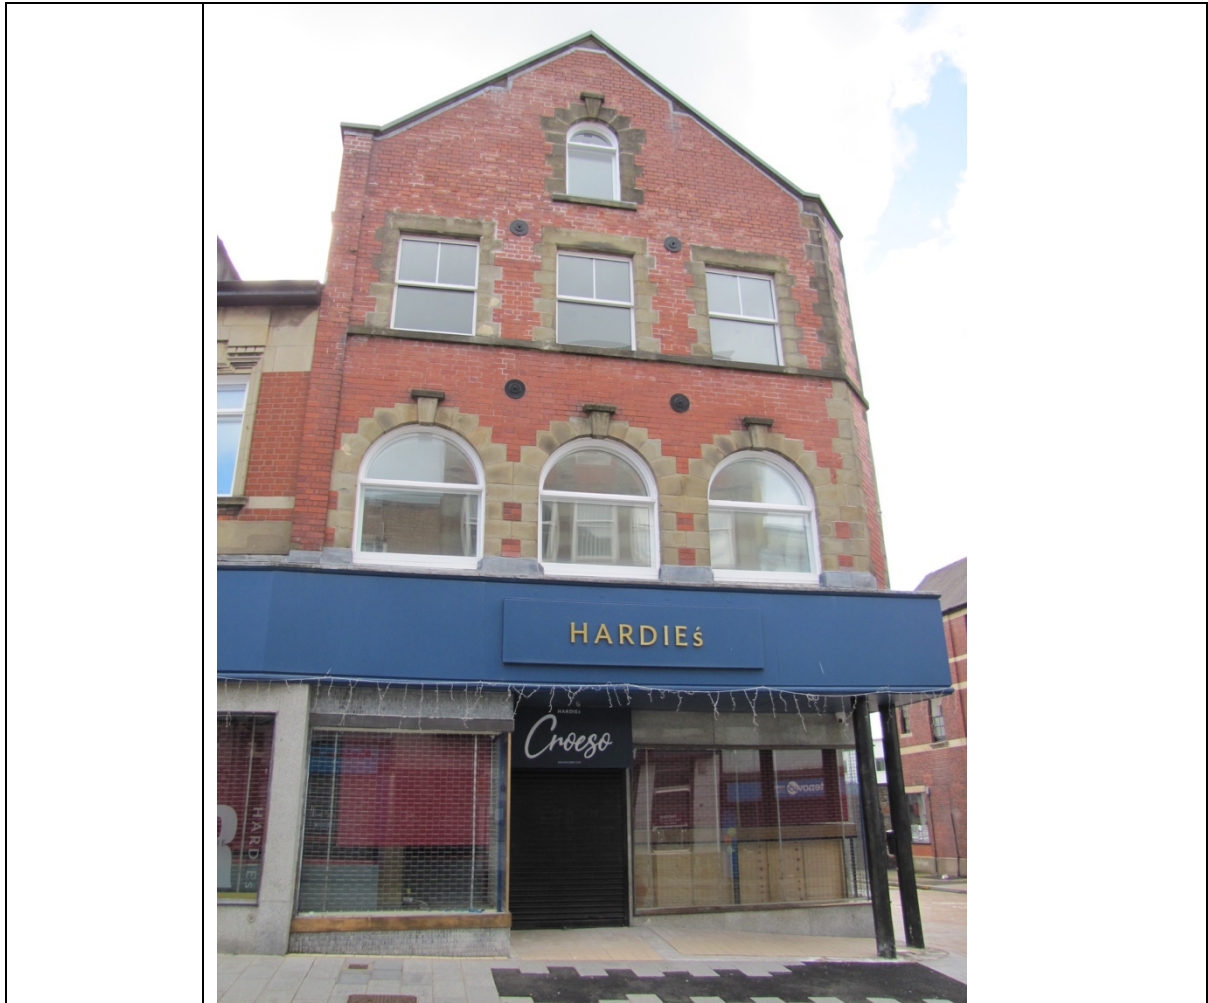
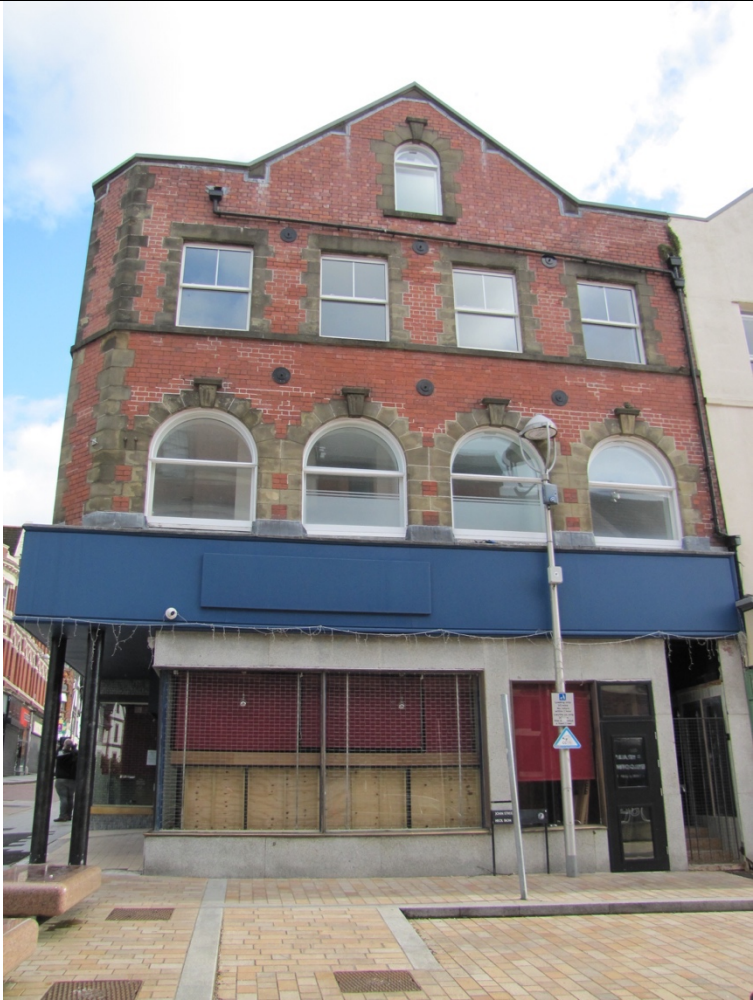
64, 65 & 66 High Street

Current use	Hardie's (bar) (nos.64 & 65) & Darlington's Opticians (no.66)
Architectural Description & Condition	<p><u>Hardie's (no.65)</u></p> <p>A fairly plain building.</p> <p>The ground floor frontage is all modern, probably mid-20th century, with some sheet bronze or sheet brass detailing to its fully glazed windows, which was probably quite high quality / expensive for the time. Marble cladding with signage above this. Corner columns.</p> <p>1st, 2nd and 3rd floor walls are red clay facing brickwork panels with dressed stone surrounds and lintels. There's a parapet with coping stones to a flush gable on its south side.</p> <p>All modern marble cladding but quite nice brass cills to the windows and glazing bars.</p> <p>Looks like fibre-cement slate pitched roof.</p> <p>Painted timber soffit boards and fascia.</p> <p>Look like metal painted rainwater goods.</p>

<p><u>Hardie's bar (no.64)</u></p> <p>Hardie's turns the corner into 64 High Street.</p> <p>64 High Street appears to have been built at the same time as the optician at no.66 and they share some details.</p> <p>Two-storeys.</p> <p>1st and 2nd floor walls are red clay facing brickwork panels with dressed stone surrounds.</p> <p>Large and widely proportioned 1st floor window. 1st floor window looks like painted timber with no glazing bars, which, along with its wide proportions gives it a modern appearance. Ashlar dressed stonework around 1st floor window.</p> <p>Large dormer in the roof that looks to be lead sheet clad and with quite crisp detailing to its roof. Plastic dormer window.</p> <p>Looks like fibre-cement slate pitched roof.</p> <p>Painted timber soffit boards and fascia.</p> <p>Look like metal painted rainwater goods.</p> <p><u>Opticians (no.66)</u></p> <p>66 High Street appears to have been built at the same time as no.64 and they share some details.</p> <p>1st and 2nd floor walls are red clay facing brickwork panels with dressed stone surrounds.</p> <p>6-over-6 painted timber sash windows with horns and deeply moulded dressed stone window surrounds.</p> <p>Ashlar stone cladding above modern painted timber to shop frontage.</p> <p>Looks like natural slate pitched roof.</p> <p>Painted timber soffit boards and fascia.</p> <p>Look like metal painted rainwater goods.</p>

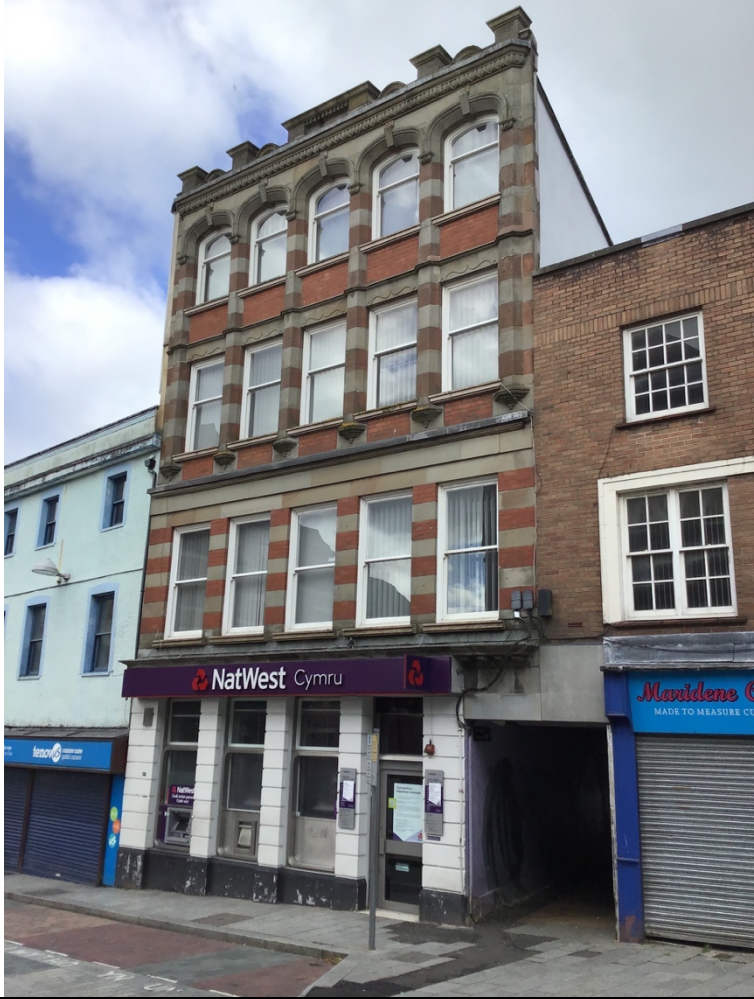
Address	<p>122 High Street</p>

Current use	Natwest (bank)
Architectural Description & Condition	<p><u>Front</u></p> <p>At four-storeys in height this building is of a dense urban scale.</p> <p>A fairly plain / not particularly attractive building.</p> <p>Street level has what look like painted stone or render pilasters, painted stone plinth, and the usual modern signage.</p> <p>Stainless steel and glazed inserts to the original window openings.</p> <p>A nicely moulded and bracketed projecting cornice above the Natwest sign with lead weatherings and some ashlar stonework over part of the lane.</p> <p>Quite tall proportioned large sash windows.</p> <p>A highly glazed elevation with not much wall / masonry.</p>

<p>Horned, painted timber sash windows with a cover bead around.</p> <p>This building is in good condition.</p> <p>Stone banding ashlar work to walls (probably Pennant or Forest of Dean Sandstone). Red clay facing brickwork panels.</p> <p>Moulded projecting cornice above 1st floor windows, roughly half-way up the elevation. 2nd and 3rd floors have octagonal slightly projecting pilasters with moulded bases. 3rd floor windows have four-centred arched heads. Ashlar work above.</p> <p>Moulded cornice above with lead weatherings and then what look like some stonework associated with a parapet or it may just be detailing along the head of the wall. Dominant central moulded element and then a pair of what look like low pillars either side and then semi-circular headed details between these.</p> <p>One oddity of this elevation is the lane that encroaches on the elevation at street level, but only for just over half the width of the lane.</p> <p>A negative is the plastic cladding visible from High Street to the southern wall extending above the Tenovus shop.</p> <p>Historic photograph (visible online at www.alangeorge.co.uk) shows this was originally 'Sandbrook' ironmongers shop and that the originally highly glazed opening to 1st floor showrooms has been infilled with brick / stone piers.</p> <p><u>Rear</u></p> <p>A dominant feature viewed from the west / rear of Victoria Street.</p> <p>Plastic weather-boarded walls.</p> <p>Flat roofs.</p> <p>Galvanised steel palisade-type fencing.</p> <p>Galvanised steel escape stairs.</p> <p><u>Hong Kong Alley (beneath Natwest)</u></p> <p>A busy link through the High Street.</p> <p>Lilac painted plain render to the walls each side.</p> <p>Concrete structure beams visible above.</p> <p>Ugly modern light fittings (not working) and plain panelled ceiling.</p>

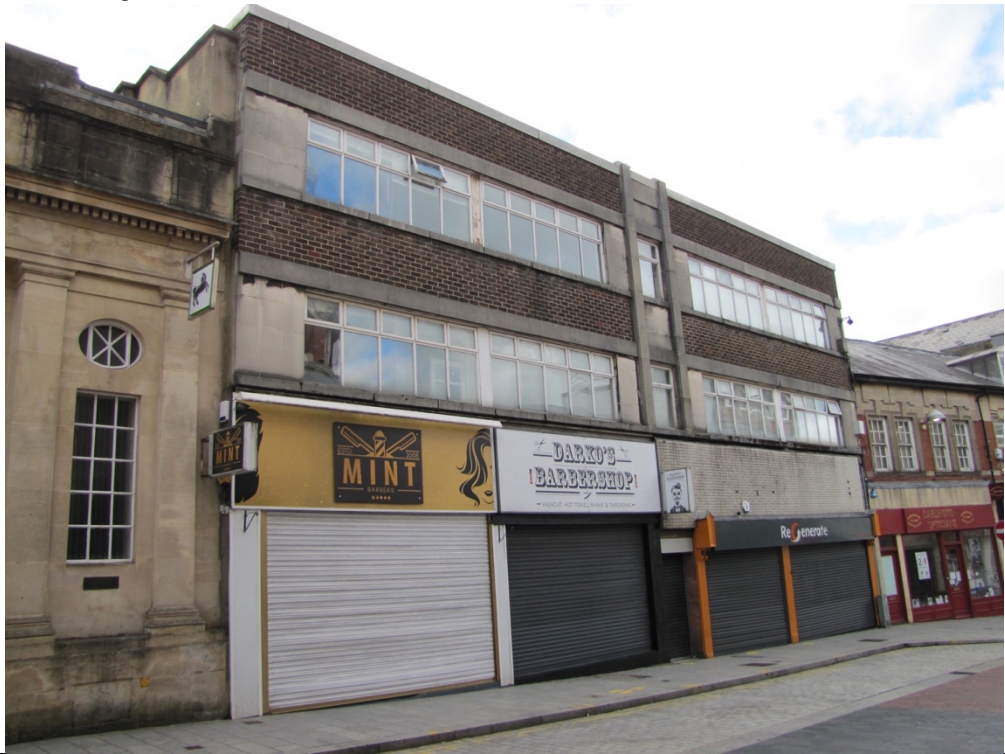
Address	<p>67 & 68 High Street</p>

Current use	2no. barbers (no.68) and ReGenerate-it (second hand / pawn shop) (no.67)
Architectural Description & Condition	<p>Unattractive, probably 1960s or 1970s, three-storeys parapeted building.</p> <p>Modern street frontage with painted moulded timber pilasters to the ReGenerate-it, matching those at 31 Victoria Street (fruit shop). Ceramic tiled band to wall above this.</p> <p>The barber shopfronts are roller shuttered and painted timber glazed and with deep signage above.</p> <p>1st and 2nd floor window cills, heads and central projecting details are all, what look like, pre-cast concrete cladding with brown facing brickwork panels and a parapet with a metal capping.</p> <p>Windows look like painted timber casements.</p>
Summary Assessment of Building's Contribution / Significance to the Conservation Area	None.

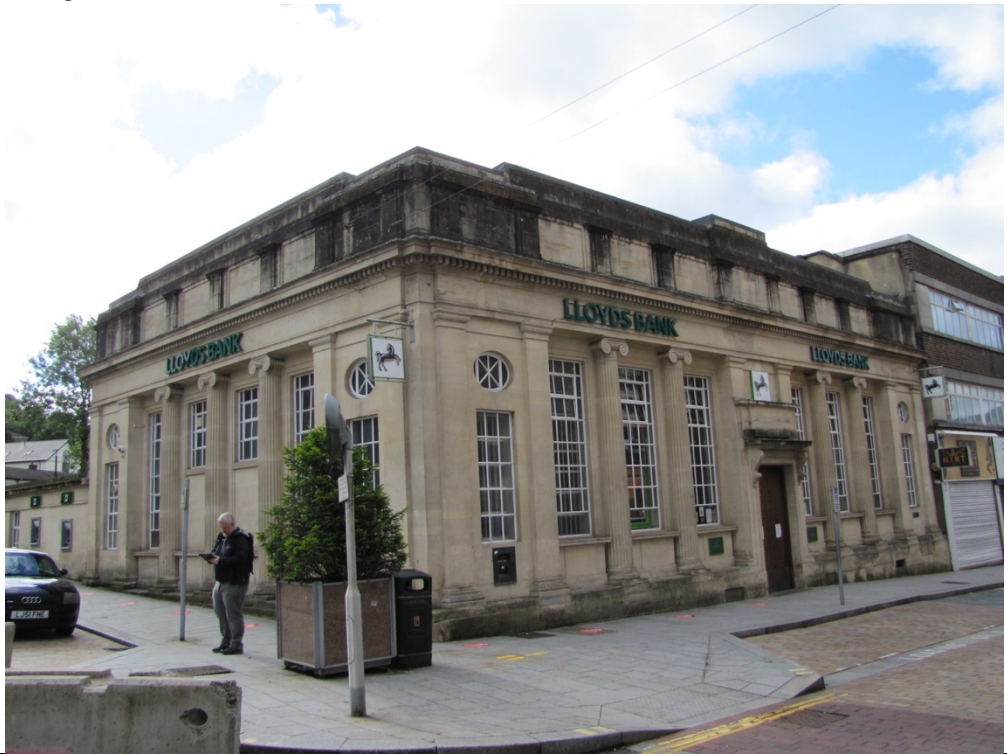
Address	69 High Street

Current use	Lloyds Bank
Architectural Description & Condition	<p>A classically styled single-storey building with a lofty / double height interior.</p> <p>All limestone ashlar elevations.</p> <p>Pair of fluted columns, symmetrical about its central entrance, with plain ashlar pilasters.</p> <p>Fairly plain ashlar plinth, dentilled cornice and fairly plain frieze. Pilasters above this form a parapet.</p> <p>Possibly 1920's or 1930's, with some slightly Art Deco, details.</p> <p>Windows look like painted metal, possibly with cast glazing bars. Glazing is all obscured to the north elevation.</p> <p>Fine panelled hardwood front doors.</p> <p>This building is in good condition.</p> <p>It turns the corner onto Church Street and then steps down to a much lower single storey, flat roofed building at its eastern end.</p>
Summary Assessment of Building's	<p>Very positive.</p> <p>Grade II listed.</p>

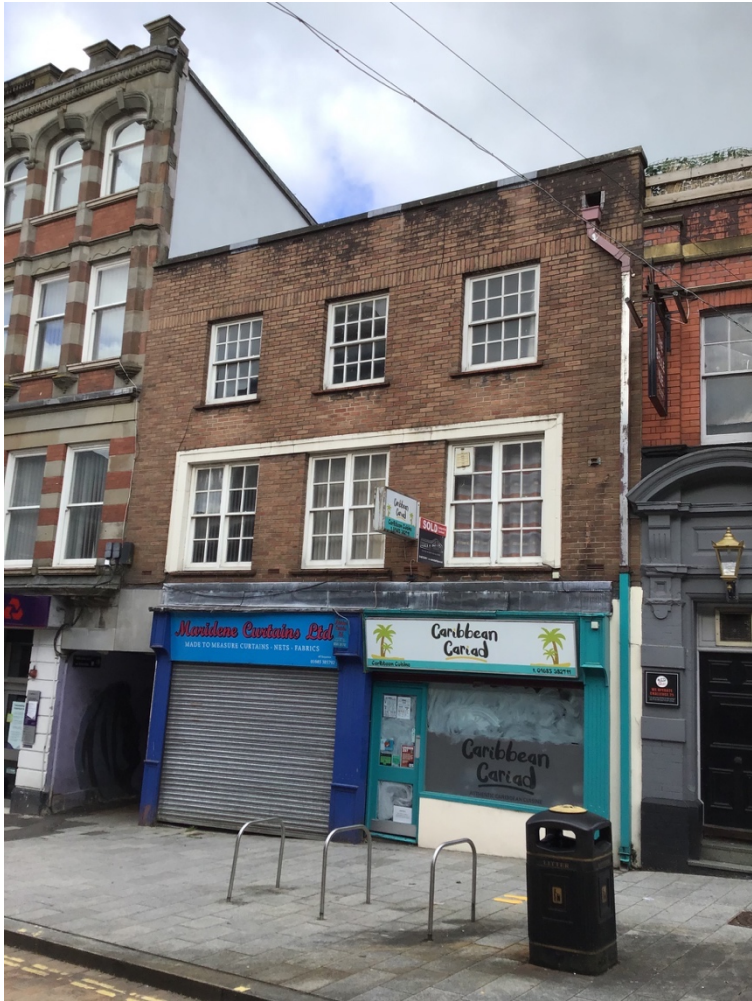
Address	120 & 121 High Street

Current use	Curtain shop (no.121) and (Caribbean) restaurant (no.120)
Architectural Description & Condition	<p><u>Front</u></p> <p>All one building probably built in mid-20th century.</p> <p>Red facing brickwork to 1st and 2nd floors.</p> <p>Street level has painted timber mouldings.</p> <p>1st and 2nd floor windows are painted timber sashes.</p> <p>1st floor windows have a moulded, probably run-render, detail over three of them linking them together visually.</p> <p>Building has quite a wide appearance, three-storeys with a parapet with probably concrete copings.</p> <p><u>Rear</u></p>

<p>Three-storeys gable-end to no.120 with a very shallow pitched concrete tiled roof. Modern painted render. Modern painted timber sash window. Plastic fascia and rainwater goods.</p> <p>Single-storey duo-pitched roof of curtain shop with roller shuttered rear door. There's a small yard immediately to the north-west of it. Above and beyond this is the rear of the three-storeys building above with a painted metal grill visible over the 1st floor's painted modern timber sash window.</p> <p>Leaking plastic rainwater goods and some modern render don't add to the appearance of this.</p>
Summary Assessment of Building's Contribution / Significance to the Conservation Area	Positive, even though a 20th century building.

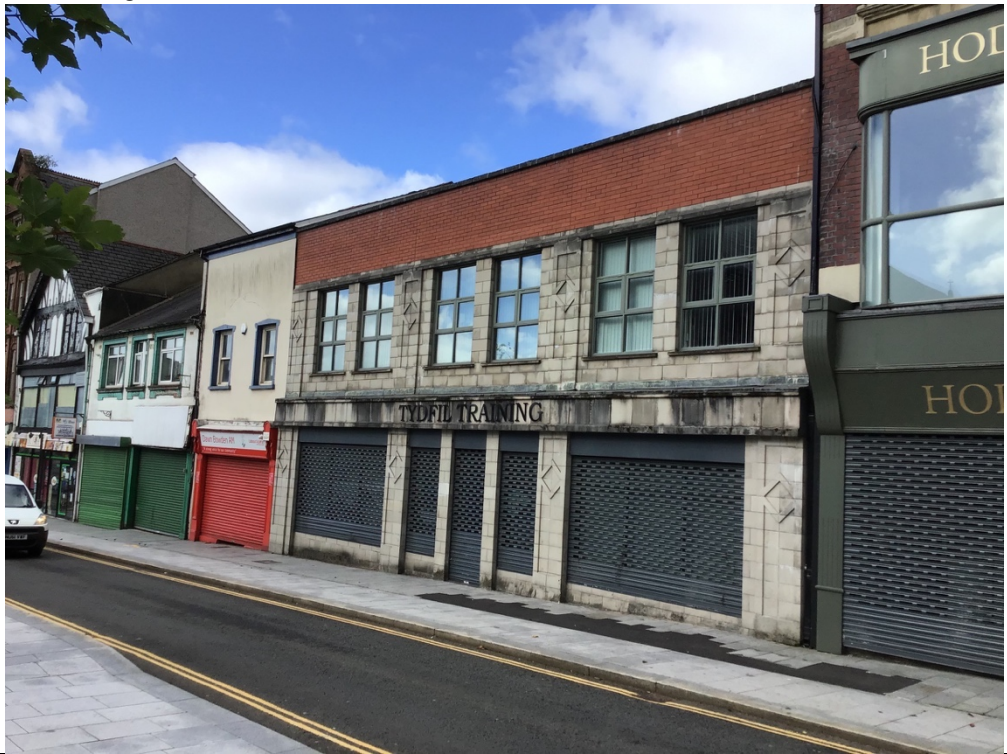
Address	<p>107-109 High Street</p>

Current use	Tydfil Training Centre
Architectural Description & Condition	<p>2 storey infill building with flat roof – likely dating to 1920's-30's. Rear elevation faces Post Office Lane.</p> <p><u>Roof</u> Flat but only parapet visible from street views.</p> <p><u>Elevations</u> Front elevation of plain pale stone ashlar (likely Portland stone) with inset pilasters and simple diamond motif to ground and first floor with plain red brick panel over (likely later). Modern aluminium shopfront and windows with relief lettering signage to ground floor fascia.</p>
Summary Assessment of Building's Contribution / Significance to the Conservation Area	Good example of well restored frontage. Constructed later than most surrounding buildings, but is of quality and has a positive impact on the street and Conservation Area.

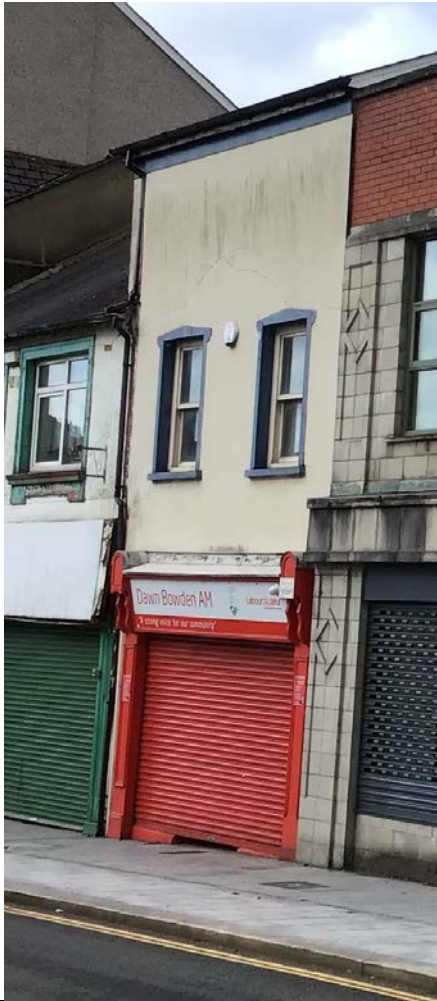
Address	110 High Street

Current use	Assembly Member's Office
Architectural Description & Condition	<p>Plain 2 storey building with likely attic rooms.</p> <p><u>Roof</u> Pitched fibre cement slate.</p> <p><u>Elevations</u> Plain painted render to upper levels with render band surround to painted timber sliding sash first floor windows.</p> <p>Probably increased in height at some stage to match height of adjoining 107 to 109 High Street.</p> <p>Reproduction painted timber shopfront with recessed central door.</p>
Summary Assessment of Building's Contribution /	Low significance for its retention of 1 st floor window openings, although the rest has been much altered.

Significance to the Conservation Area	A plain example of a typical smaller town centre retail property that would benefit from appropriate refurbishment to improve its impact on the area.
---------------------------------------	---

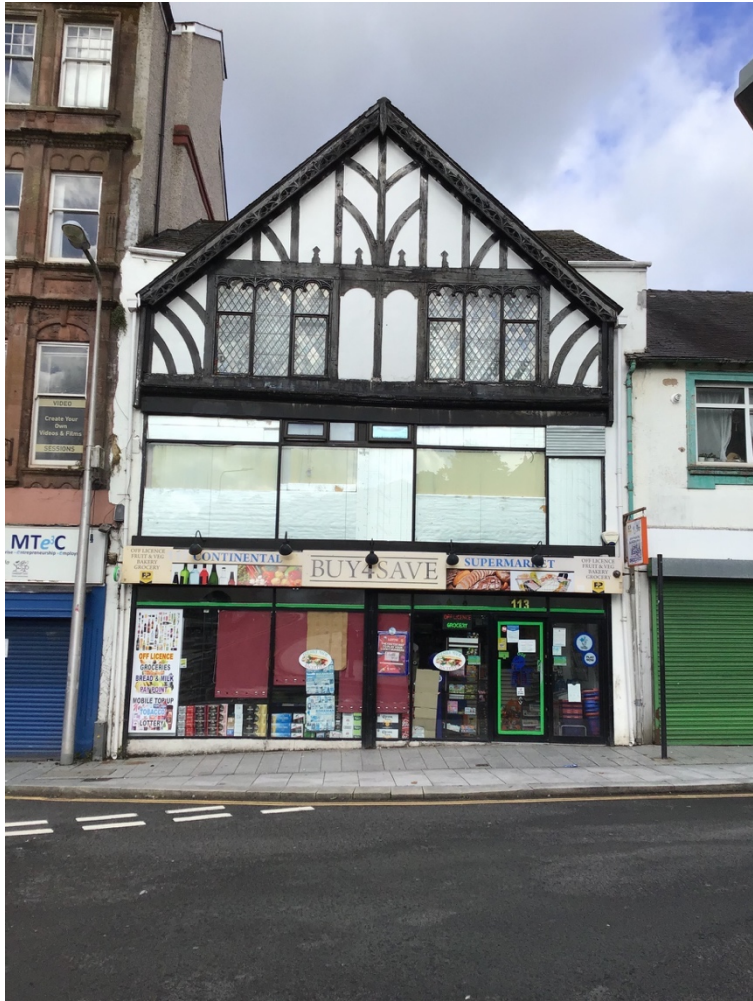
Address	<p>113 High Street</p>

Current use	Buy 4 Save Continental Supermarket to Ground Floor
Architectural Description & Condition	<p>Gable fronted 3 storey property.</p> <p><u>Roof</u> Pitched fibre cement slate.</p> <p><u>Elevations</u> Ground and first floor substantially glazed with modern large glazed units. Modern printed shop signage. Traditional mock Tudor style half-timbered upper storey with painted render panels. Upper windows of trefoil design with metal casements and leaded lights. Decorative pierced barge to wide gable frontage.</p>
Summary Assessment of Building's Contribution / Significance to	Significant / positive for its fine upper storey character let down by poor modern alterations to ground and 1 st floors.

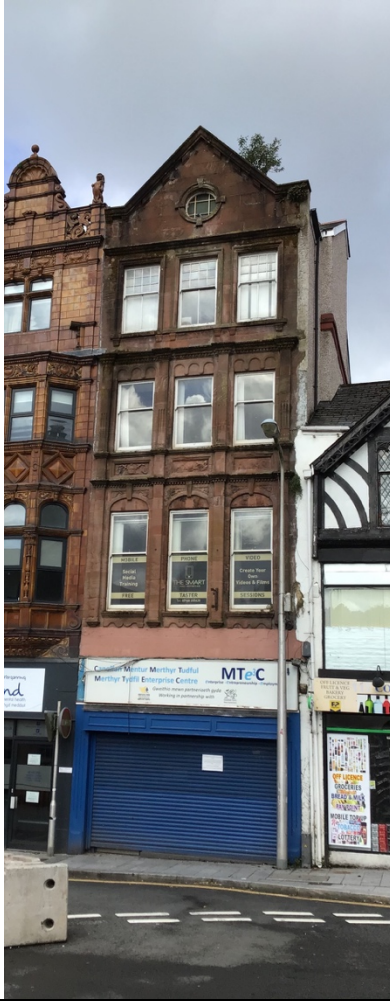
Address	<p>114 High Street</p>

Current use	Merthyr Tydfil Enterprise Centre to Ground Floor with offices above.
Architectural Description & Condition	<p>Gable fronted tall and narrow 4 storey property with attic rooms.</p> <p><u>Roof</u> Pitched slate (likely fibre cement) with crested red clay ridge tiles. Only visible in oblique distant views.</p> <p><u>Elevations</u> Ground floor shopfront – poor quality modern interpretation of traditional arrangement with modern plastic signage over. Upper floor levels of fine decorative sandstone with pilasters, decorative cornices to each level and enriched relief panels and features. Roundel window to gable with deep overhanging masonry decorative frieze to parapet gable. Timber sash windows to 1st, 2nd and 3rd floors. 3rd floor arrangement likely original with small paned upper sashes (12 over 2 arrangement). 1st and 2nd floor with 1 over 1 arrangements, likely to be later alterations.</p>

Summary Assessment of Building's Contribution / Significance to the Conservation Area	<p>Fine upper storey character with rather insipid modern shopfront arrangement.</p> <p>Highly positive town centre property of good urban proportions.</p>
--	---

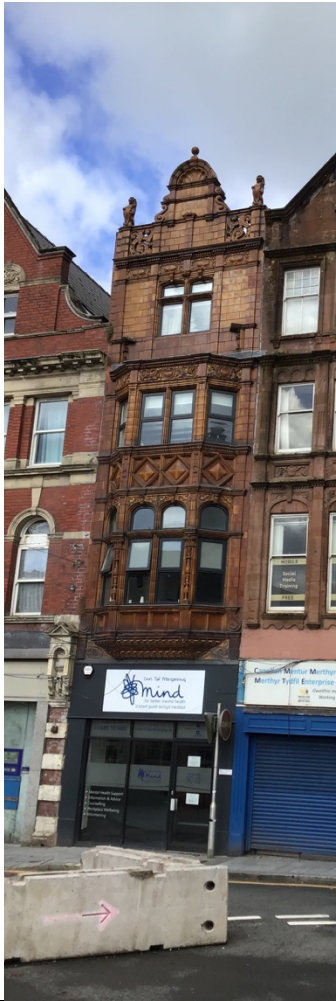
Address	115 High Street

Current use	Mind offices with offices above.
Architectural Description & Condition	<p>Flemish gable fronted tall and narrow 4 storey property with attic rooms.</p> <p><u>Roof</u> Pitched slate (likely fibre cement). Only visible in oblique distant views.</p> <p><u>Elevations</u> Ground floor shopfront – modern aluminium set between painted timber pilasters. Pilasters missing cappings to project either side of shop sign fascia. Upper floor levels of fine period decorative brown glazed terracotta tiles with double height projecting oriel bay window to first and second floors. Previous balcony arrangement above bay missing. Decorative Flemish gabled arrangement with scalloped central arch and ball finial with terracotta glazed lions. Modern aluminium windows set to existing openings executed well.</p>
Summary Assessment of	Very fine building, sympathetically restored in recent years.

Building's Contribution / Significance to the Conservation Area	Highly positive town centre property of good urban proportions. Grade II listed.
--	---

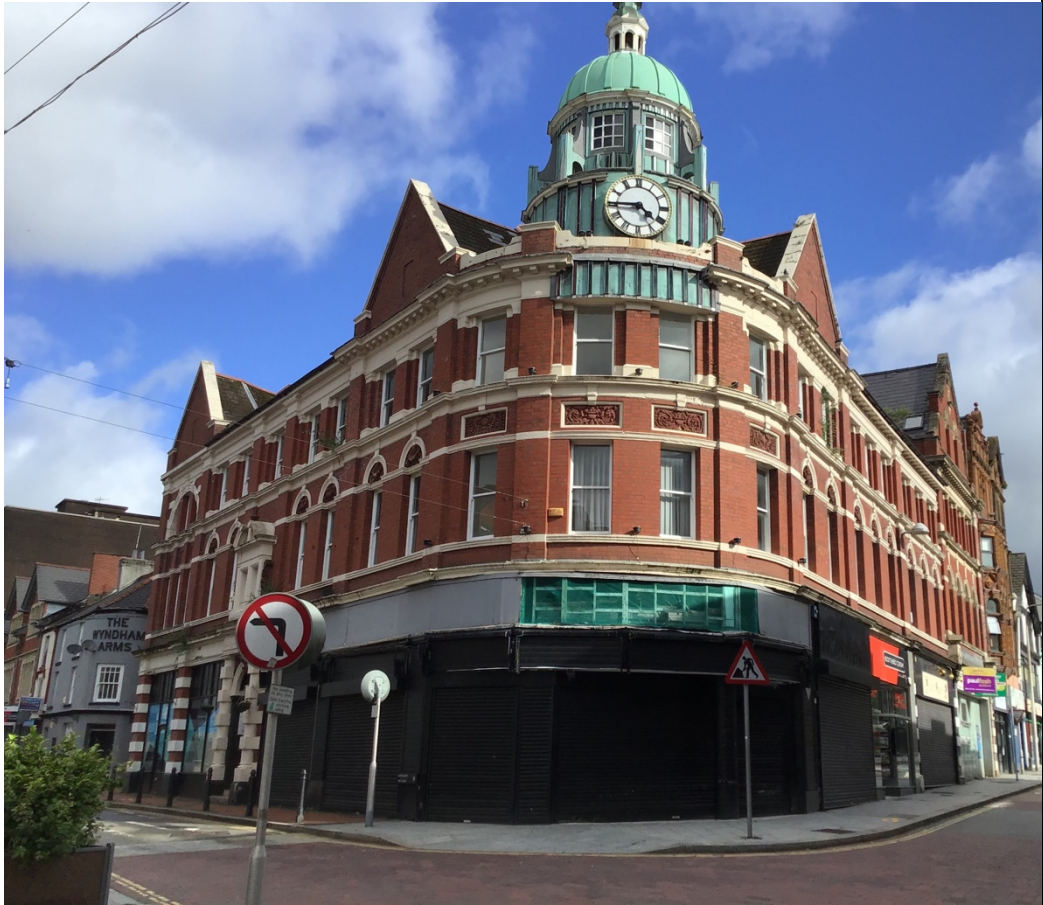
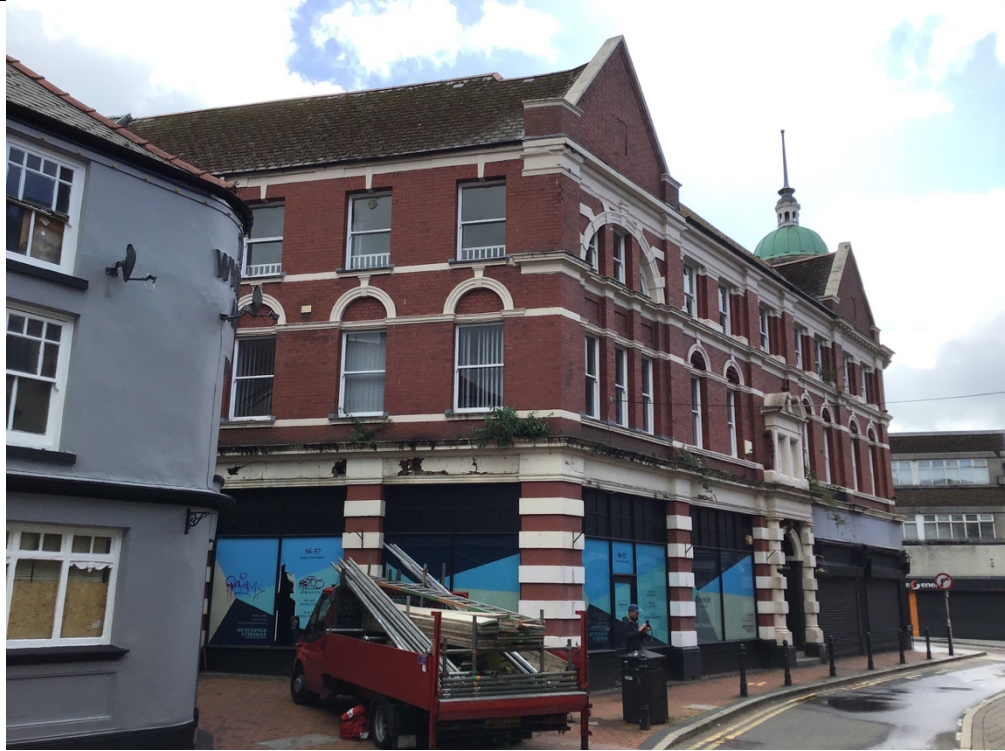
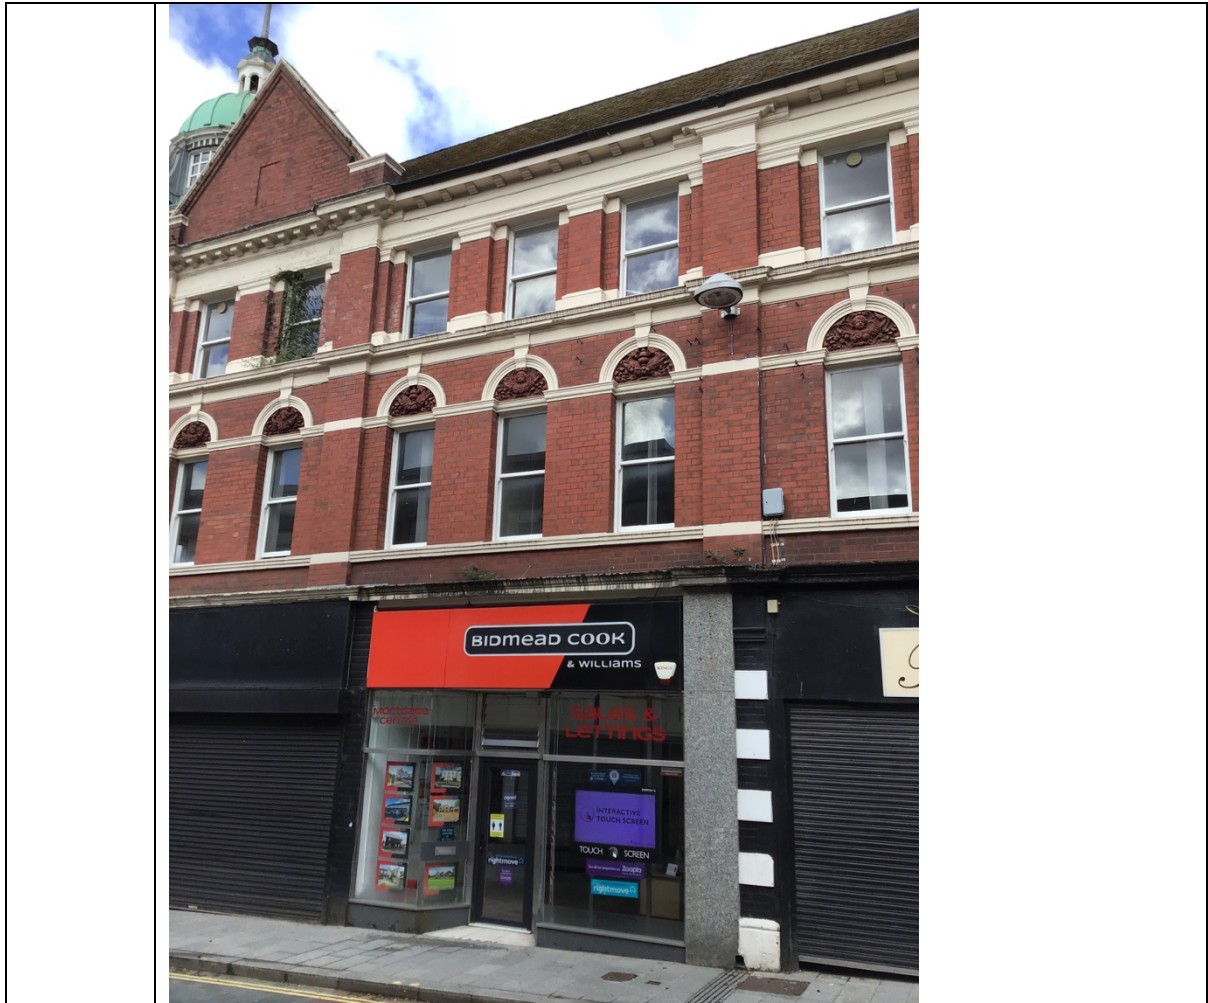
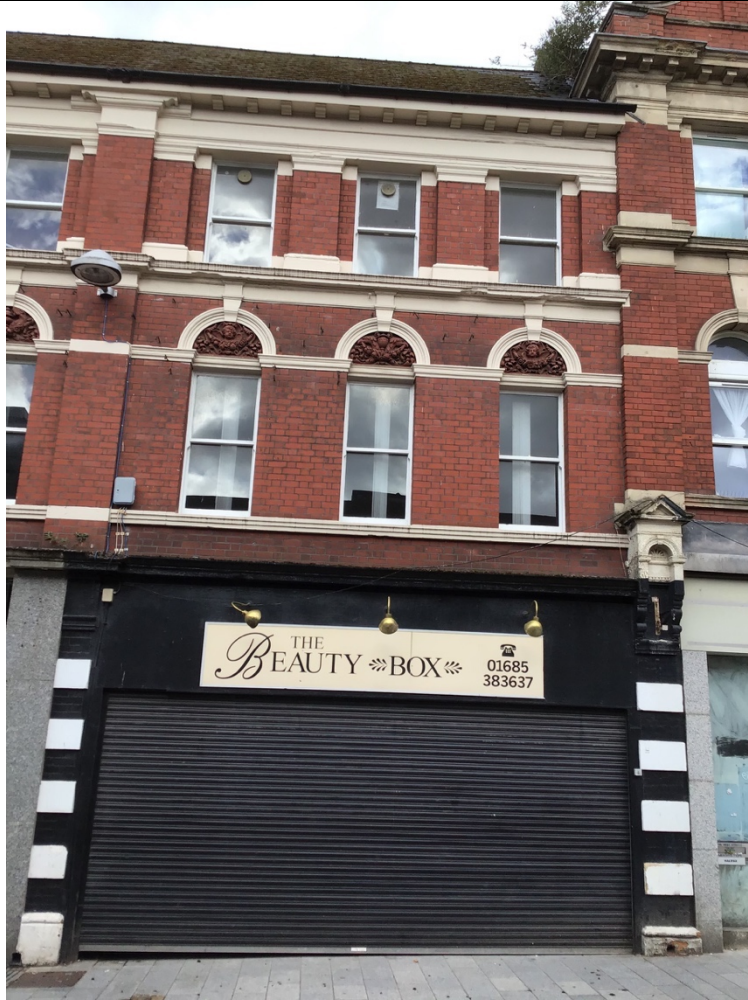
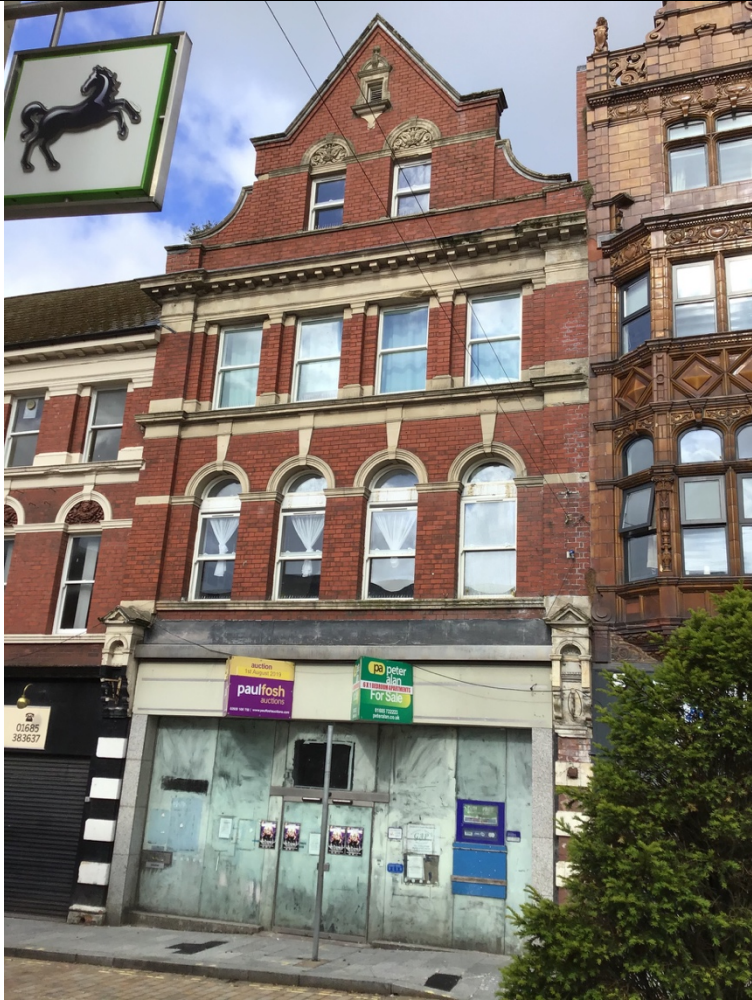
Address 115 to 119 High Street & 56 & 57 Glebeland Street

Current use	Estate agent (no.118 High Street), beauty salon (no.117 High Street), vacant (nos. 116, 119 & 56 / 57 Glebeland Street).
Architectural Description & Condition	<p>Prominent three-storeys building built along corner between Glebeland Street and High Street.</p> <p>Prominent copper clad cupola clock tower at its southeast corner.</p> <p>1st and 2nd floors have facing clay brickwork again, following the curve around the corner.</p> <p>Some nice terracotta panels above 1st floor windows.</p> <p>A lot of moulded dressed stonework with paint finish to 1st and 2nd floors' elevations.</p> <p>Painted timber sash windows to 1st and 2nd floors.</p> <p>Two gables with stone copings on both street elevations.</p> <p>Street level has a moulded stone stringcourse along its head.</p> <p>Fine architectural features and an impressive copper dome with clock facing down the High Street.</p>

<p>Pitched roof with slate coverings, but only visible in oblique distant views.</p> <p>Upper floor levels of facing red brickwork with painted stone string courses to suit window heads and cill levels. Embellished terracotta faience panels to first floor arched window heads.</p> <p>Upper windows generally painted timber sashes (1 over 1 arrangement) set to existing openings.</p> <p>Feature copper clad dome arrangement on prominent corner of High Street & Glebeland Street incorporating painted timber windows, large finial and large town clock.</p> <p><u>No.119 High Street (probably formerly a shop, currently vacant)</u></p> <p>All roller shuttered doors and modern canopies – seems to be unoccupied at the moment.</p> <p>Projecting cornice has bracketed cornice.</p> <p>Look like plastic gutters with downpipes within pilasters in the walls. This detail creates a high-risk of water ingress / damp problems in the building.</p> <p>Modern tiled inserts although I can't see the joints, certainly not grouted.</p> <p>Slightly fluted surrounds to the openings that may be the same age as the canopies.</p> <p>Unsightly fibre-boarded soffits.</p> <p><u>Beauty salon (no.117 High Street)</u></p> <p>Retains examples of the likely original pilasters. These are now all painted with some projecting stone quoins with facing brickwork in between. A stone plinth below and a fairly plain moulded capital at the top of each pilaster.</p> <p><u>Estate agent (no.118 High Street)</u></p> <p>Modern frontage.</p> <p><u>Vacant (no.116 High Street), with flat(s) above</u></p> <p>Gable fronted tall 4 storey property with attic rooms.</p> <p>Ground floor shopfront – modern frameless glass shopfront set between decorative brickwork and stone pilasters with fine dressed stone projecting cappings. Plain shop fascia set above shopfront.</p> <p>Upper floor levels of red brick with bathstone string course, window heads and frieze registers to each floor. Dressed stone coping to gable.</p> <p>Modern replacement painted timber sash windows (1 over 1 arrangement) set to existing openings.</p>

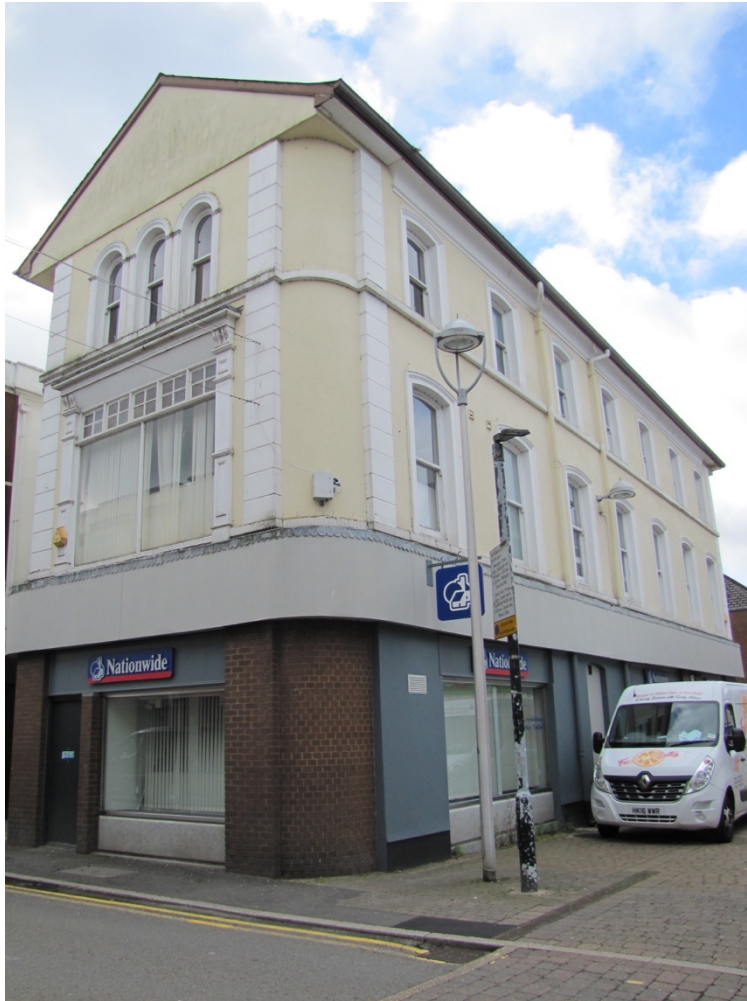
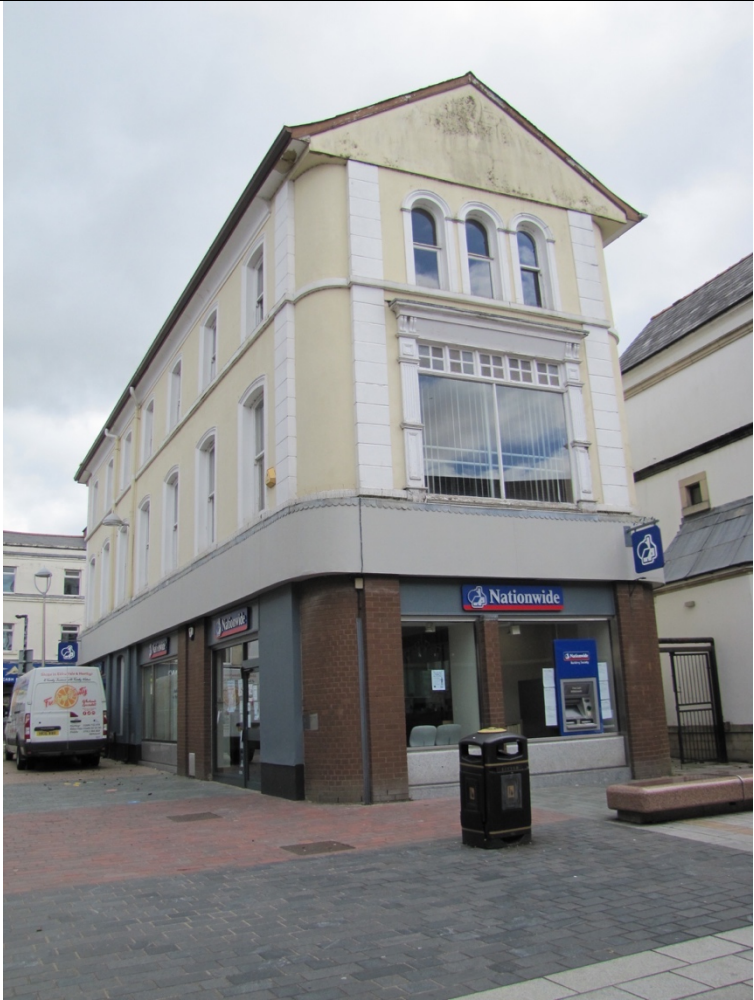
3 Victoria Street

Current use	Nationwide Anglia (building society)	
Architectural Description & Condition	<p>Street level frontage is all modern with brown facing brickwork, aluminium framed infill windows and modern signage. There's a deep plain rendered band running above this.</p> <p>Well-proportioned 1st and 2nd floor windows.</p> <p>2nd and (particularly) 1st floor windows have quite lofty proportions and quite slender window proportions except for the southern-most elevation, where there's a large glazed opening at 1st floor level with timber moulded pilasters and moulded frieze.</p> <p>2nd floor windows have three semi-circular headed timber painted sash windows that give the building quite a chapel-like appearance from the south. I think only one of these windows is still a timber sash, whilst the other two are modern replicas in the matching pattern. Pilaster to these and the arched heads have run rendered surrounds.</p> <p>Rusticated pilasters each side of the 1st and 2nd floor windows.</p> <p>The gable end facing southwards is very plain and I think this is a modern replacement for detailing that was originally there. This all looks rather mean / plain compared to other detailing at 1st and 2nd floor level. Moulded gable bargeboards are probably modern</p>

<p>replacements. I suspect the original was more deeply overhanging, wider and richer than what is here now.</p> <p>Painted timber sash windows with horns, no glazing bars. Slightly arched heads to the windows with run rendered window surrounds and stone cills. I think unless the top ones have been rendered, these continue as string course.</p> <p>Painted rendered wall panels with a curved southwest corner.</p> <p>West elevation has pilasters and deeply coved rendered eaves. Curiously, this stops just short of the pilasters.</p> <p>Moulded sections of masonry are retained at the north and south ends of the west elevation. A former window opening (that matches the pattern of the proportions of the 1st floor windows) exists in the northern half of this elevation.</p> <p>Plastic rainwater goods.</p> <p>A narrow lane running along the east side has modern painted metal gates. Painted stone plinth to the Nationwide building. Heat pumps and bins and concrete paving along this lane is not a publicly accessible area.</p> <p>North elevation matches the south elevation. I can see what looks like the base of an old rendered chimneystack in the wall visible along the lane although the chimneystack is missing now.</p> <p>The lane elevation has matching detailing to the rest of the Nationwide Anglia but with fewer window openings.</p> <p>The north elevation makes this quite a prominent building, again quite chapel like in its free-standing form.</p> <p>Not shown on 1875 Ordnance Survey Map, although the site appears to be dotted.</p>

Summary Assessment of Building's Contribution / Significance to the Conservation Area	<p>Highly positive for its retention of its historic form and historic details.</p>
