APPENDIX B - BUILDING-BY-BUILDING ASSESSMENT (2020)

1 LOWER HIGH STREET SQUARE, ST.TYDFIL'S CHURCH & COURT STREET

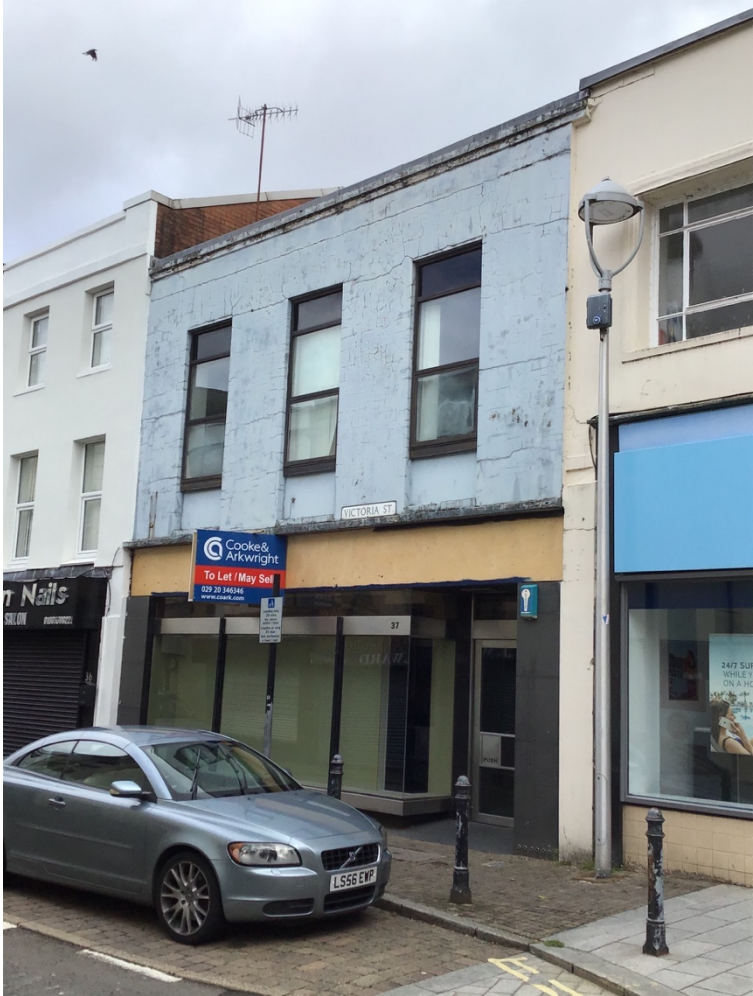
Address	<p>38 Victoria Street</p>

Current use	Vacant (formerly William Hill (betting shop))
Architectural Description & Condition	<p>Two-storeys and of a similar height to 124 High Street.</p> <p>Modern 1st floor windows with very tall / vertical emphasis.</p> <p>All modern frontage at street level.</p>
Summary Assessment of Building's Contribution / Significance to the Conservation Area	None.

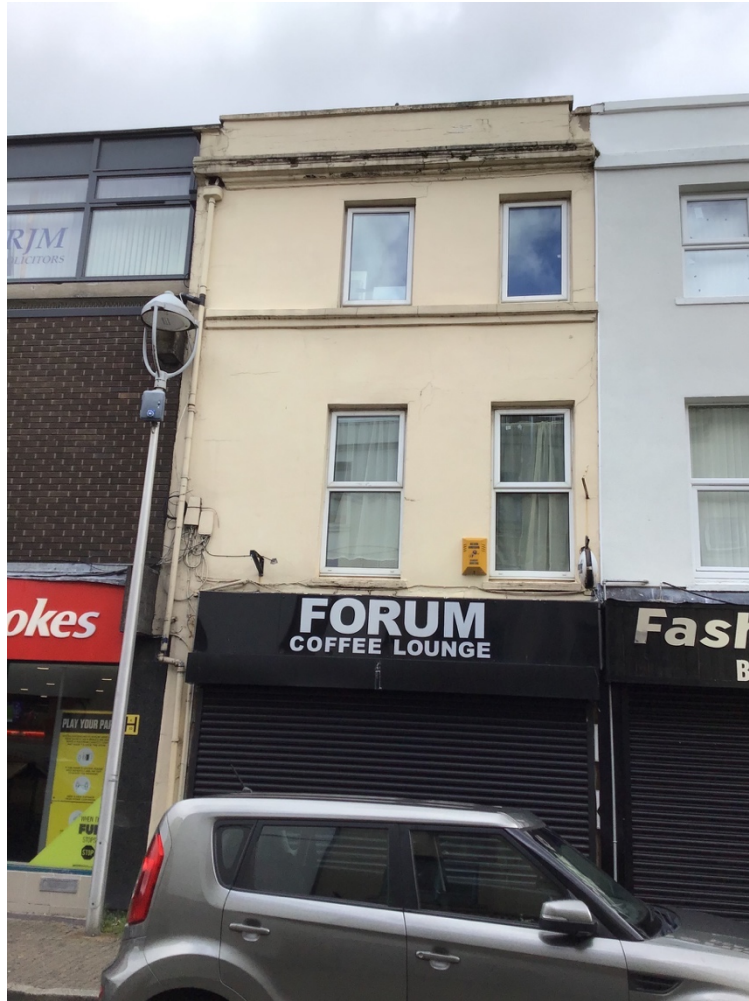
36 & 37 Victoria Street

Current use	Forum Coffee Lounge (café) (no.36) & Fashion Nails (manicurists) (no. 37)
Architectural Description & Condition	<p>Three-storeys.</p> <p><u>Nail bar (no.36)</u></p> <p>Modern, painted plain render.</p> <p>Parapet with a plain stringcourse along its bottom edge.</p> <p>Plastic windows.</p> <p>All modern shopfront.</p> <p>Taller proportioned 1st floor windows and shorter proportioned 2nd floor window openings are as they would have been originally.</p> <p><u>Forum Coffee Lounge (no.35)</u></p> <p>As above, although the windows are not symmetrical about the centre line of this elevation for some reason.</p>

<p>There is a rendered cornice, possibly with stone cappings, running along the bottom of the parapet to the Forum Coffee Lounge.</p> <p>1st floor window cills are stone, although one has been replaced with uPVC.</p> <p>There is a stringcourse at cill level to the Forum Coffee Lounge with what look like truncated / cut back stone cills to the 2nd floor.</p> <p>Plastic windows.</p> <p><u>Summary</u></p> <p>Clearly a pair of old buildings, retaining their historic form and historic window opening proportions to upper floors. A little historic detailing remains (e.g. rendered cornice to Forum Coffee Lounge).</p>
Summary Assessment of Building's Contribution / Significance to the Conservation Area	<p>Some significance, for its retention of 1st and 2nd floor window opening proportions & retention of building's original form, although historic details are largely missing.</p>

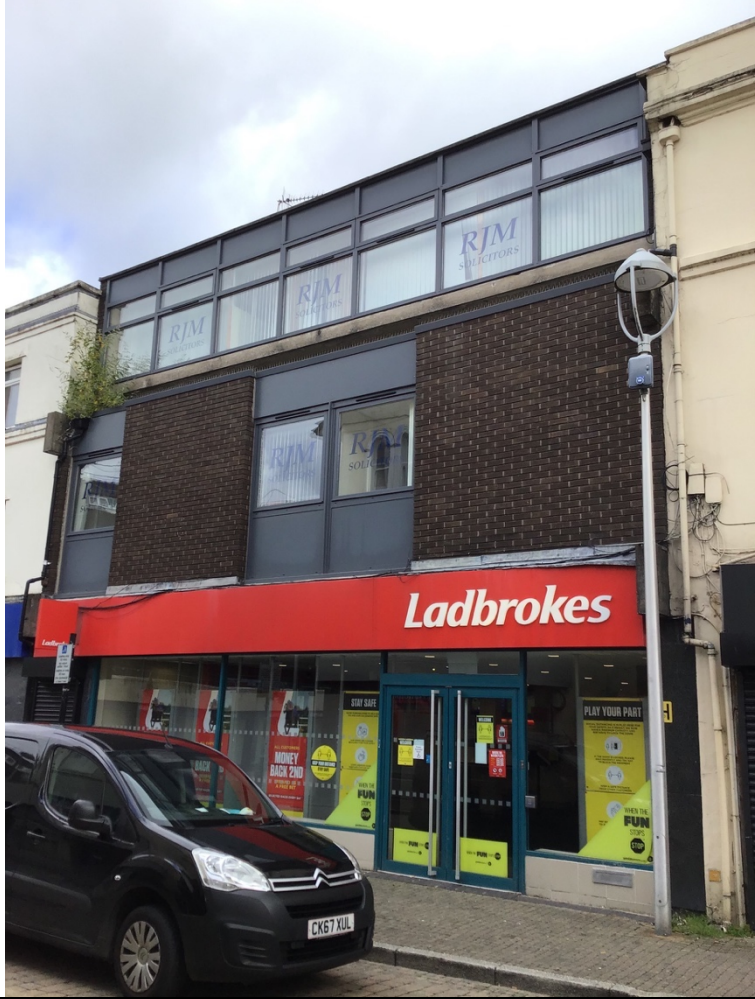
Address	<p>34 Victoria Street (possibly incorporating 35 Victoria Street)</p>

Current use	Ladbrokes (betting shop) (ground floor) with solicitors' office to upper floors
Architectural Description & Condition	<p>All a modern three-storeys building.</p> <p>Brown facing brickwork to 1st floor level.</p> <p>All modern shopfront.</p> <p>Top 2nd floor is set back slightly from the rendered elevations either side.</p> <p>There's quite a wide proportion to this building compared to the rendered buildings alongside.</p> <p>Some projecting elements of concrete structure to the upper storey.</p> <p>Top floor elevation is largely aluminium windows.</p> <p><u>Summary</u></p>

This building is visually poor within the Conservation Area. This is partly because its scale is slightly higher than it should have been (it looks about a foot higher than the parapets alongside).
Summary Assessment of Building's Contribution / Significance to the Conservation Area	None.

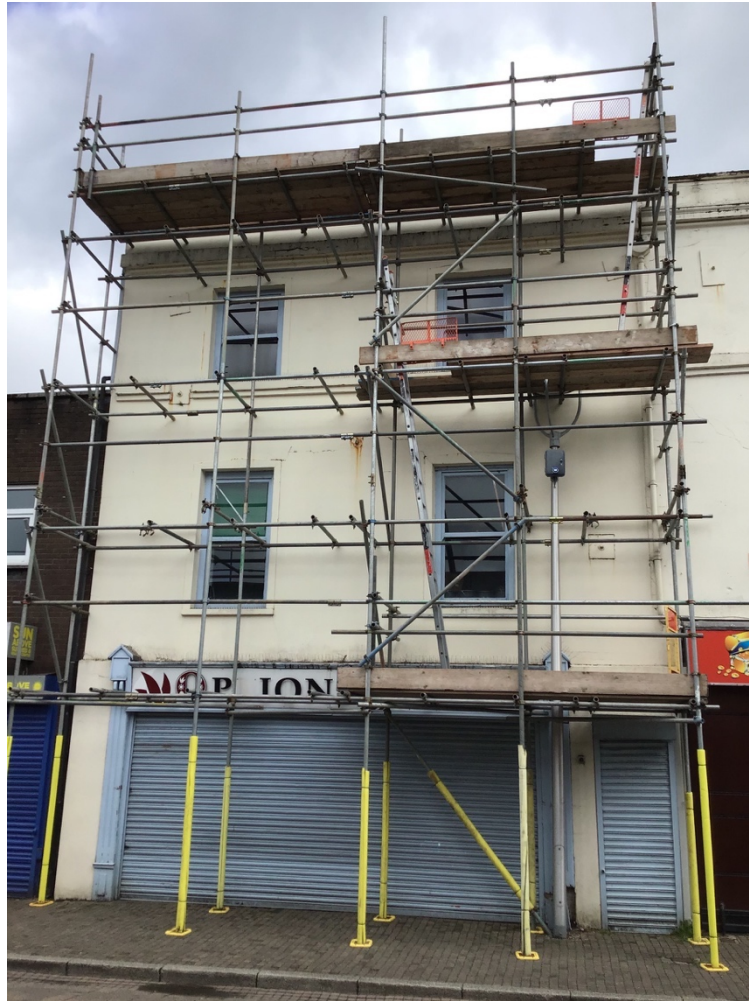
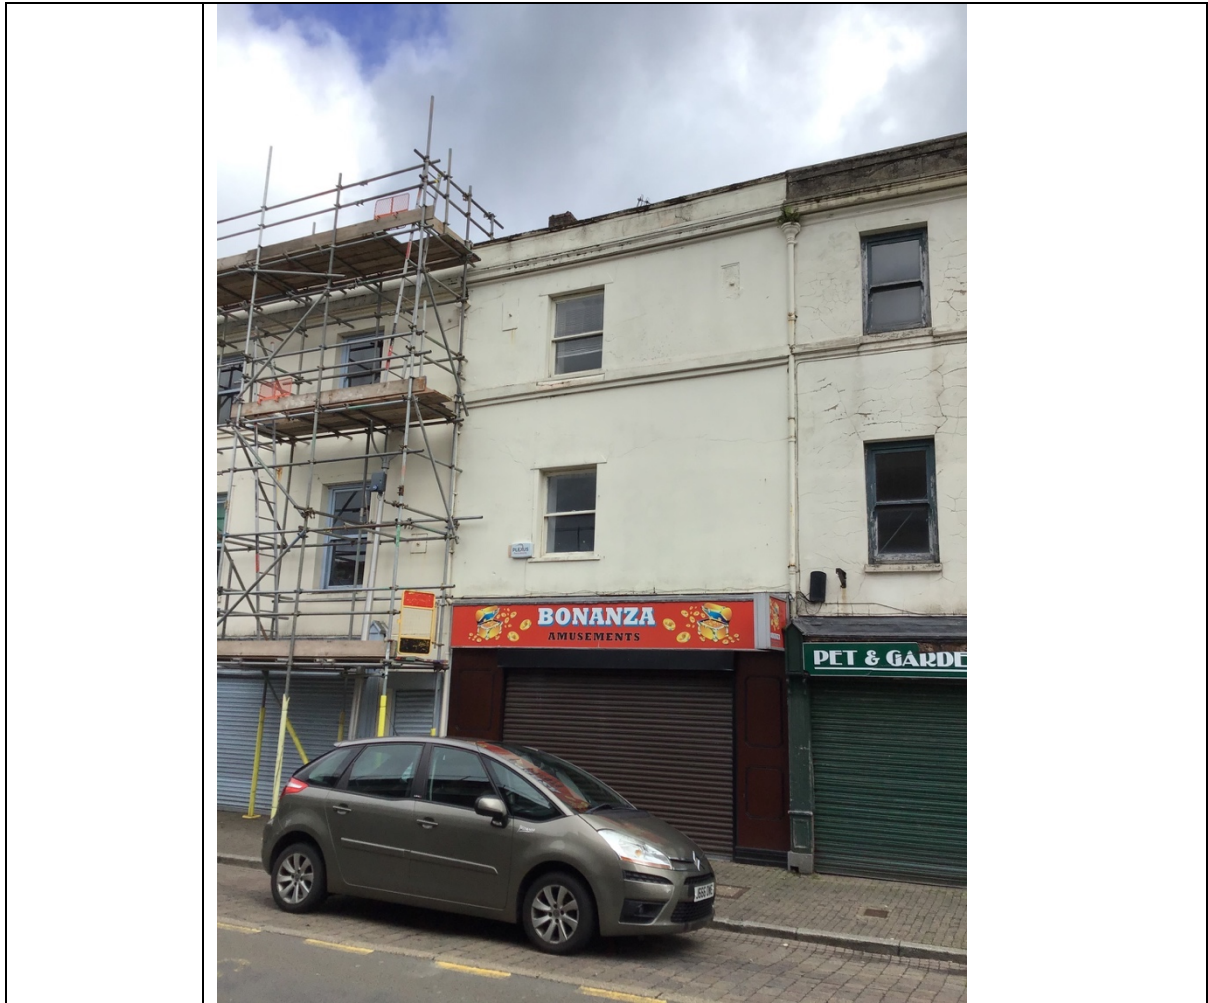
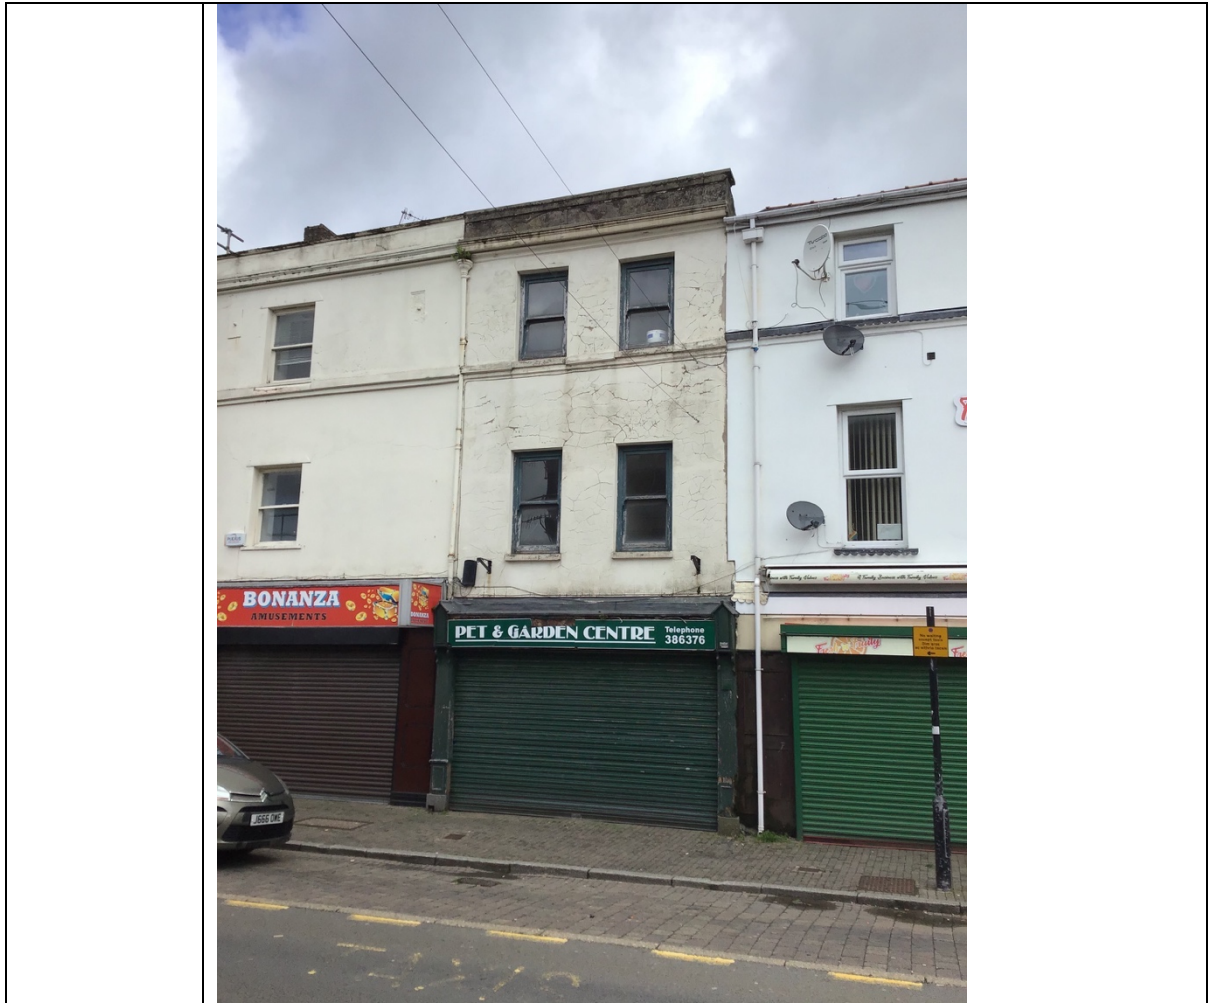
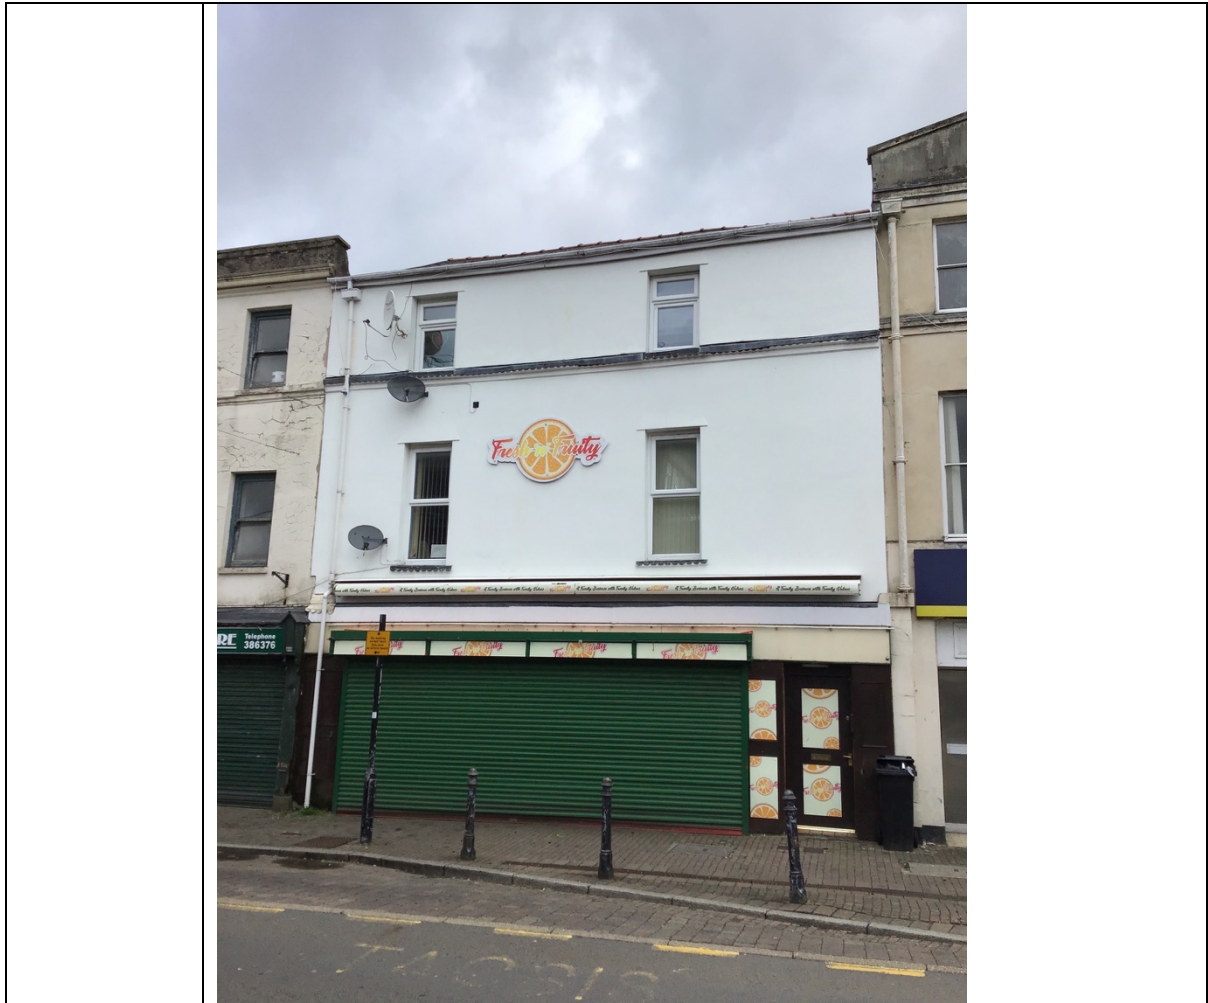
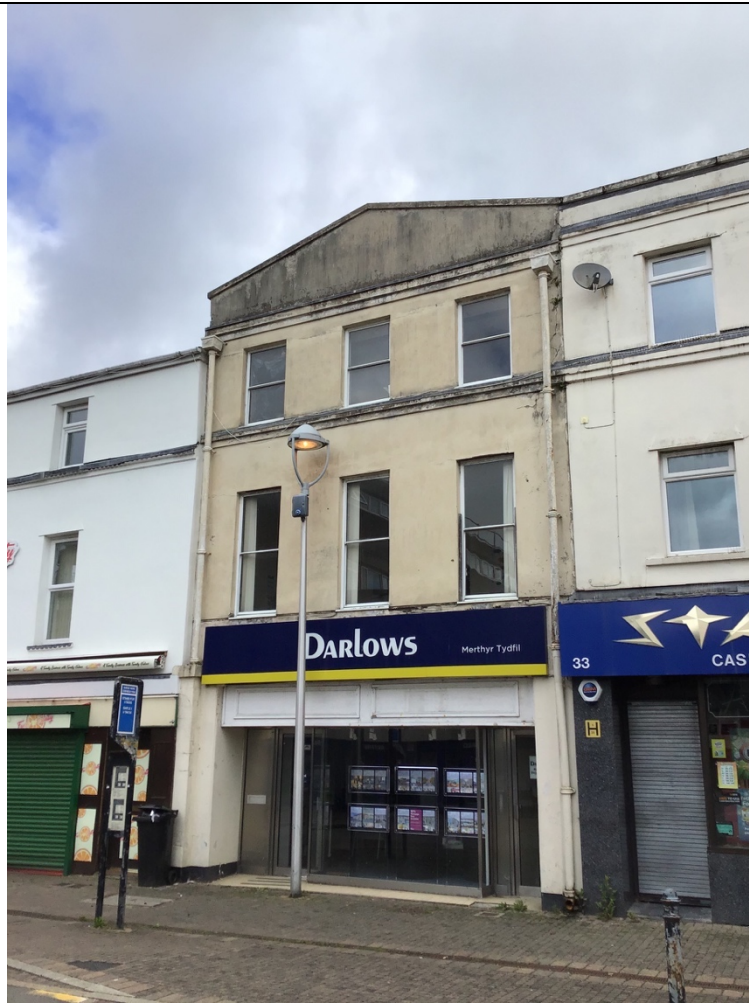
28 to 33 Victoria Street

Current use	Options Cards & Gifts (gift shop) (no.28), Bonanza (amusements) (no.29), pet & garden centre shop (no.30), fruit shop (no.31), Darlows (estate agents) (no.32), & Stardust (amusements) (no.33)
Architectural Description & Condition	<p>Probably one façade originally.</p> <p><u>Darlows (no.32)</u></p> <p>1st and 2nd floors are accentuated in height by the shallow pediment. The bottom of this pediment matches the height of the Stardust building.</p> <p>1st and 2nd floors have nicely proportioned window openings, taller to the 1st floor. These windows look like metal sash windows.</p> <p>A large modern streetlight has unfortunately been placed tight to the building.</p> <p>Stringcourse at 2nd floor window cill level matches the stringcourse on the Forum Coffee Lounge (no.36).</p> <p>A plain stringcourse or cornice at the base of the pediment.</p>

<p>Plain rendered walls.</p> <p>All modern shopfront of stainless steel and glass with some timber mouldings and a modern sign.</p> <p>1st floor window cills look like they are plastic although they could be aluminium.</p> <p><u>Stardust (no.33)</u></p> <p>A relatively wide frontage with much squatter proportioned plastic windows.</p> <p>I suspect the 2nd floor windows might be closer to their original form than the 1st floor windows. I suspect all these window openings have been changed though. They look like concrete cills.</p> <p>2nd floor window cills are a continuation (although at a slightly higher level) of the plain rendered stringcourse below the 2nd floor windows of Darlows (no.32).</p> <p>Ground floor shopfront is all modern with marble cladding glazed aluminium frames.</p> <p>A low plain rendered stringcourse / cornice at the base of the parapet. It's at a slightly higher level than the cornice to Darlows.</p> <p>Plain coping stones to parapet.</p> <p><u>Fruit shop (no.31)</u></p> <p>Even wider proportioned than Stardust (no.33) although I suspect there was originally a parapet to this. The parapet has been taken down so I can just see the roof above. This looks like fibre-cement slating with red clay capped ridge tiles.</p> <p>Plastic rainwater goods.</p> <p>The 1st floor windows are quite tall and slender and are similar to Darlows (no.32) but slightly smaller and slightly lower down, and the 2nd floor window openings are quite small, slightly smaller proportions than Darlows. Their arrangement is quite spaced, so it looks to me as though the window openings have been remodelled and some windows possibly infilled.</p> <p>All plain painted render.</p> <p>2nd floor window cills have a projecting stringcourse with lead weatherings.</p> <p>1st floor windows also have lead weatherings over the window cills.</p> <p>2nd floor window cill stringcourse is slight lower level than the Darlows stringcourse at this approximate level.</p> <p>Shopfront is all open and largely hardwood and glazing. Timberwork at street level is all modern and in poor condition.</p>

<p>A negative is the loss of the parapet.</p> <p><u>Pet and Garden Centre (no.30)</u></p> <p>Three-storeys.</p> <p>Plain painted render with parapets of a similar height.</p> <p>Street level shopfronts all modern.</p> <p>Timber painted pilasters each side of pet shop (no.30) shopfront.</p> <p>1st and 2nd floor windows are painted timber box sash windows. Quite a lot of the box frame is visible. These windows have horns, they don't look in great condition at their bottoms. Both are of a similar proportion although the 1st floor windows are slightly larger.</p> <p>1st and 2nd floor window cills are stone.</p> <p>Rendered stringcourses, simple plain run moulded stringcourse at 2nd floor window cill level. A slightly more-deeply moulded projecting cornice, run-moulded, at the bottom of the parapet and what look like concrete copings to the top of the parapet. Both run-rendered details continue onto Bonanza Amusements (no.29).</p> <p>2nd floor windows' cills are slightly lower than those of no.31 (fruit shop).</p> <p>Shopfront all modern, plastic timber and glass.</p> <p>There is what looks like a cast iron downpipe and ornamental hopper between nos. 29 & 30.</p> <p><u>Bonanza Amusements (no.29)</u></p> <p>Three-storeys.</p> <p>Plain painted render with parapets of a similar height.</p> <p>Street level shopfronts all modern.</p> <p>Only has one window in each of its 1st and 2nd floor levels. These are both fairly squat proportioned window openings with what look like concrete cills and a modern bell-cast type drip to the hood to the windows. I suspect these are modern window openings and that the originals have been infilled.</p> <p>I can just about see a brick chimneystack at the western end of this roof.</p> <p>Painted timber windows with no horns, but they are probably fairly modern late 20th century windows.</p> <p><u>Options Cards & Gifts (no.28)</u></p> <p>Three-storeys.</p>

Summary Assessment of Building's Contribution / Significance to the Conservation Area	<p>Some significance since the original three-storeys form and some retained original window openings to upper floors are retained.</p> <p>Opportunity to reinstate missing historic details.</p> <p>Rear elevations are largely visually poor, although some trees at the eastern end help to visually screen some of these (during the summer at least).</p>

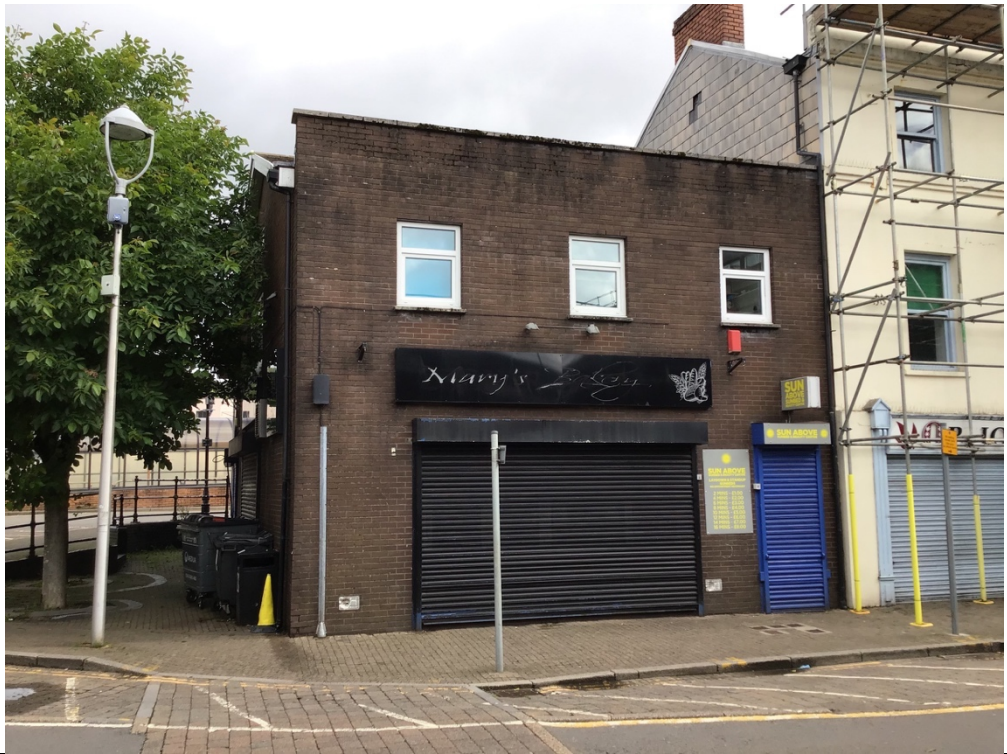
Address	27 Victoria Street

Current use	Mary's Bakery and Sun Beauty Centre
Architectural Description & Condition	<p>Modern two-storeys built up to the height of the stringcourse on no.28.</p> <p>1st floor elevation is brown facing brickwork with concrete capped parapet.</p>
Summary Assessment of Building's Contribution / Significance to the Conservation Area	None.

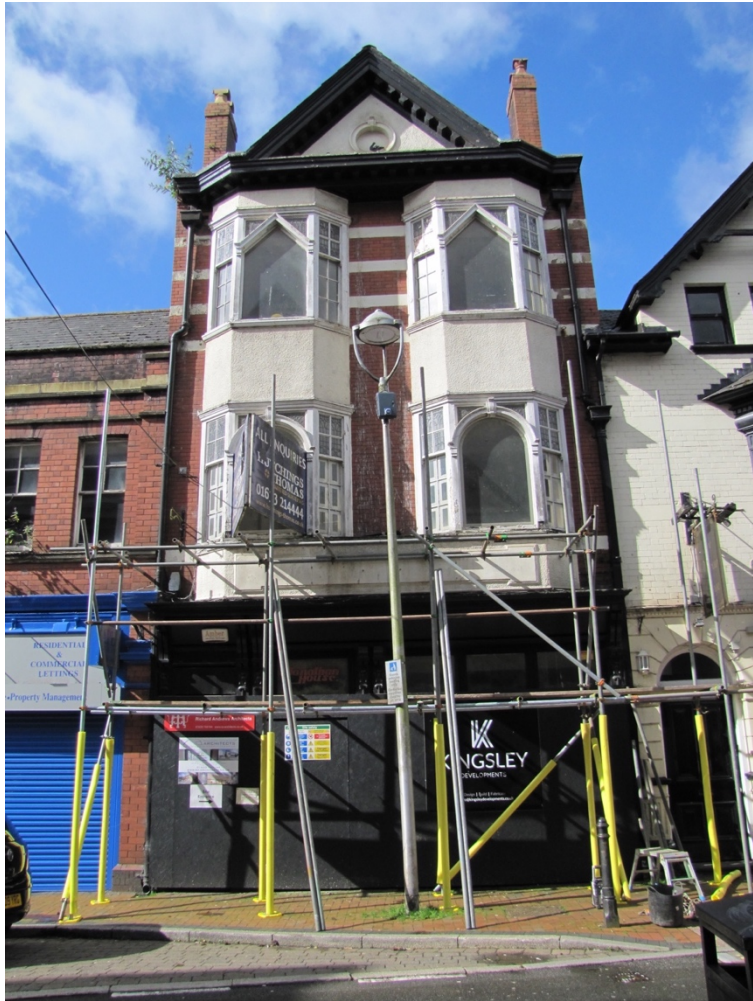
Address	<p>3 Glebeland Street (Jonathan House)</p>

Current use	Presumed offices (appears unoccupied)
Architectural Description & Condition	<p><u>Front</u></p> <p>Very nicely detailed three-storeys building with an old shop frontage.</p> <p>Glazed brick wall panel below the shop front window has moulded pilasters, panelled double entrance doors, roller shutter to the door providing access to the 1st floor.</p> <p>Slightly Art Nouveau detailing, quite tall slender appearance to the building and the details.</p> <p>Pair of bay windows at 1st and 2nd floors.</p> <p>Nice detailing to the timber windows with leaded lights to the upper sashes of the side splays.</p> <p>Deep bracketed cornice with a pediment above this with a circular moulded centre piece.</p> <p>Painted moulded timber barges.</p>

<p>Pair of brick chimneystacks.</p> <p>Rendered east wall.</p> <p>Small red facing brickwork with very fine / tight joints.</p> <p>Some stone banding currently with a paint finish to the upper floor.</p> <p>Old roughcast render to the bays and there's a moulded plain rendered panel below the 1st floor windows, which is a continuation of the bays themselves.</p> <p>The windows need repairing.</p> <p><u>Rear</u></p> <p>Four-storeys and thus with the greatest presence along Wheatsheaf Lane.</p> <p>Duo-pitch roof with natural slate roof coverings. Moulded timber painted bargeboards to the western gable.</p> <p>Old render to walls.</p> <p>Two brick chimneystacks either side of the western gable to the four-storeys section.</p> <p>Small yard between this and a three-storeys building to rear, which is immediately on Wheatsheaf Lane. Again, quite a lofty building so quite dominant. White glazed brickwork to the yard walls. Looks to be for sale and vacant. Large brick chimneystack matching the style of the ones to the northern building. Painted timber with fascia and barges, and what look like cast iron ogee gutters and cast iron downpipes. Pennant stone cills to the windows, painted timber sash windows to the rear southern elevation. Small overgrown yard and brick boundary walls.</p>

Summary Assessment of Building's Contribution / Significance to the Conservation Area	<p>A very positive contribution.</p> <p>Would be good to see the three storey house to the south side of Jonathan House brought back into use.</p>

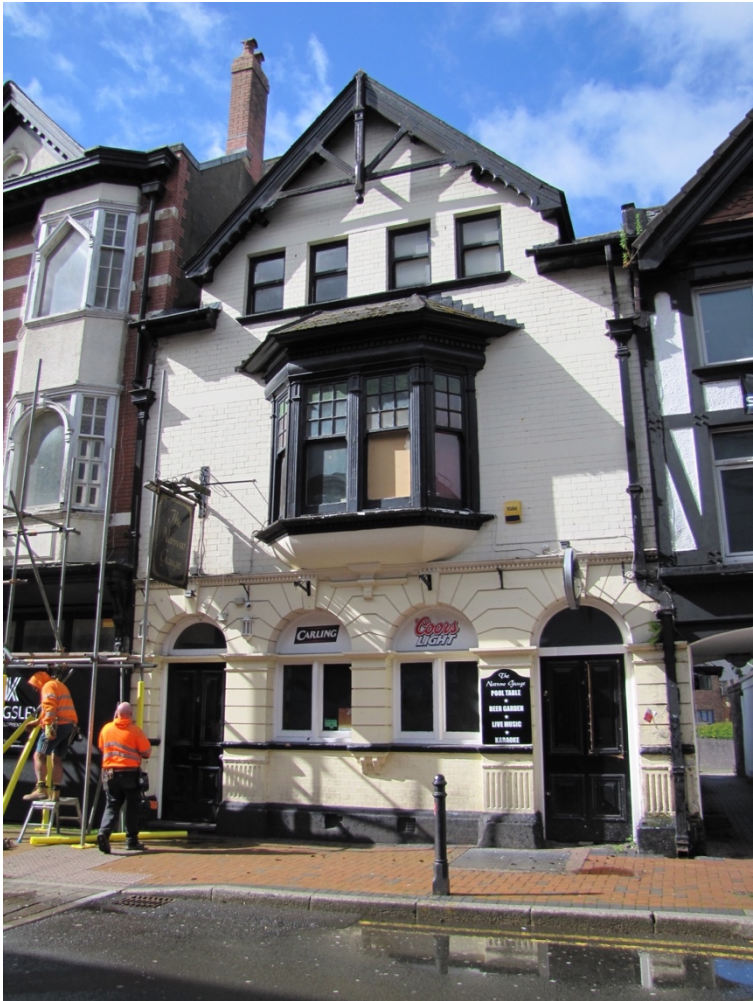
Address	<p>4 Glebeland Street</p>

Current use	The Narrow Gauge (public house)
Architectural Description & Condition	<p><u>Front</u></p> <p>Gabled front elevation.</p> <p>Projecting bay window at 1st floor with painted timber sash windows, mouldings and dentils.</p> <p>1st and 2nd floors have painted facing brickwork with some stone banding. The gable brickwork itself and window openings are fairly plain. The cill is continuous across all 4no. windows.</p> <p>Good projecting fairly decorative gable timberwork and clay crested ridge tiles.</p> <p>Ground floor is painted stonework with facing brickwork central panels and doors each side. Arched head openings, dentilled stringcourse along the top of this and rusticated pilasters and arched heads. A painted stone plinth, painted timber windows and doors to traditional patterns.</p>

<p>Bay window has a shallow hipped slated roof.</p> <p><u>Rear</u></p> <p>Rear elevation all painted render.</p> <p>Lane alongside the Narrow Gauge has quite a nice scale about it. Only the very northern end is built over and its tall proportions help its appearance and daylight levels. Arched heads both ends of the lane. Walls are painted render within the enclosed part of the lane.</p> <p>Windows have cills of roughly dressed stone to have a rock-faced appearance and modern painted steel window guards.</p> <p>Roller shutter to the side door.</p> <p>Quite a nice, although modern, canopy over the side door, possibly a modern reproduction of something that may have been here before but I quite like the design of it. It helps to give a little bit of ownership of the lane.</p> <p>Metal gate to rear yard.</p> <p>Painted rendered walls.</p> <p>Fibre-cement slated roof.</p> <p>1st floor is a wide, full-width, outrigger gable-ended construction with painted timber sash windows and the rock-faced stone cills, painted timber barges, very mean projecting purlin stubs.</p> <p>Velux-type rooflight visible in the three-storeys part of the building along Glebeland Street and one window, again with a stone cill, centrally in the three-storeys section's western gable. Partly decayed and tight bargeboards on this gable end.</p>

Summary Assessment of Building's Contribution / Significance to the Conservation Area	<p>Front – Very positive.</p> <p>Rear – Not unpleasant and the lane alongside it is visually acceptable as well.</p> <p>Locally listed.</p>

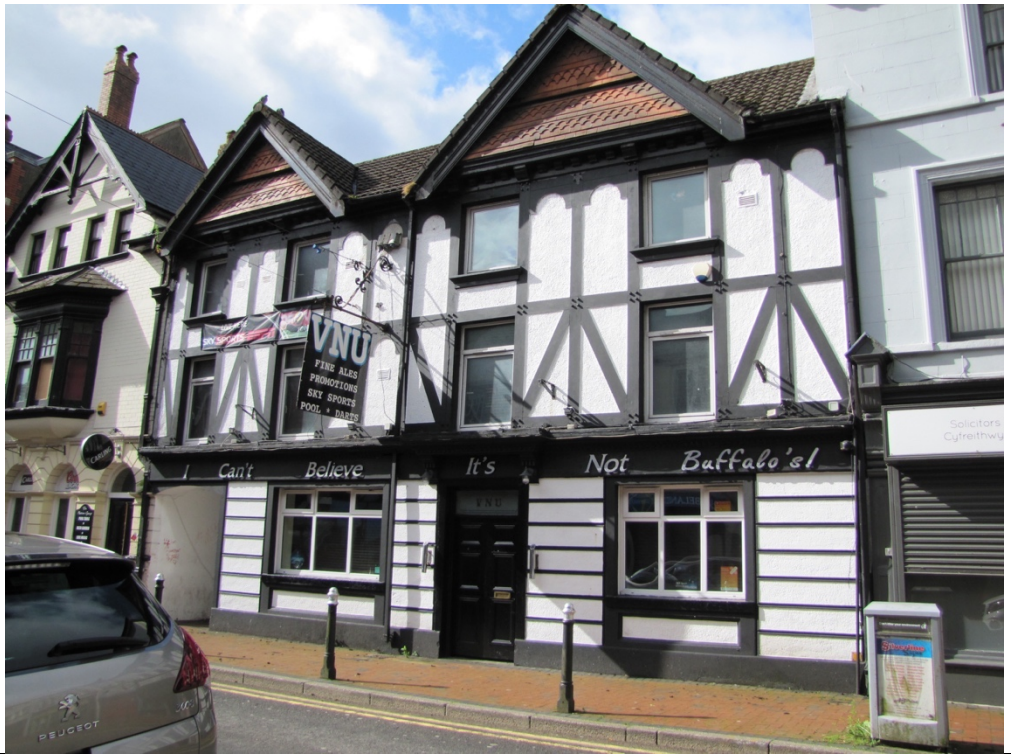
Address	<p>5 Glebeland Street</p>

Current use	VNU (public house)
Architectural Description & Condition	<p><u>Front</u></p> <p>Not a particularly attractive building. The wide proportions and black and white paint scheme do not help</p> <p>Modern starkly white painted roughcast rendered panels and timber framing to 1st and 2nd floors.</p> <p>Plastic 1st and 2nd floor windows.</p> <p>Lane leading to the bus station is well used.</p> <p>Ground floor has deeply rusticated, rendered pilasters and dentilled cornice.</p> <p>Modern doors & windows with wide proportions.</p> <p>Ground floor has probably been remodelled and the windows widened.</p> <p>Two gables with clay tile hangings.</p> <p>I suspect some missing details at the bottom of the barge boards, which are moulded painted timber.</p> <p>Concrete tiled duo-pitched roofs.</p>

<p><u>Rear</u></p> <p>Rear elevation all painted rendered walls.</p> <p>Cat-slide concrete tiled roof. Mono-pitch roofed extension and an external flat roofed metal outbuilding and a small yard.</p> <p>Numerous services e.g. heat pumps on the side of the mono-pitched building.</p> <p>Modern timber gates to rear yard.</p>
Summary Assessment of Building's Contribution / Significance to the Conservation Area	<p>Some significance, although much modernised.</p> <p>Could be improved.</p>

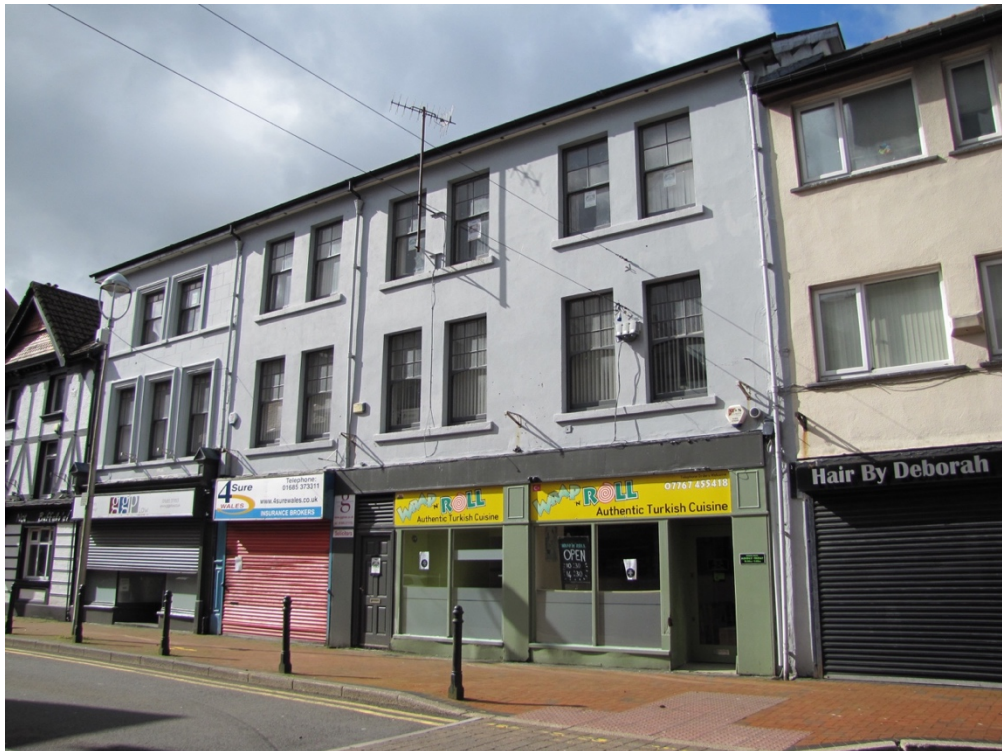
Address	<p>6 to 9 Glebeland Street</p>

Current use	Solicitors (offices) (presumed no.6), Insurance broker (presumed no.7), possible entrance to 1 st & 2 nd floors (no.8), and Turkish restaurant (presumed no.9)
Architectural Description & Condition	<p>Shown on 1851 Public Health Map.</p> <p>Three-storeys, so has some dominance when viewed from Wheatsheaf lane to rear.</p> <p>Modern painted fascia boards and soffits, unfortunately the latter with soffit vents particularly visible because the soffits have been painted white.</p> <p>Rear elevations all painted render.</p> <p><u>Solicitors (offices) (no.6)</u></p> <p>Good traditionally detailed painted timber pilastered frontage at street level with inset doorway.</p> <p>Three well-proportioned sash windows to 1st floor with two squatter windows to 2nd floor. Moulded rendered window surrounds. Stone cills with the fairly plain stringcourses continuous with cills.</p> <p>Plain rendered walls with stucco line struck to 1st and 2nd floors, possibly renewed recently.</p> <p><u>Insurance broker (no.7) & Restaurant (no.8)</u></p>

<p>Pairs of 1st and 2nd floor windows with stone cills linking the pairs. Matching painted timber sash windows to both properties, although the detailing of these windows may be relatively modern.</p> <p>Stringcourse render detailing to upper floor elevations, as seen at no.6, has presumably been removed in the past.</p> <p>Shop frontages all modern moulded details.</p> <p>Both elevations recently repainted suggesting they may be in one ownership.</p> <p><u>Rear</u></p> <p>Free-standing barber building to rear of no.8 is all modern pebble dash render, plastic rainwater goods, roller shutters, modern concrete cills, aluminium windows, concrete tiled roof.</p> <p>Beyond this, the slightly elevated three-storeys rear elevations are urban in their scale.</p> <p>The painted rendered walls have nicely proportioned second floor windows in particular. Some are still fitted with timber painted sash windows although one has been replaced with a more modern casement window.</p> <p>Plastic rainwater goods and fascia.</p> <p>Roof covering is slate, but I'm not sure if it's fibre cement or natural slate or a mixture of the two.</p> <p>Two-storeys duo-pitched outriggers to each of the properties.</p> <p>Several lean-to constructions at ground floor level.</p> <p>Modern palisade galvanised steel gates to the rear of no.6.</p> <p>Modern painted steel gates to the rear of no.7.</p> <p>Eastern gable end of no.6 (solicitors) is visible, rendered, with projecting bracketed purlin ends, I presume with timber soffit to the barge. Some unevenness in this wall suggests that this is quite an old wall or there had been something built against it historically.</p>

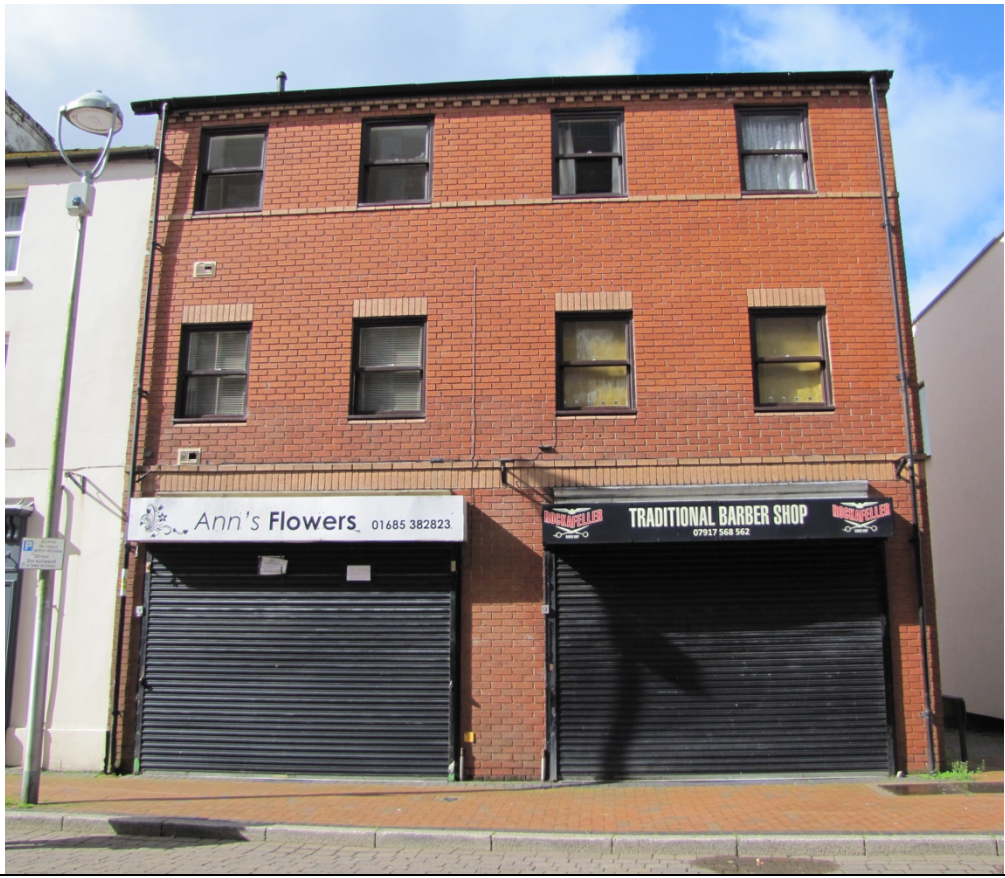
Address	<p>13 & 14 Glebeland Street</p>

Current use	Barbers (no.13) and florist shop (no.14)
Architectural Description & Condition	<p><u>Front</u></p> <p>A modern building.</p> <p>Facing red brickwork walls.</p> <p>Roller shuttered shop frontages.</p> <p>Three-storeys matching height of Barbers at no.10 (?) Glebeland Street.</p> <p><u>Rear</u></p> <p>Single-storey 'Regeneration' shop, all modern, although it was probably converted from an old garage.</p> <p>Fibre-cement slate roof with plastic rainwater goods and fascia.</p>
Summary Assessment of Building's Contribution	None.

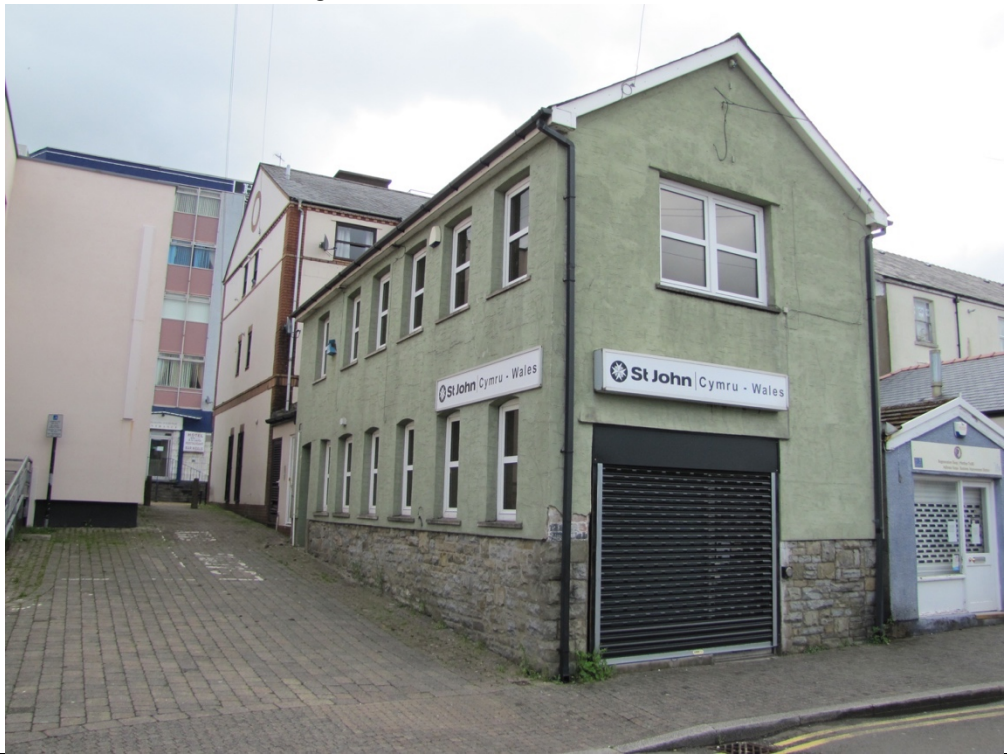
Address	14a Glebeland Street (although on Wheatsheaf Lane)

Current use	St. John's Ambulance (presumed training centre)
Architectural Description & Condition	<p>Two-storeys with duo-pitched roof. This form is visible on 1929 aerial photographs.</p> <p>Textured render finish to 1st floor walls.</p> <p>Concrete cills, plastic windows.</p> <p>The scale and gable-ended form of the building are traditional but the Pennant stonework plinth looks recently built or re-built.</p> <p>Plastic rainwater goods and fascia.</p>
Summary Assessment of Building's Contribution / Significance to the Conservation Area	Low, because its historic form and side window opening proportions have been retained.

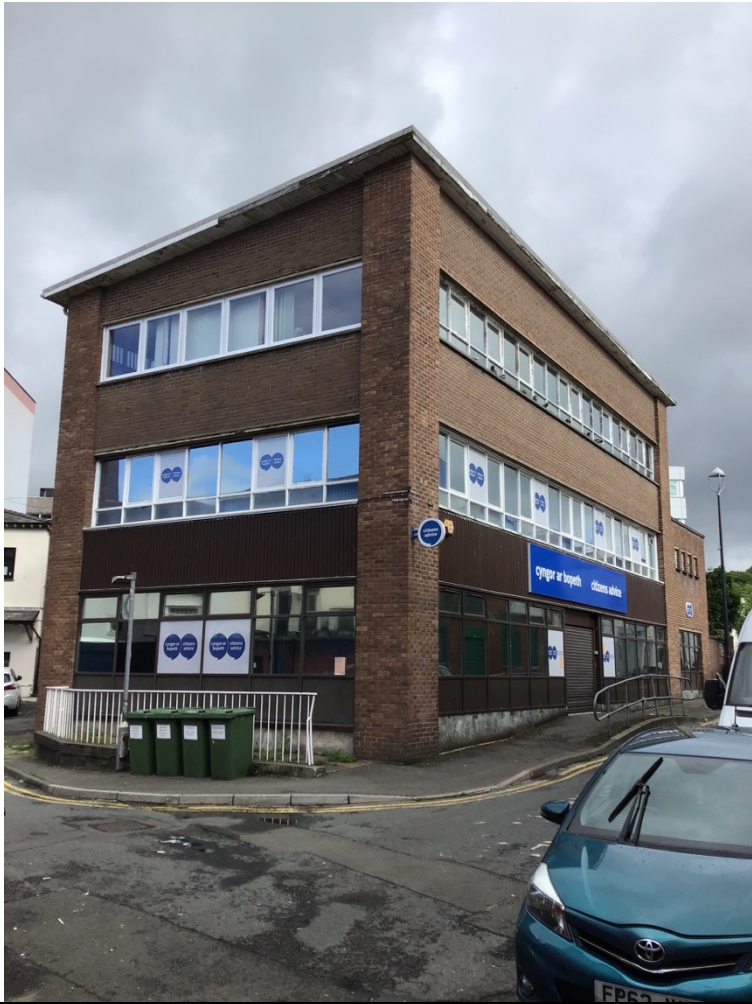
Address	Post Office Lane

Current use	Citizens Advice Centre
Architectural Description & Condition	<p>Modern 3 storey flat roofed office block.</p> <p><u>Roof</u> Flat with overhanging eaves.</p> <p><u>Elevations</u> Brown brick elevations generally with horizontal strip windows to each level of principal front and rear elevations. Stained vertical timber boarding set above ground floor windows. Ground floor windows of brown PPC aluminium. Upper level windows of modern painted timber with metal opening casements.</p>
Summary Assessment of Building's Contribution / Significance to the	None.

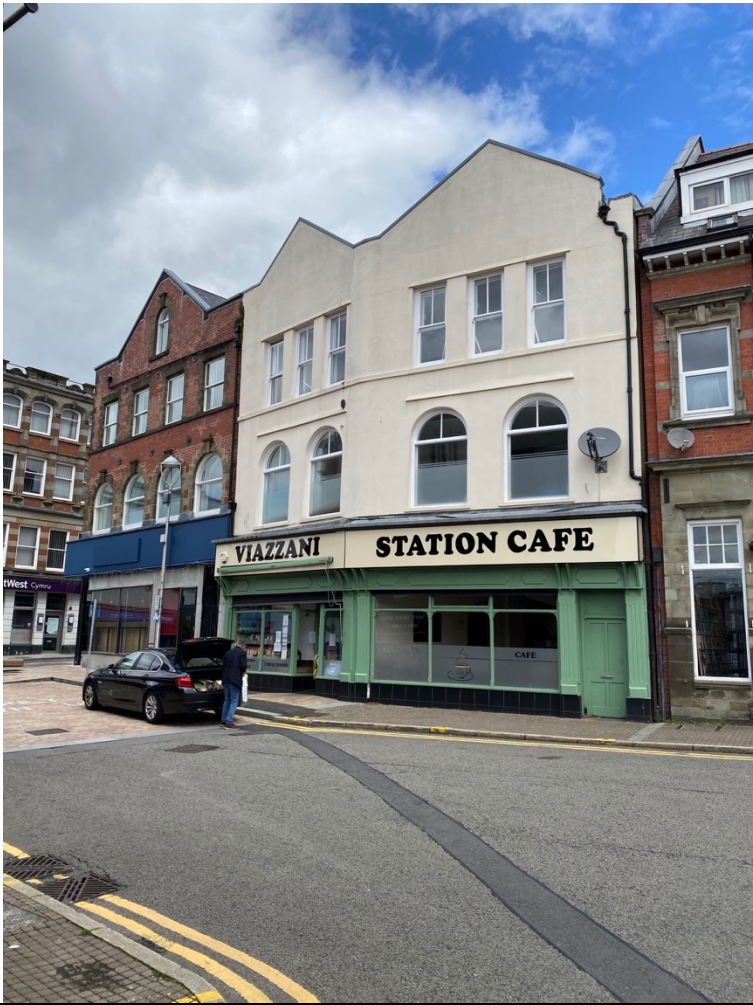
Address	<p>1 John Street</p>

Current use	G & M Viazani's Station Café
Architectural Description & Condition	<p>All modern, painted signage and timber work at street level.</p> <p>1st and 2nd floors have all recently been refurbished with painted timber windows, sash windows to the 2nd floor, and plain painted render (all modern detailing and fairly plain).</p>
Summary Assessment of Building's Contribution / Significance to the Conservation Area	Low or some significance.

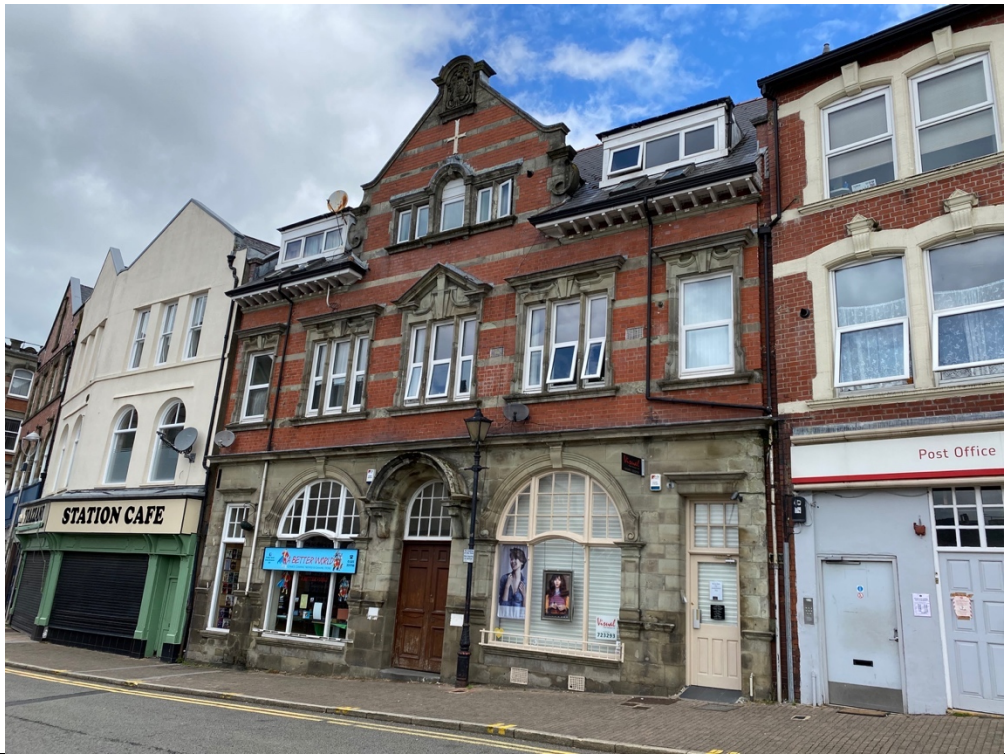
Address	1a & 2 John Street

Current use	Comic bookshop (1a) and Visual Hair Design (hairdresser) (2)
Architectural Description & Condition	<p>A grand brick and stone building.</p> <p>Ground floor is all dressed stonework, quite nicely detailed timber painted windows and doors. A cornice above this.</p> <p>1st and 2nd floors are red clay facing brickwork with dressed stone surrounds and mullions.</p> <p>The roof has quite wide dormer window at each side of the dressed stone and brick central gable. The dormers have lead cheeks but plastic fascia, cladding and windows. Main roof covering looks like a fibre-cement slate. Some Velux rooflights.</p> <p>1st and 2nd floor windows are all plastic.</p> <p>Eaves have painted timber brackets and plastic moulded rainwater goods.</p> <p>A good looking building with an attractive green sandstone used to the ground floor frontage.</p> <p>Ashlar stonework, a good arched canopy, painted timber windows to ground floor.</p> <p>Plastic 1st and 2nd floors windows.</p> <p>Dormers are quite wide and squat looking.</p> <p>Velux rooflights.</p>

<p>Fibre-cement slate roofs with good bracketed projecting eaves and deeply moulded stonework to 1st floor windows.</p> <p>Good central gable.</p> <p>Aluminium rainwater goods, partly defective.</p> <p>Dressed stone has spalled quite a lot.</p>
Summary Assessment of Building's Contribution / Significance to the Conservation Area	A visually positive building.
