APPENDIX B - BUILDING-BY-BUILDING ASSESSMENT (2020)

1 LOWER HIGH STREET SQUARE, ST.TYDFIL'S CHURCH & COURT STREET

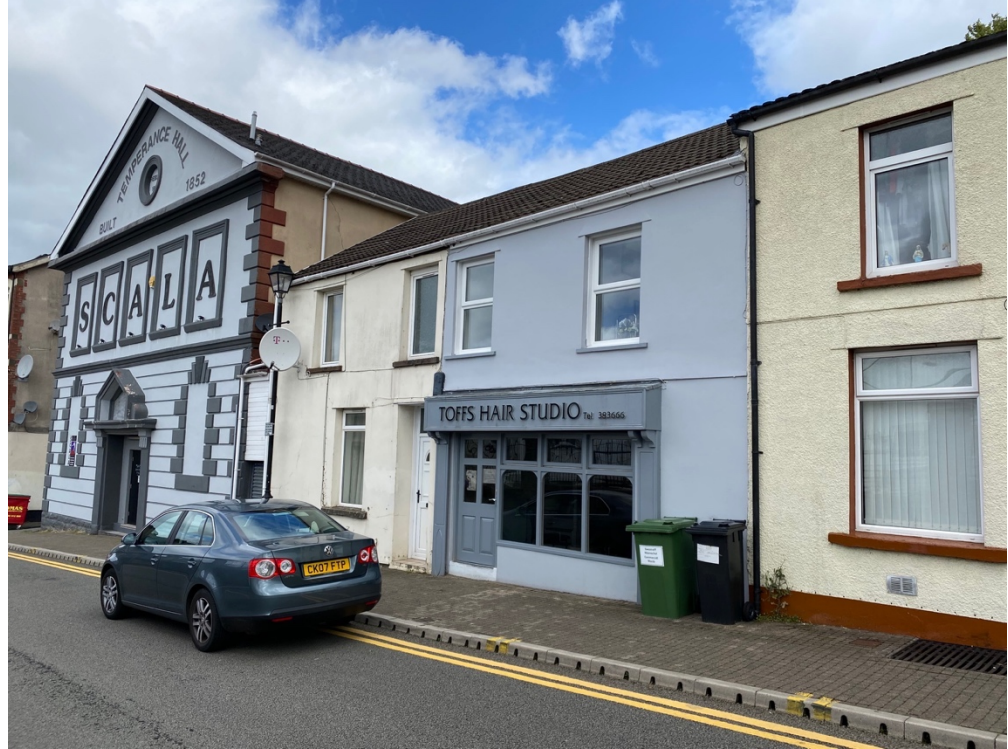
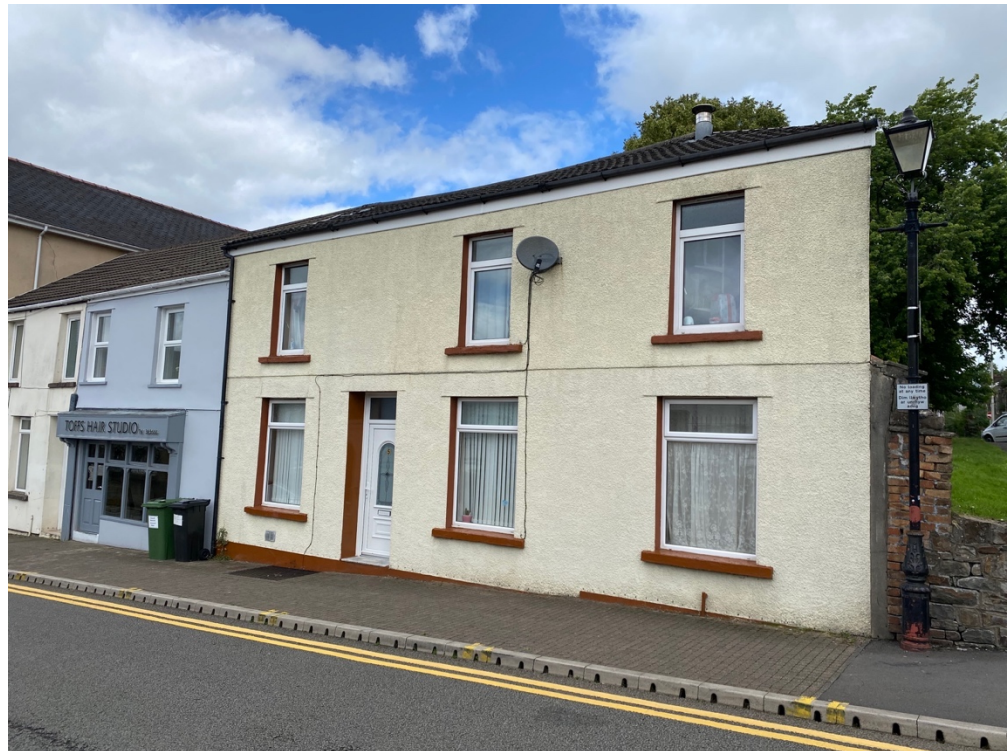
3 to 5 John Street

Architectural Description & Condition	<p>Low two-storeys cottages.</p> <p>Shallow profiled concrete tiled roofs.</p> <p>Modern, painted rendered walls.</p> <p>No.5 is modern rough cast, the others are painted plain render with modern bell-cast stop-beads.</p> <p><u>Nos. 3 & 5</u></p> <p>Plastic windows with painted plain rendered reveals and painted stone cills.</p> <p><u>No. 4</u></p> <p>Modern painted shopfront to barber with modern painted timber mouldings.</p> <p>2-over-2 painted timber sash 1st floor windows.</p>
Summary Assessment of Building's Contribution / Significance to the Conservation Area	<p>Some significance for retention of historic form and openings, although their inclusion in the Conservation Area could be questioned.</p>

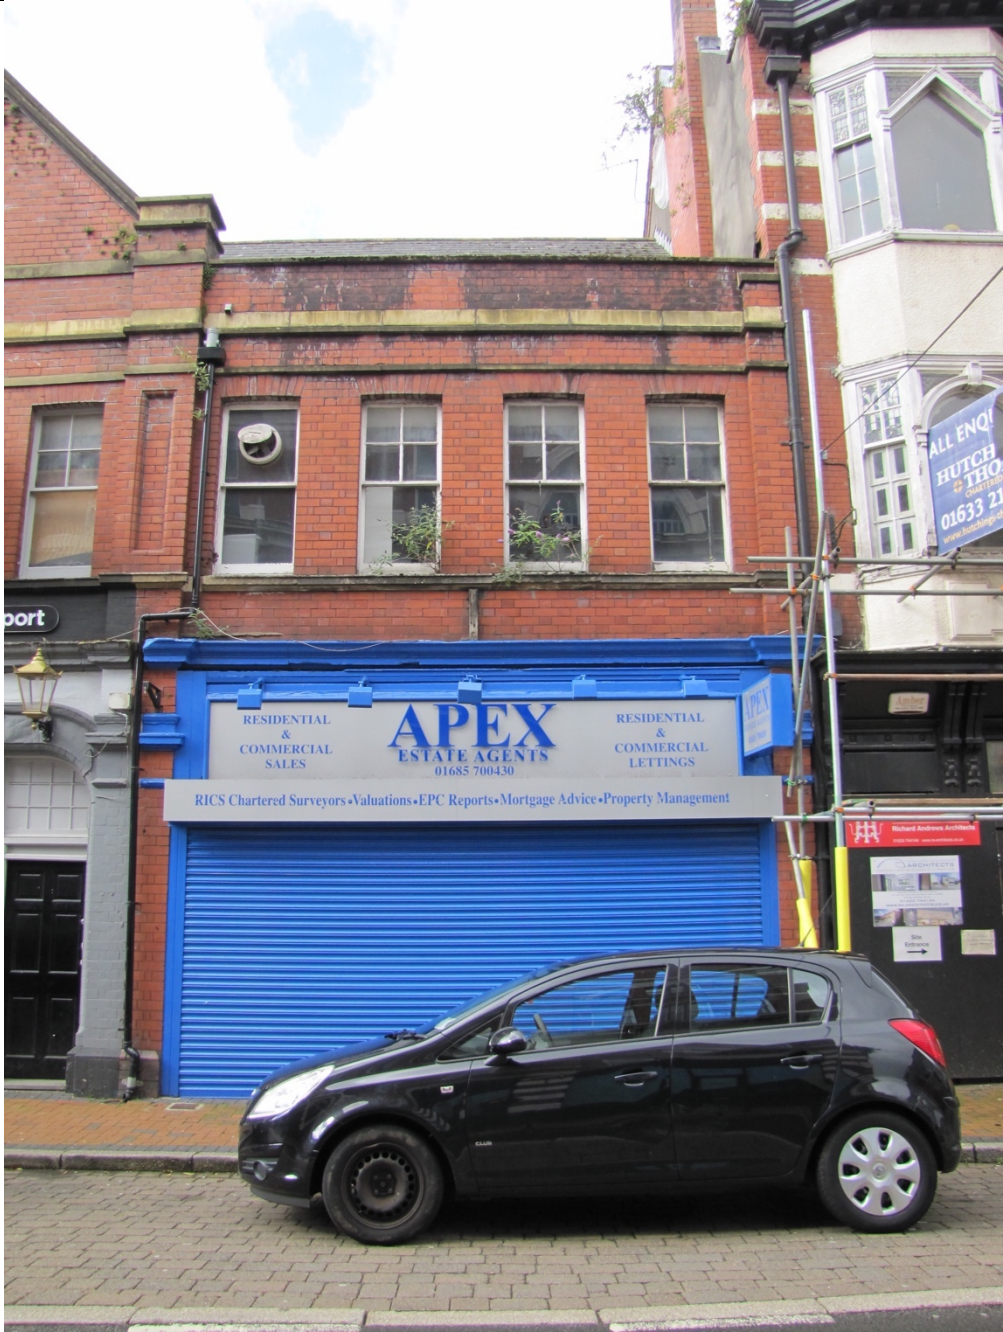
Address	<p>1 & 2 Glebeland Street</p>  
---------	---

Current use	Belle Vue (public house) (no.1) & Apex Estate Agents (no.2)
Architectural Description & Condition	<p><u>Belle Vue (public house) (no.1)</u></p> <p>A dominant urban scale building within Glebeland Street.</p> <p>Only a slight presence on High Street due to its narrow plot at that point.</p> <p>Painted brick pilasters and some quite nice deeply moulded painted timberwork at street level.</p>

<p>Main entrance seems to have been created at the narrowest High Street end where there is a slightly higher semi-circular headed moulded painted stone surround to this doorway.</p> <p>1st floor windows are painted timber sashes with a curved one on the corner.</p> <p>All red clay facing brickwork to 1st floor and there's a band of what looks like bathstone running along the bottom of its parapet.</p> <p>A painted stone moulded stringcourse running along the head of the ground floor although there's a large piece of this missing due to spalling.</p> <p>The building increases in height at its western end with quite a large but fairly plain brick gable with coping stones. The fibre-cement slate duo-pitched roof is visible above this. The rest of the low parapet has a modern timber handrail and guarding behind this.</p> <p>There's work currently going on in the street adjacent to this area. I fear this may be finished (although perhaps temporarily) with tarmacadam infill as seen elsewhere in this Conservation Area.</p> <p>2nd floor windows in the gable are plastic.</p> <p><u>Apex Estate Agents (no.2)</u></p> <p>Nos. 1 and 2 appear to have been built at the same time and share some details (e.g. moulded cornice above shopfront). No.2 appears to have always been a shop. Modern shop frontage.</p> <p><u>Rear</u></p> <p>Roller-shuttered rear yard with a brick boundary wall in fairly poor condition.</p> <p>Three-storeys rear gable to pub with fibre-cement slate roof.</p> <p>A couple of painted timber sashes in the recessed section of wall at its western end and then the rest of this elevation is facing brickwork around the windows and what look like painted stone cills and modern plain painted render to the panels.</p> <p>Plastic windows in the original proportioned window openings.</p> <p>There's what looks like a small electricity sub-station just on the pavement adjacent to this area.</p>

Summary Assessment of Building's Contribution / Significance to the Conservation Area	<p>Positive.</p> <p>Locally listed.</p>

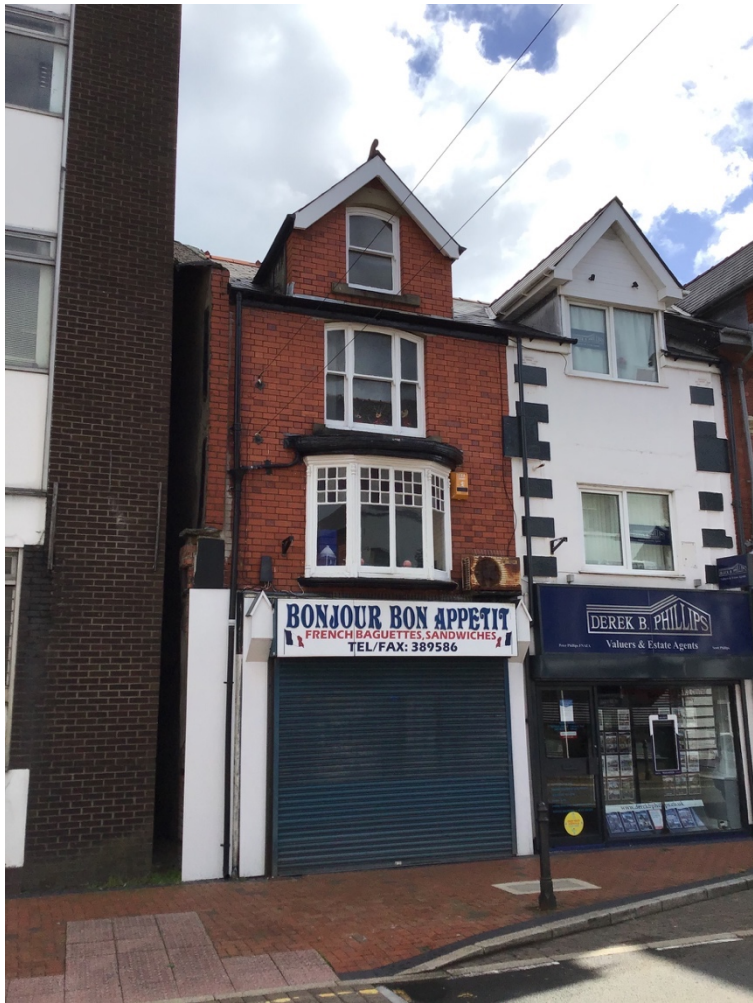
Address	<p>50 Glebeland Street</p>

Current use	Bonjour Bon Appetit Sandwich Shop. Presumably residential use above.
Architectural Description & Condition	<p>Narrow 2 storey terraced building with gabled attic room above. Appears to have originally been constructed as part a pair with no. 51 next door.</p> <p><u>Roof</u> Roof believed to be of fibre cement slates, but only gable visible from street views.</p> <p><u>Elevations</u> The ground floor generally is of a modern shopfront set in from building face between two plain modern reproduction painted timber pilasters. Modern signage over. External mounted security roller shutter.. Upper elevations of red brickwork. Oriel bay window arrangement to first floor with original widow. Seemingly fixed panes with 9 small paned decorative panes over larger clear viewing portion. Bow headed wide central timber sash window set immediately below eaves to second floor with heavy stone sub-cill. Small bow headed timber sash window to third floor gable with heavy stone sub-cill. Modern plain painted timber fascia to gable.</p>

Cast iron ogee profile gutter and painted timber fascia to main roof eaves that carries across below gable arrangement.
Summary Assessment of Building's Contribution / Significance to the Conservation Area	Attractive building with numerous remaining original features above ground floor level. Plays a positive part in the street scene of the Conservation Area.

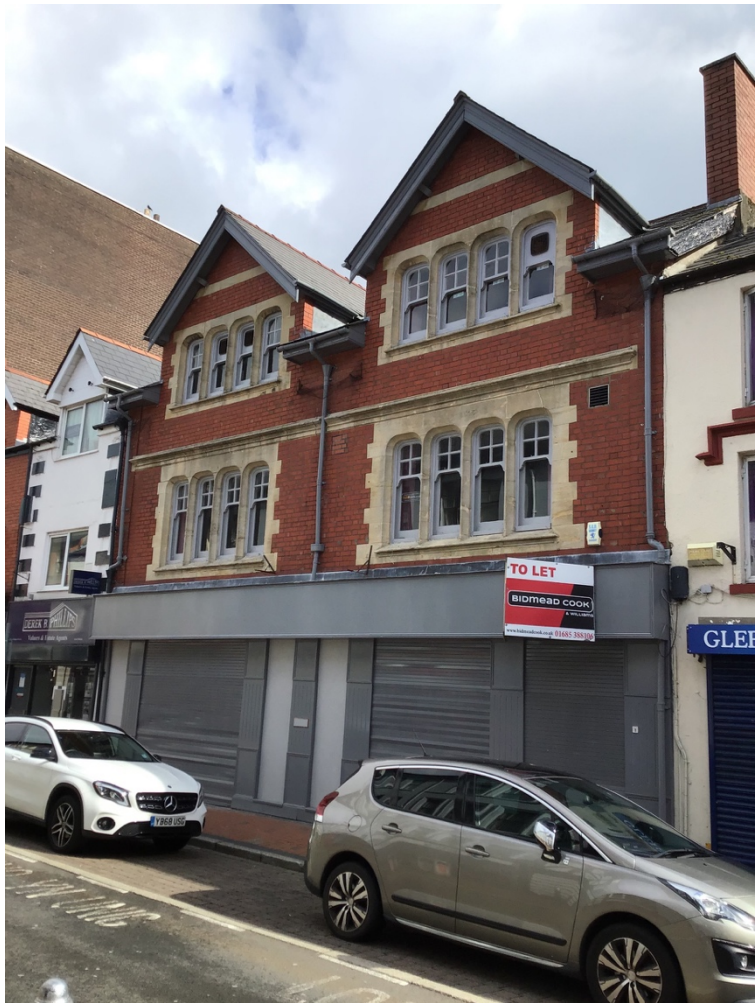
Address	<p>52 & 53 Glebeland Street</p>

Current use	Vacant. Former office of Merthyr Express.
Architectural Description & Condition	<p>Wide double gable fronted 2 storey building with attic storey over.</p> <p><u>Roof</u> Roof believed to be of fibre cement slates, but only gables visible from street views. Brickwork chimney stack to right side.</p> <p><u>Elevations</u> The ground floor generally is of a modern shopfront set between plain modern reproduction painted timber pilasters. Modern signage over. External mounted security roller shutters. Upper elevations of red brickwork with bathstone window surrounds, mullions and string courses. Two 4-light window arrangement to first floor. Each light with an original painted timber sliding sash window (4 over 1 arrangement). Two 4-light window arrangement to second (attic) floor. Each light with an original painted timber sliding sash window (4 over 1 arrangement except where modern extract fans installed to upper sashes).</p>

Decorative painted timber barge to gables. Deep overhanging eaves to main roof with beaded painted timber fascia and solid boarded soffit.
Summary Assessment of Building's Contribution / Significance to the Conservation Area	Attractive building with numerous remaining original features above ground floor level. Plays a positive part in the street scene of the Conservation Area.

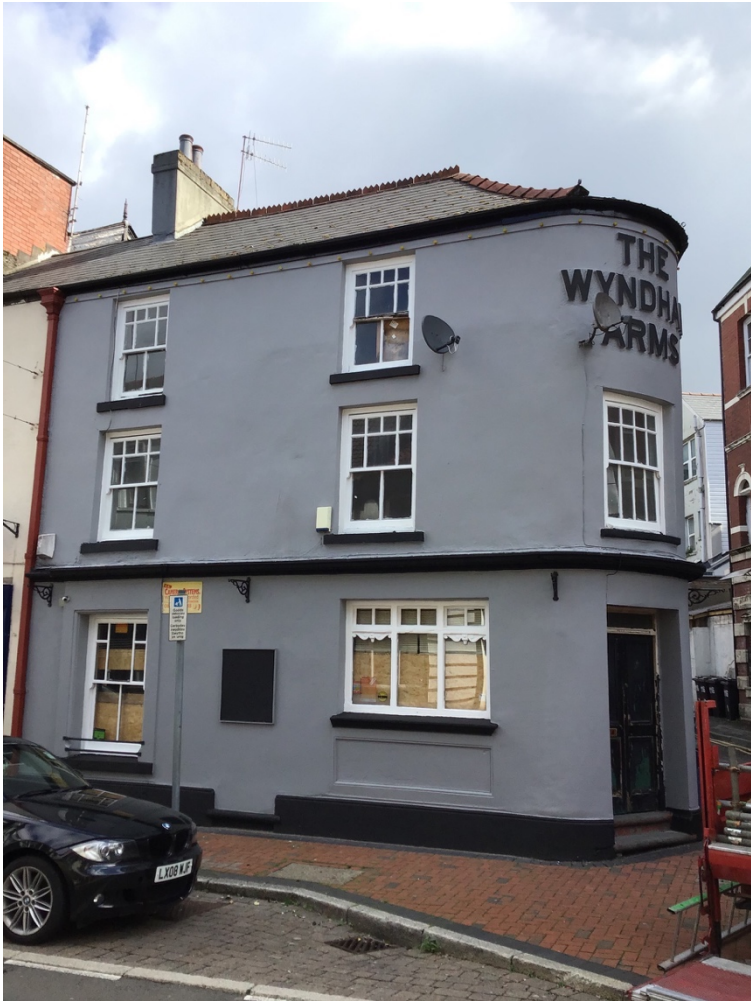
Address	<p>55 Glebeland Street</p>

Current use	The Wyndham Arms Public House
Architectural Description & Condition	<p>Shown on 1851 Public Health Map and John Woods' 1836 town map.</p> <p>Prominent three storey corner building.</p> <p><u>Roof</u> Roof of natural slates with red clay ridge and hip tiles. Painted rendered chimney stack to left side.</p> <p><u>Elevations</u> Painted render with low level rendered plinth and inset relief render panel beneath higher cill ground floor window. Projecting cornice at first floor level. Painted timber sash windows with painted stone sub-cills. Unusual glazing configuration to upper sashes. uPVC gutter and fascia.</p>

Summary Assessment of Building's Contribution / Significance to the Conservation Area	<p>Notorious town centre public house with numerous original features.</p> <p>Plays a positive part in the street scene of the Conservation Area.</p> <p>Would benefit from refurbishment.</p> <p>Locally listed.</p>
--	---

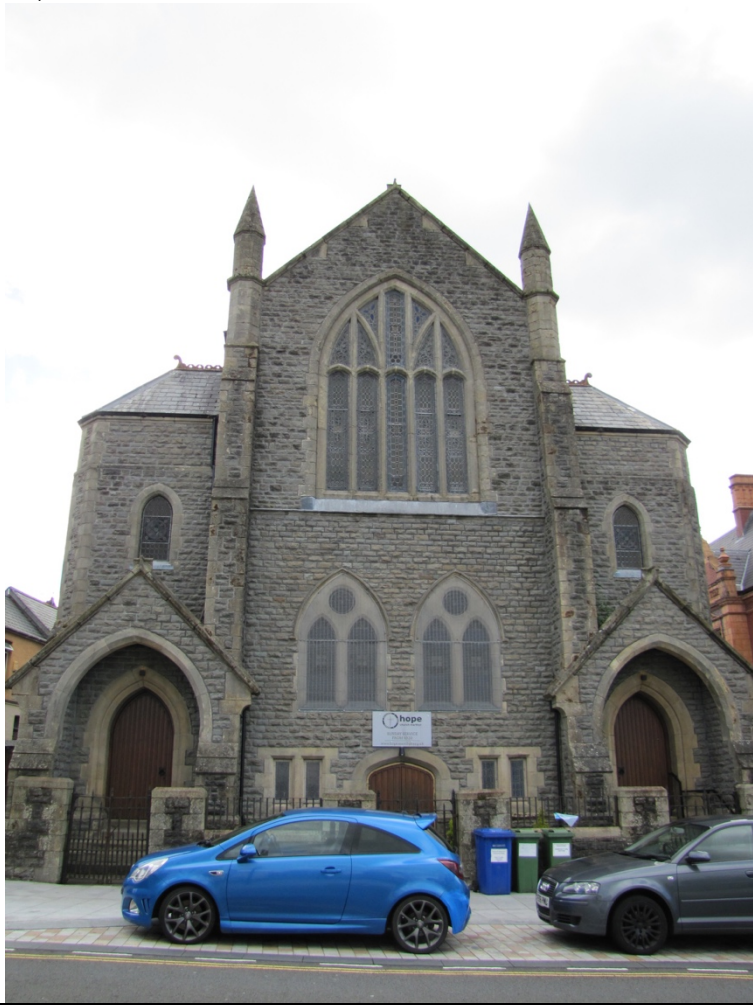
Address	<p>Hope Church</p>

Current use	Place of worship (Independent church)
Architectural Description & Condition	<p>Coflein (https://coflein.gov.uk/en/site/9887/details/hope-mission-calvinistic-methodist-chapel-high-street-merthyr-tudful-merthyr-tydfil-ward-1) states that:</p> <p><i>'Hope Methodist Chapel was built in 1861 and rebuilt in 1891. The later chapel was built in the Gothic style with a gable-entry plan, leaded perpendicular windows and flanking turrets.'</i></p> <p>Common to its building type and date of design / construction it is a very insular building.</p>
Summary Assessment of Building's Contribution / Significance to	<p>Positive.</p> <p>Locally listed.</p>

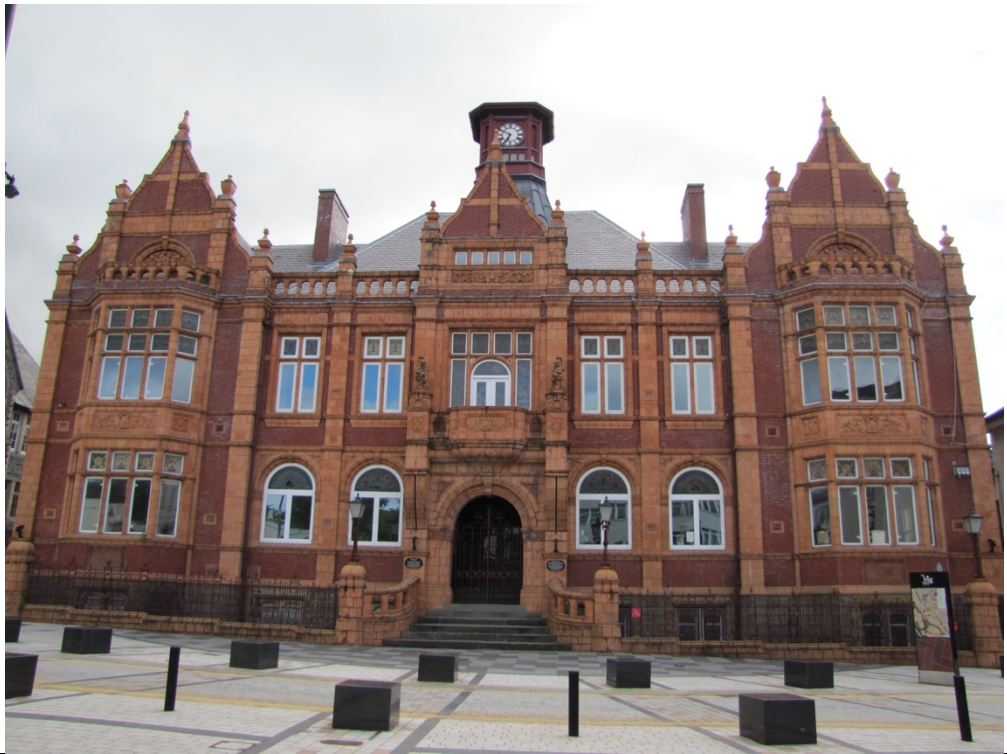
Address	<p>Old Town Hall</p>

Current use	An arts and creative industries centre.
Architectural Description & Condition	<p>The dominant building in the square.</p> <p>Coflein (https://coflein.gov.uk/en/site/31910/details/town-hall-and-county-court-merthyr-tydfil) states that:</p> <p><i>'Built in the Jacobethan style and dated by the foundation stone, May 1896, the Town Hall and County Court was designed by E A Johnson MSA, architect of Abergavenny and Merthyr. It has a seven-bay facade with emphasised centre and a symmetrical entrance front of two storeys, attics and basement. It also has red brick facings with terracotta dressings, a rusticated stone basement and a steep slate roof with painted clock turret...'</i></p>
Summary Assessment of Building's Contribution / Significance to the Conservation Area	<p>Highly positive.</p> <p>Listed Grade II*.</p>

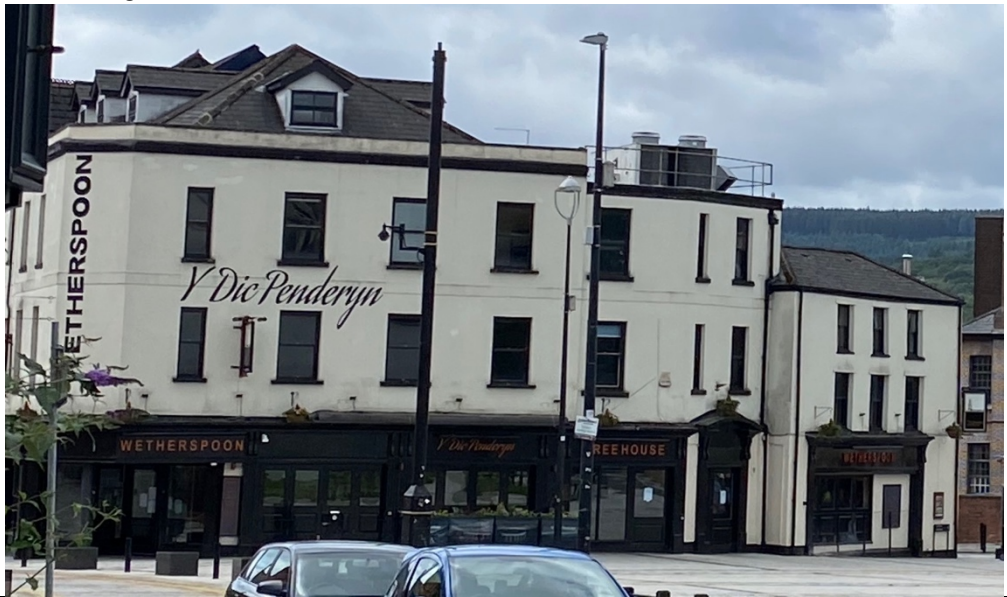
Address	102-103 High Street

Current use	Y Dic Penderyn (JD Weatherspoon) Pub (no.102), access to 1 st & 2 nd floors (presumed no.103)
Architectural Description & Condition	<p>Large prominent 3 storey public house facing onto Penderyn Square.</p> <p>Most of the elevation and fenestration facing the square must have been created following removal of the earlier corner building (visible on 1851 Public Health Map and on 1919 Ordnance Survey Plan) during the 20th century. It is possible that the westernmost end (visible to the right hand side of the photograph above) is visible on the 1851 Public Health Map (but not on John Woods' 1836 town map).</p> <p><u>Roof</u></p> <p>Roof of fibre cement slates to the majority, with a flat roof part set behind a low parapet on which quite a large AC condenser is visible.</p> <p><u>Elevations</u></p> <p>The walls are of painted render above ground floor generally with later, modern timber sash windows (1 over 1 arrangement).</p> <p>The ground floor generally is of a timber pub/shopfront type frontage with lots of glass. The overall form of the frontage is traditional and whilst not well executed is not out of place.</p>

Summary Assessment of Building's Contribution / Significance to the Conservation Area	Whilst the building has a satisfactory appearance insofar as it has some prominence as a result of its size and location it is of minimal heritage significance. Significant refurbishment in recent years has effectively removed any historic elements that may have existed.

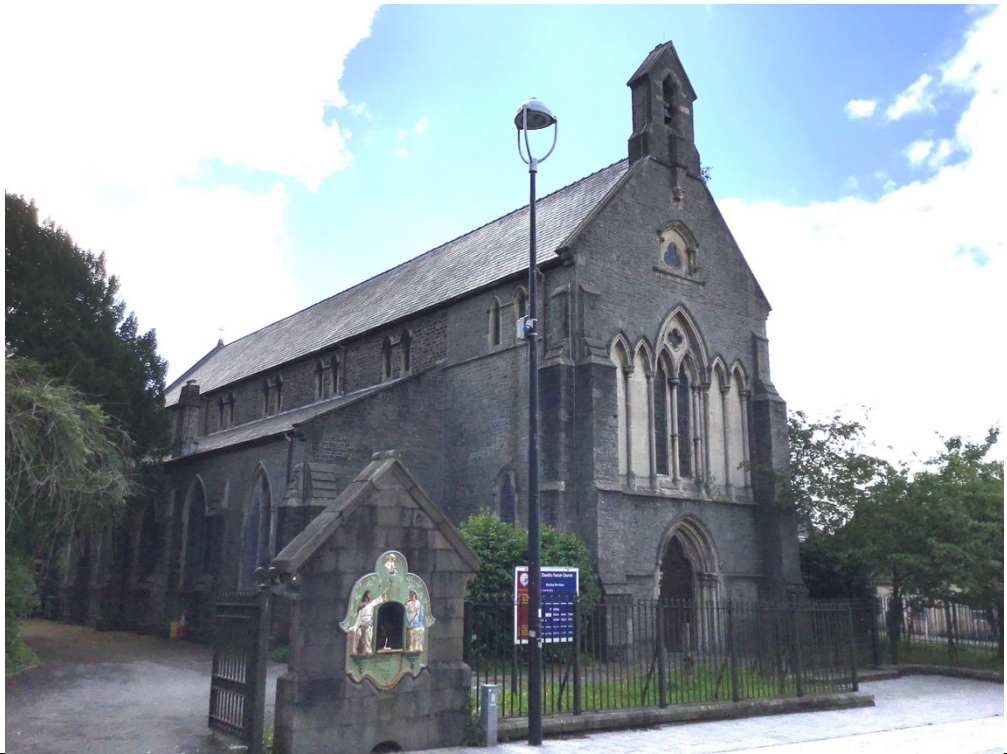
Address	<p>St.David's Church</p>

Current use	Place of Worship (Church in Wales)
Architectural Description & Condition	<p>Coflein (https://coflein.gov.uk/en/site/13223/details/st-davids-church-merthyr-tudful) states that:</p> <p><i>'It was built in 1846-7 in mid-thirteenth century English Gothic style with lancet windows to designs of architects T.H.Wyatt and D.Brandon of London; later alterations include the enlargement of old school buildings to form a church hall with attached vestries in 1936.</i></p> <p><i>The church is built of snecked rubble facings with pale freestone dressings and slate roofs. It consists of aisled nave, short lower and narrower chancel, south porch, vaulted west porch within gable end (below a single bellcote), and extensive hall and vestry blocks to the east and north-east.'</i></p> <p>Condition appears generally sound.</p>
Summary Assessment of Building's Contribution / Significance to the Conservation Area	<p>Very positive, although insular.</p> <p>Grade II listed (Commemorative fountain in St David's Chuchyard Wall and Church Hall are both separately Grade II listed)</p>

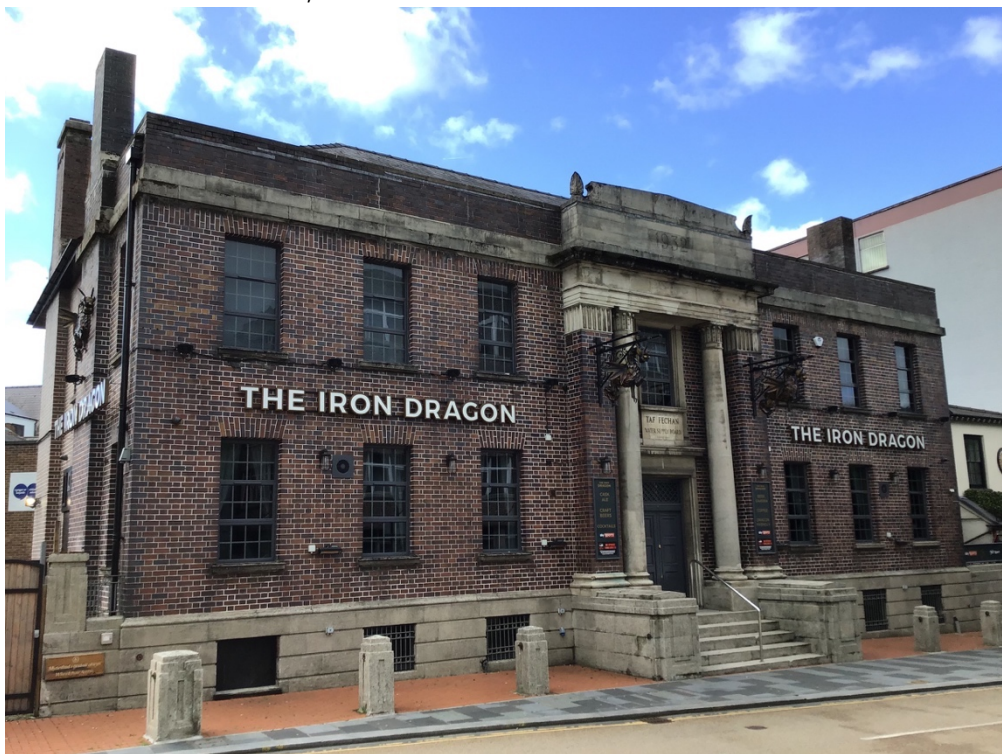
Address	Former Water Board Offices, Castle Street

Current use	Iron Dragon Public House.
Architectural Description & Condition	<p>Classically influenced large 2 storey civic detached building (formerly Offices to Tâf Fechan Water Supply Board) constructed in 1932.</p> <p><u>Roof</u> Pitched slate. Only visible in oblique distant views.</p> <p><u>Elevations</u> Dark brindle brick elevations with substantial 2 storey portico to main entrance with bathstone stylised Corinthian columns with heavy stone pediment. Brick parapet to street elevation. Finely detailed main entrance doors with decorative pierced over-door light. Raised ground floor level to incorporate basement, clad with rusticated coursed concrete ashlar plinth. Stylized monumental chimney stacks to end elevations. Modern aluminium windows to traditional pattern. Decorative iron security gratings to basement level windows.</p>
Summary Assessment of Building's Contribution / Significance to the	Excellent example of stylised high quality 1930's civic building. Strong contributor to Conservation Area.

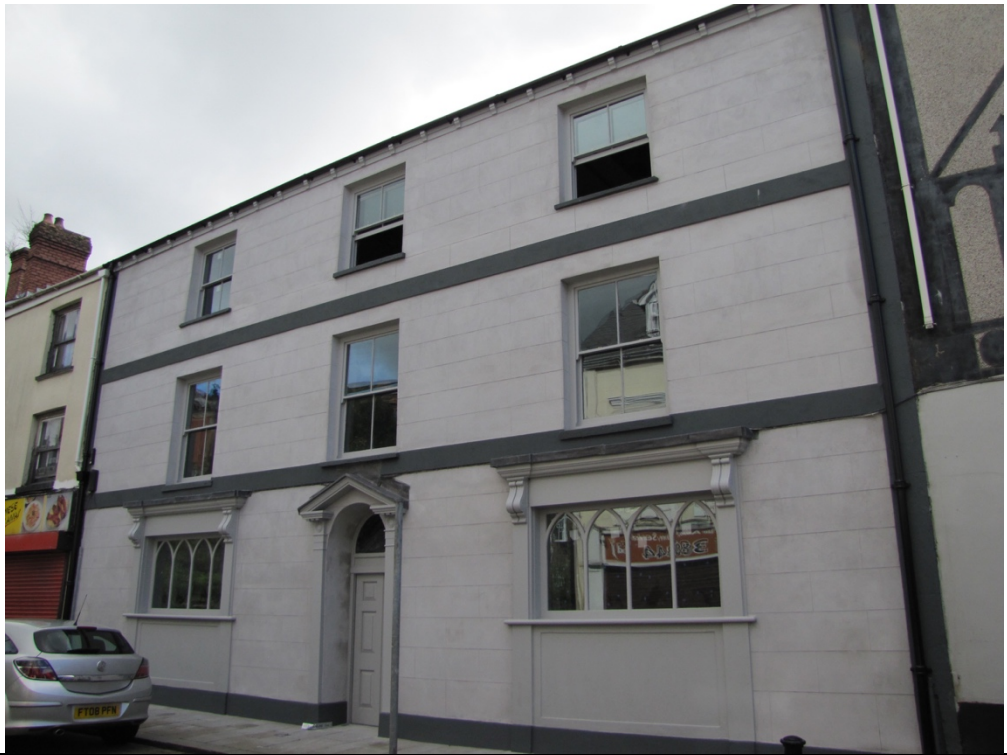
Address	<p>Former Morlais Castle (Inn), 73 Pontmorlais</p>

Current use	(Former) Public House, presumably planned to be residential (not yet occupied).
Architectural Description & Condition	<p>Shown on 1851 Public Health Map.</p> <p>Three-storeys with duo-pitched roof.</p> <p>Modern extensions to rear.</p> <p>Work of re-rendering elevations and installing new windows and doors, and renewing some historic details have been completed in 2020.</p>
Summary Assessment of Building's Contribution / Significance to the Conservation Area	Some significance, much improved visually following restoration of the front elevation.

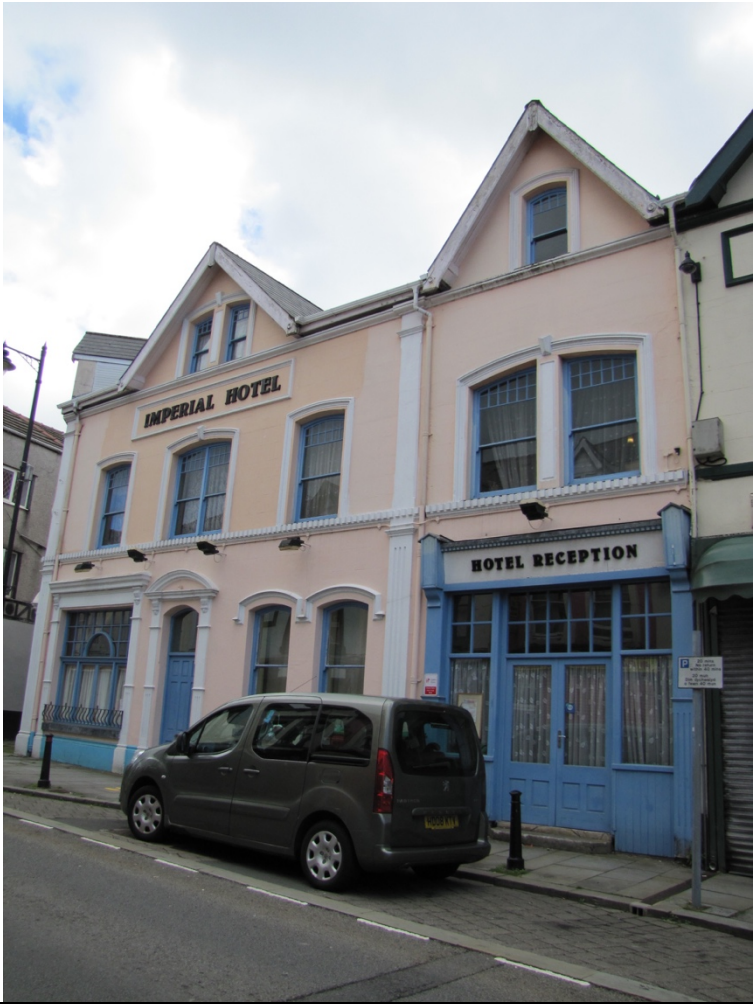
Address	<p>Imperial Hotel, Pontmorlais</p>

Current use	Hotel (originally the Tiger Inn)
Architectural Description & Condition	<p>Rendered elevations with run-moulded rendered window and door opening surrounds.</p> <p>Duo-pitched roof with gablets.</p>
Summary Assessment of Building's Contribution / Significance to the Conservation Area	<p>Very positive although its appearance in the Conservation Area could be much improved with a more appropriate colour scheme.</p> <p>Locally listed.</p>

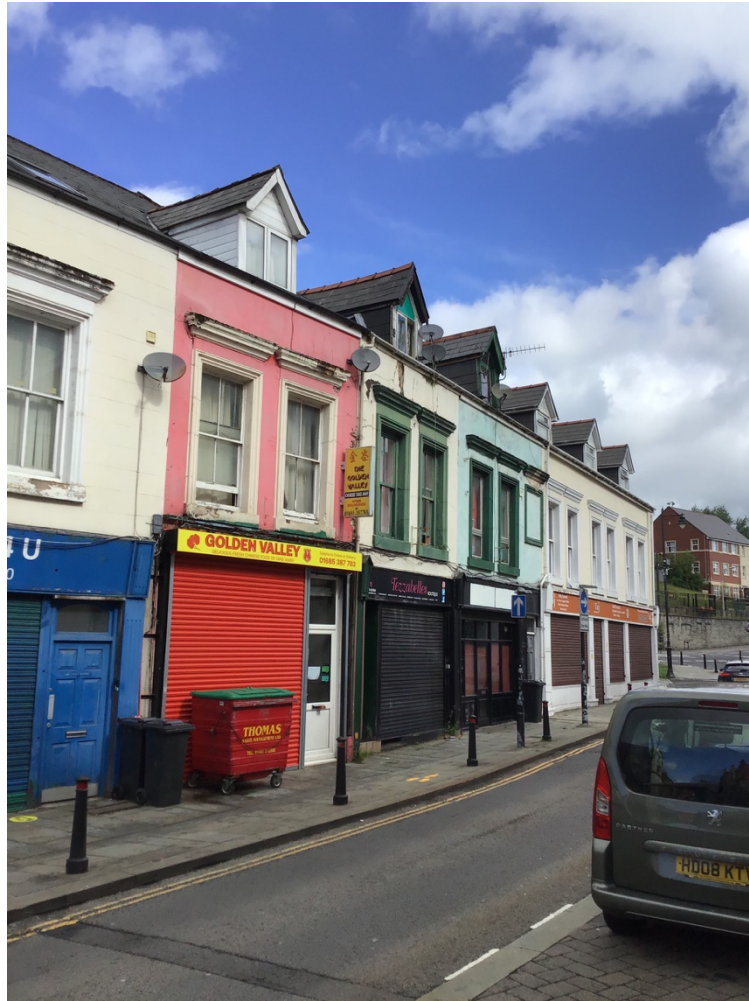
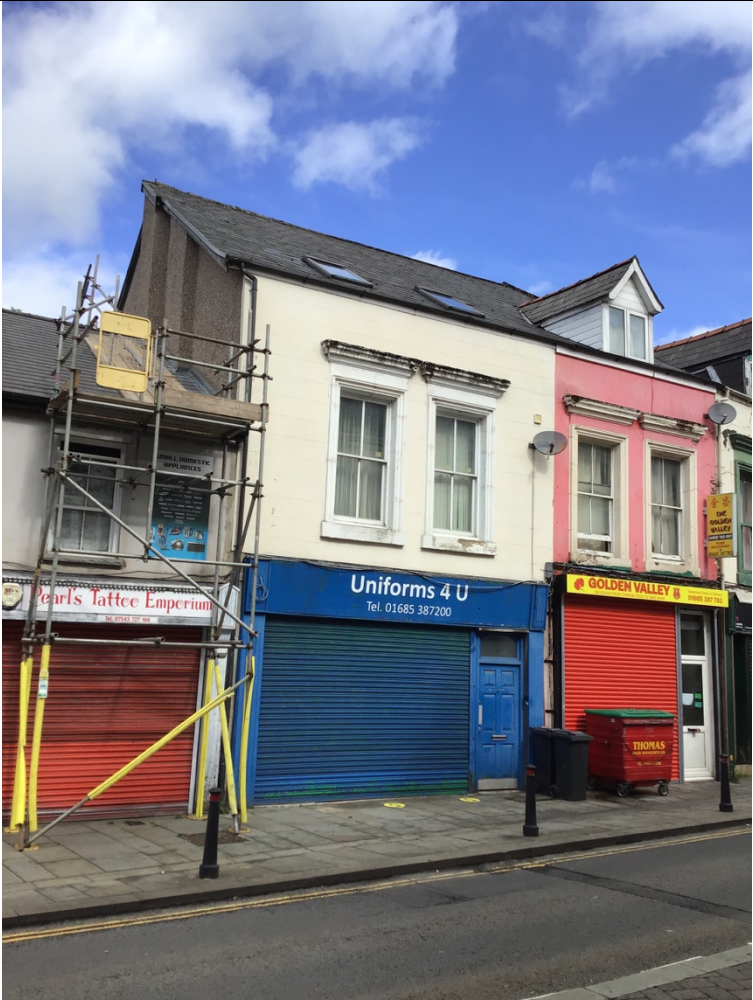
16, 17, 18 & 19 Pontmorlais

Current use	Uniforms for You (clothing shop) (no.16), Golden Valley (fast food / takeaway) (no.17), Tezzabelles boutique (no.18)	
Architectural Description & Condition	<p>Appears to be shown on 1851 Public Health Map.</p> <p>All matching detailing with the dormers and rendered hoodmoulds to 1st floor windows.</p> <p>Street frontages are a mixture with a lot of modern (i.e. non-traditional) detailing.</p> <p>All roller shuttered with some up and some down during the day.</p> <p>Only no.19 retains old timber detailing to the dormer, which has a glazed triangle to the upper portion to the small gablet. All dormers have fibre-cement weather-boarded cheeks.</p> <p>Visually poor modern aluminium windows to no.19.</p> <p>Timber sash windows to nos.16, 17 and 19.</p> <p>The modern shop frontages and restaurant frontages are poor.</p>

Velux-type windows have replaced a dormer above no. 16.
Summary Assessment of Building's Contribution / Significance to the Conservation Area	<p>Positive, although could be improved.</p> <p>Replacement of modern windows in no.19 and redecoration of 1st floor walls in suitable colours would be visually beneficial.</p> <p>Dormers could be greatly improved by replacing fibre-cement weather-boarded cheeks with natural slate, and replacement of Velux-type windows with traditionally detailed dormer.</p>

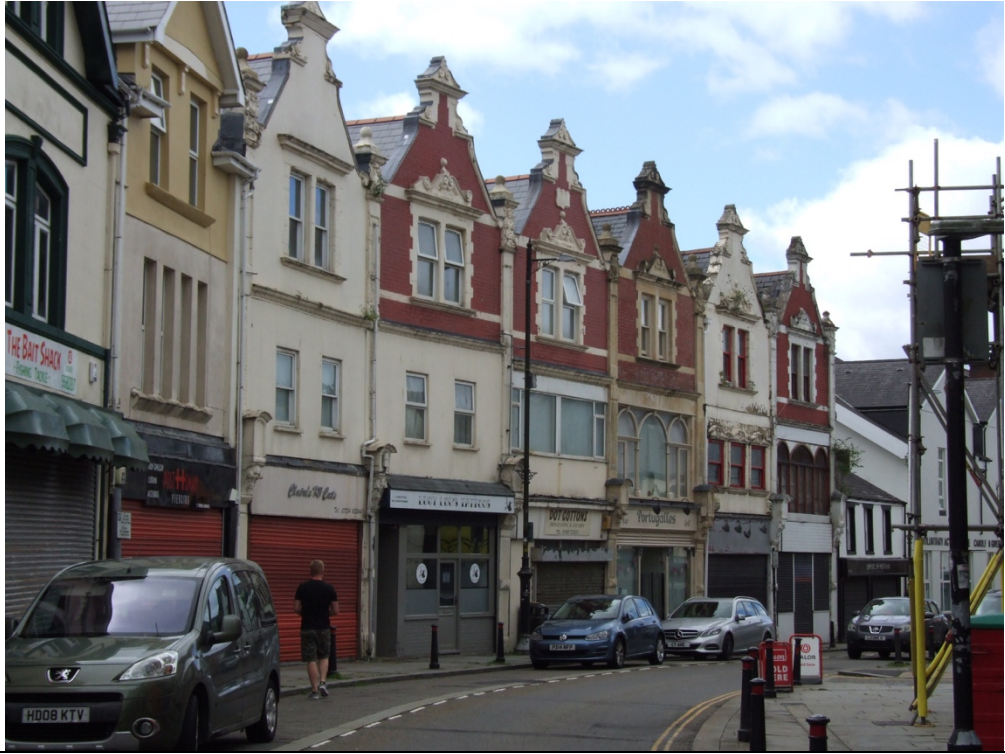
Contribution / Significance to the Conservation Area	
Address	<p>1 to 6 Morlais Buildings, Pontmorlais</p>

Current use	Claire's K9 Cuts dog grooming parlour (no.6), Sherocks body piercing shop (no.5), Dot Cottons launderette (no.4) Portugalles restaurant (no.3), Team Iron Warriors martial arts training (no.2), possibly vacant (no.1)
Architectural Description & Condition	<p>No.3 was well restored and refurbished in 2016. The other shop frontages are all modern, visually very poor and are roller shuttered.</p> <p>The gabled frontages add quite a distinct urban scale.</p>
Summary Assessment of Building's Contribution / Significance to the Conservation Area	<p>Significant as a group, and visually important at this curve in the street, and retaining numerous historic details.</p> <p>One (No.3) has been well restored recently. The others are locally in poor condition or have been poorly altered in the past at Ground and 1st floors.</p>

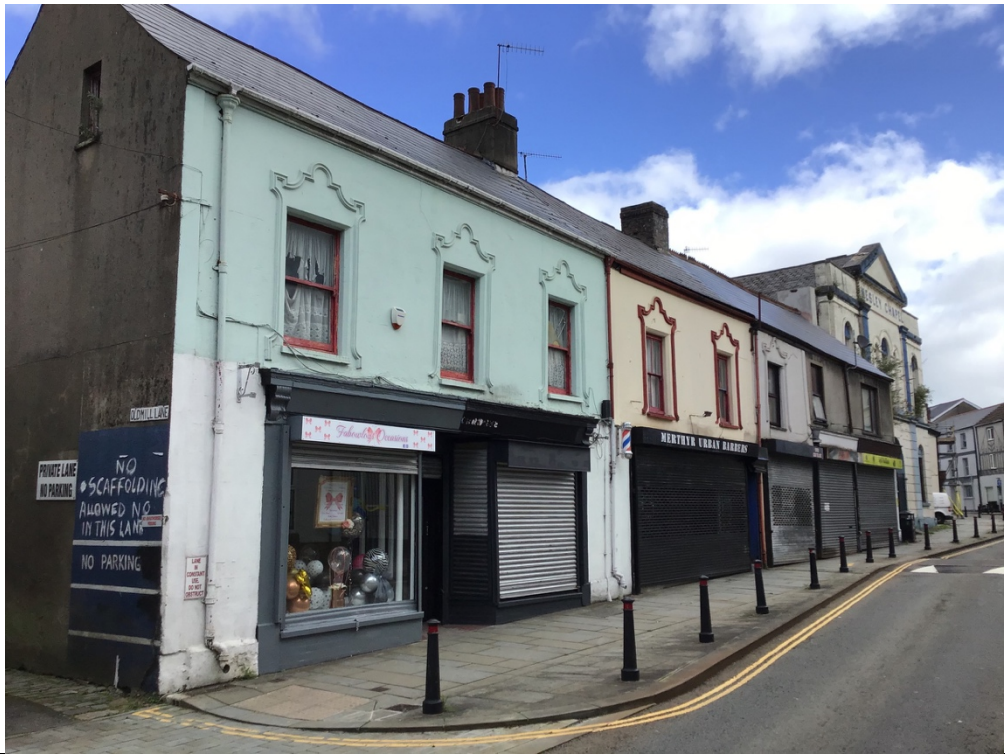
Address	<p>9, 10, 11, 12 & 12a Pontmorlais</p>

Current use	Shops to ground floor.
Architectural Description & Condition	<p>Appears to be shown on 1851 Public Health Map.</p> <p>Fibre-cement slate duo-pitched roofs, with crested clay ridge tiles to the northern half of the terrace.</p> <p>Small rendered brick chimneystacks.</p> <p>Southern two-thirds of terrace have attractive decorative moulded rendered surrounds to 1st floor windows with 'stucco' lines struck in the plain render.</p> <p>Northern third of terrace has plain rendered window surrounds and modern proportioned windows and modern plastic sashes.</p> <p>All have roller shuttered shop fronts (those to no.9 are well integrated though) and these are a negative, as they are shut during the day.</p>
Summary Assessment of Building's Contribution / Significance to the Conservation Area	Significant as a surviving example of an early two-storeys domestically-styled commercial building retaining some historic details.

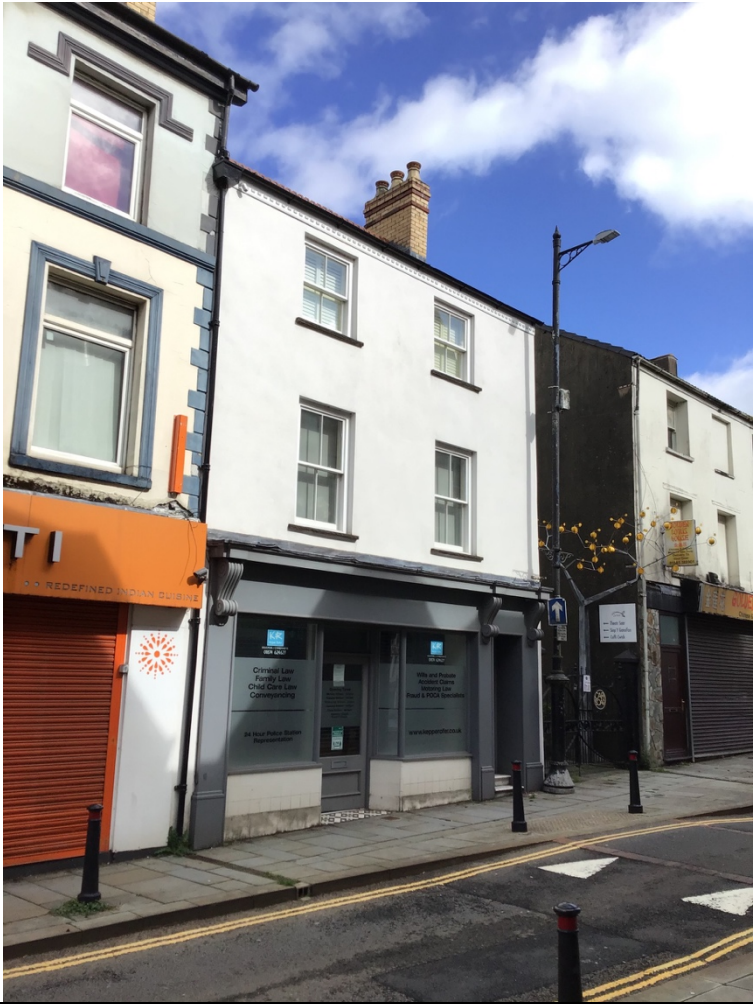
Address	<p>5 Pontmorlais</p>

Current use	Solicitors
Architectural Description & Condition	<p>Recently well refurbished</p> <p>1st and 2nd floor and roofs and chimneystacks are all visually positive.</p>
Summary Assessment of Building's Contribution / Significance to the Conservation Area	Very positive.

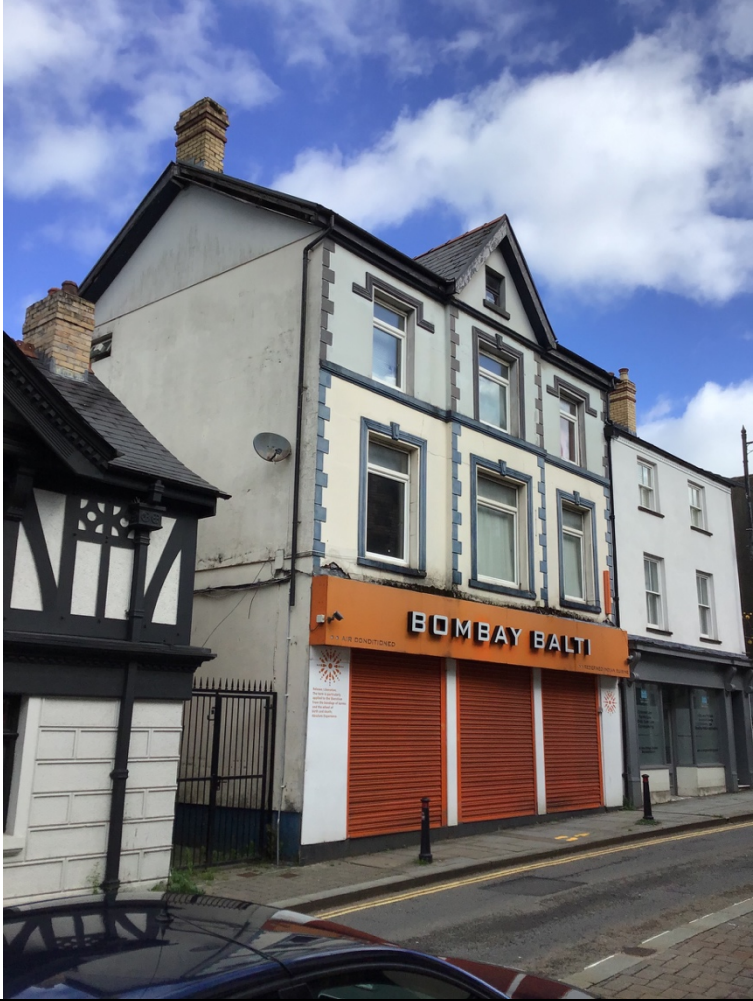
Address	<p>3 & 4 High Street, Pontmorlais</p>

Current use	Bombay Balti restaurant
Architectural Description & Condition	Modern orange signage and orange roller shutters are overbearing and inappropriate in the Conservation Area.
Summary Assessment of Building's Contribution / Significance to the Conservation Area	<p>Shop front is visually very poor and could be much improved.</p> <p>1st and 2nd floor and roofs and chimneystacks are all visually positive.</p> <p>Building as a whole is positive.</p>

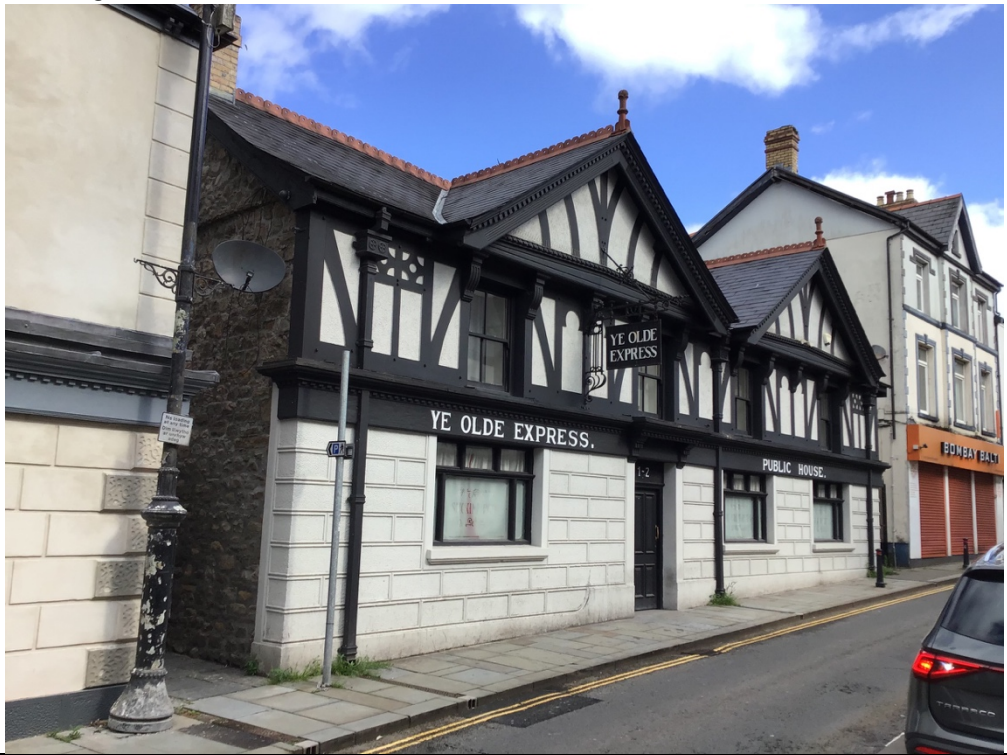
Address	<p>1 & 2 High Street</p>

Current use	Ye Olde Express public house
Architectural Description & Condition	<p>Low two-storeys scale.</p> <p>Dominant timbered gables.</p> <p>Exposed timber framed to 1st floor and gables with harled render panels.</p> <p>Deeply rusticated render to ground floor walls.</p>
Summary Assessment of Building's Contribution / Significance to the Conservation Area	<p>Attractive, distinct and in very good condition. Highly positive.</p> <p>Locally listed.</p>

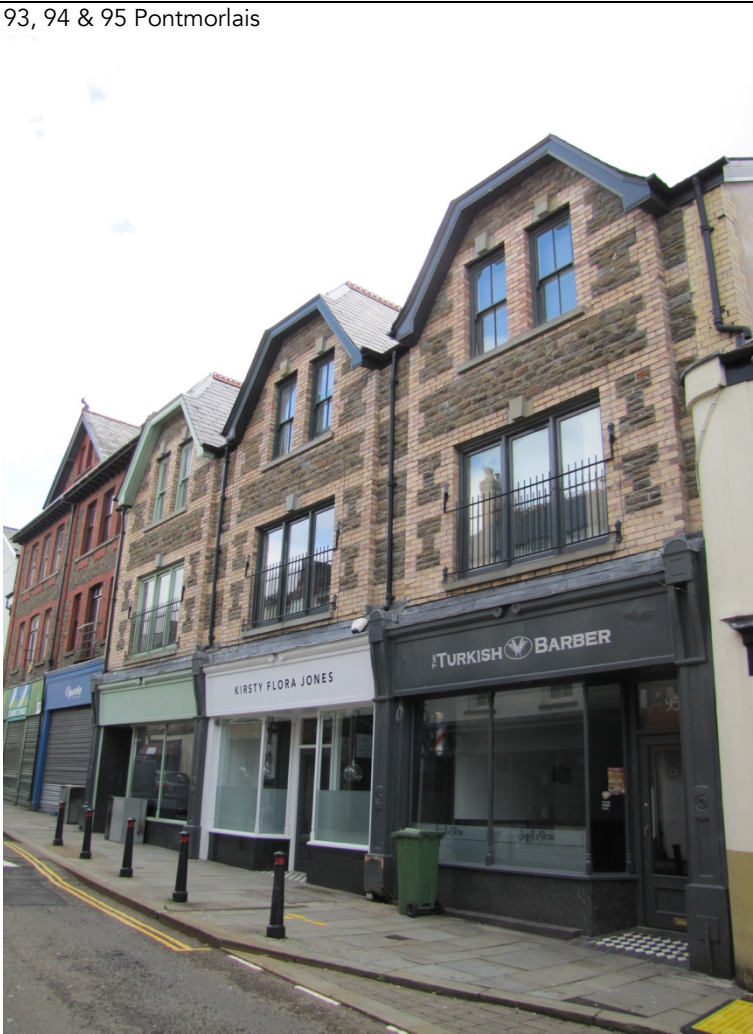
Address	<p>93, 94 & 95 Pontmorlais</p>

Current use	Barbers (no.95), Sign writing shop (no.94), and ironing and/or an internet café (no.93).
Architectural Description & Condition	<p>Three hipped and gabled buildings designed and built together.</p> <p>Recently refurbished with new and well-designed shop frontages.</p> <p>All modern windows, but somebody has given them some thought, so the 2nd floor are sashes, the 1st floor look to be large inward opening doors or casements.</p> <p>Upper storey walls are predominantly coursed rock-faced pennant stonework with buff clay facing brickwork dressings, banding and quoins.</p>
Summary Assessment of Building's Contribution / Significance to the	Very positive, and in very good condition.
