APPENDIX B - BUILDING-BY-BUILDING ASSESSMENT (2020)

1 LOWER HIGH STREET SQUARE, ST.TYDFIL'S CHURCH & COURT STREET

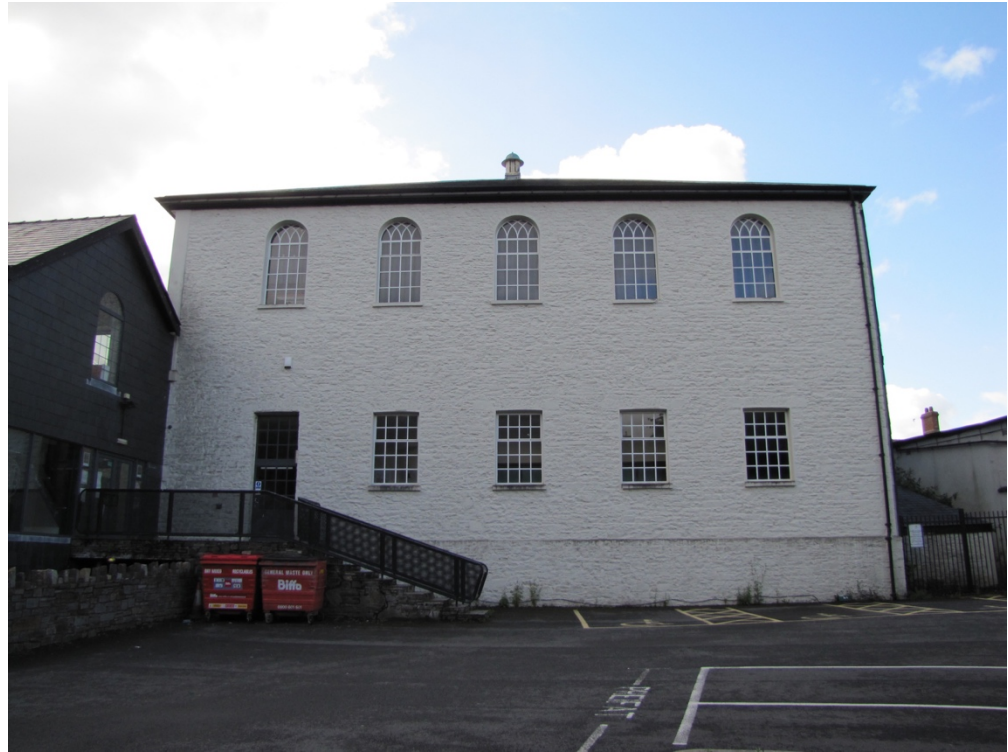
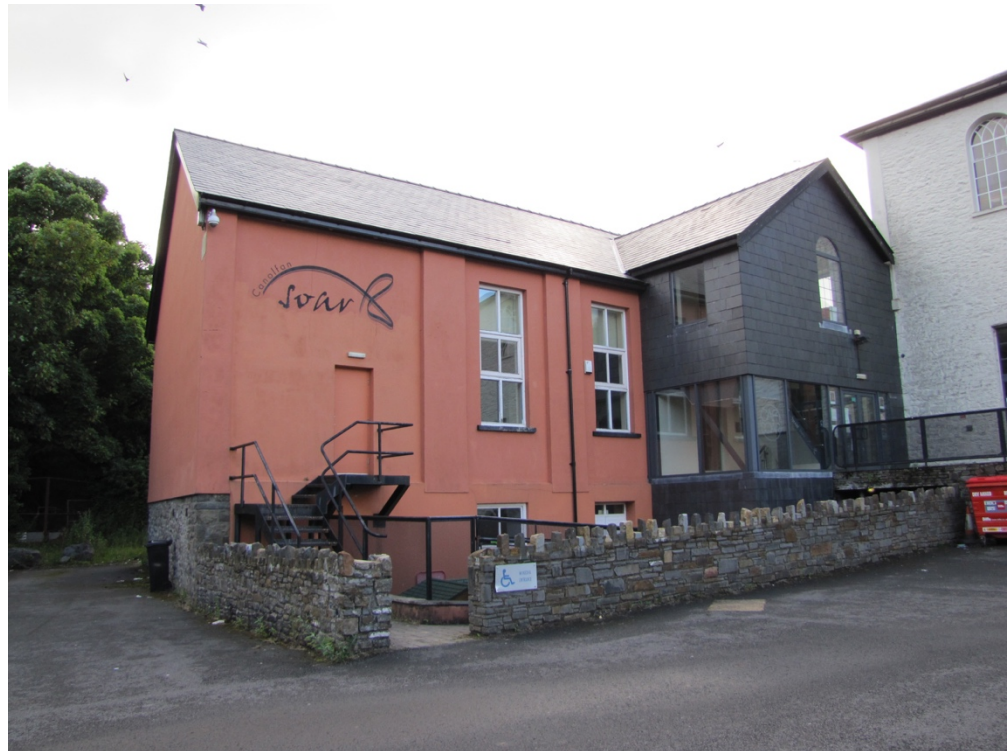
Canolfan Soar / Theatr Soar (formerly Capel Soar)

Welsh language centre & theatre.

Architectural Description & Condition	<p><u>Canolfan Soar</u></p> <p>Partly rendered & partly slate-hung duo-pitch roofed extension.</p> <p><u>Theatr Soar / former Capel Soar</u></p> <p>Coflein (https://coflein.gov.uk/en/site/9874/details/zoar-welsh-independent-chapelcapel-yr-annibynwyr-soar-ynysgau-high-street-pontmorlais#site-details) states that:</p> <p><i>'Zoar Independent Chapel was built in 1801, rebuilt in 1825 and again in 1842. The present chapel, dated 1842 was designed by architect Benjamin Owen and builder D. Richards, and the final phase of re-building, in 1884, by architect Jacob Rees of Rhondda and builder D. Jenkins of Merthyr. The chapel is Vernacular in style with an integral porch with entrances to the left and right hand side of the central porch position.'</i></p> <p>Some slate hanging needs to be re-fixed.</p>
Summary Assessment of Building's Contribution / Significance to the Conservation Area	<p>Very positive.</p> <p>Listed Grade II (iron gates and gate posts at end of lane onto High Street are separately Grade II listed).</p>

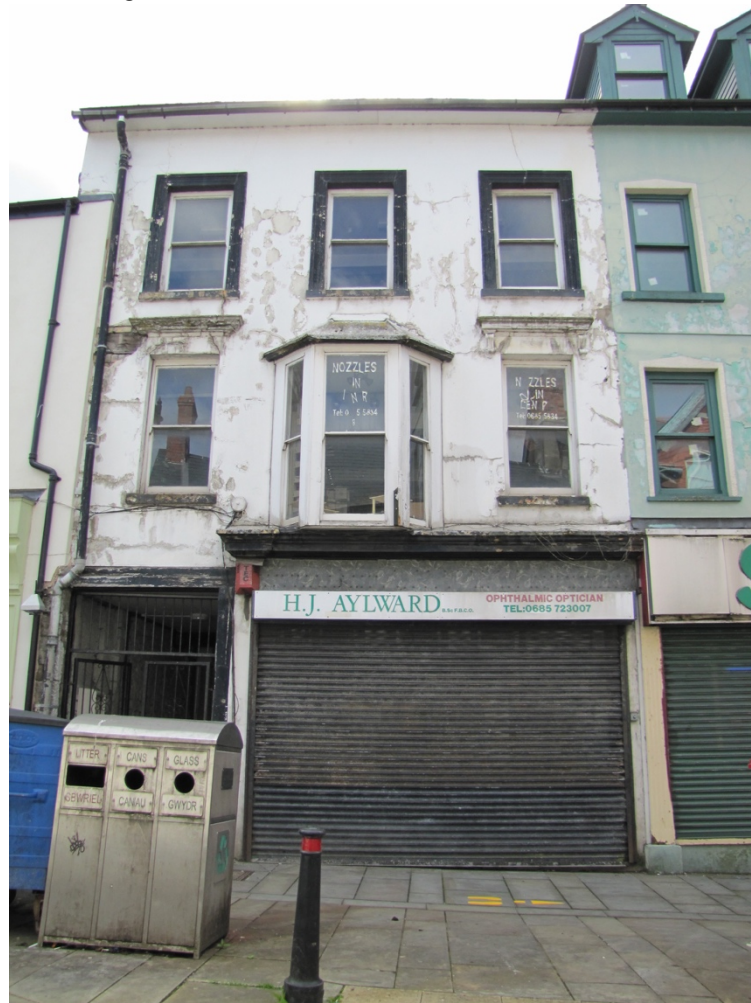
87 & 88 High Street

Current use	HJ Aylward Optician (no.88) & Sami's kebab house (no.87)
Architectural Description & Condition	<p>Shown on 1851 Public Health Map.</p> <p>Lofty three-storeys scale.</p> <p>Plain rendered walls are in poor condition with lots of peeling paint, so visually a negative.</p> <p>Shop frontages all modern.</p> <p><u>No.88</u></p> <p>Remnant of an old cornice to shop frontage.</p> <p>Modern metal gates to lane.</p> <p>Condition of one of the moulded 1st floor window heads looks fragile and in very poor condition.</p> <p>Pained timber windows to 1st and 2nd floors.</p>

1st floor oriel (bay) window.
Summary Assessment of Building's Contribution / Significance to the Conservation Area	Positive, but street frontages, some details, condition and colour schemes are poor and could be much improved.

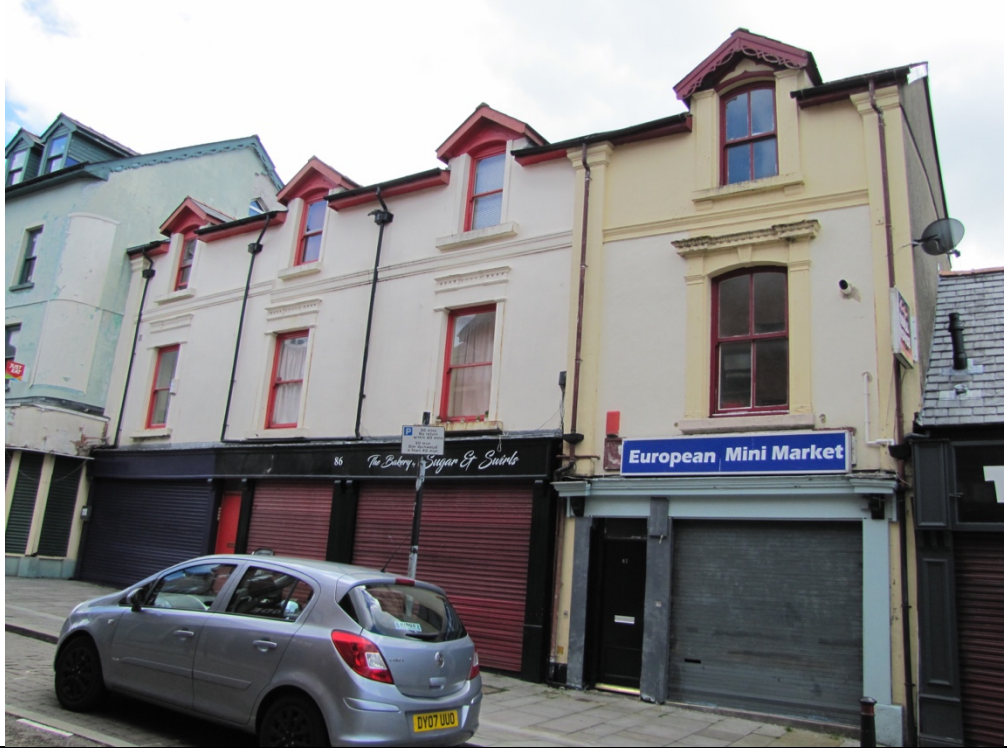
Address	<p>83, 84, 85 & 86 High Street</p>

Current use	Mini-market & 'The Bakery'
Architectural Description & Condition	<p>Shown on 1851 Public Health Map.</p> <p>A set of four partly dormered buildings built as one block.</p> <p>Three-storeys scale, but less lofty than 87 & 88 High Street.</p> <p><u>No.83</u></p> <p>One pair of old pilasters remaining.</p> <p>Decorative bargeboard to the part dormer.</p> <p><u>Nos.84, 85 & 86</u></p> <p>I expect nos.84, 85 & 86 originally matched no.83, although the existing detailing is much simplified and the mouldings have been replaced with poorer modern interpretations.</p>
Summary Assessment of Building's Contribution / Significance to the	Positive for retention of some historic details at 1 st and 2 nd floors, although street frontages could be much improved.

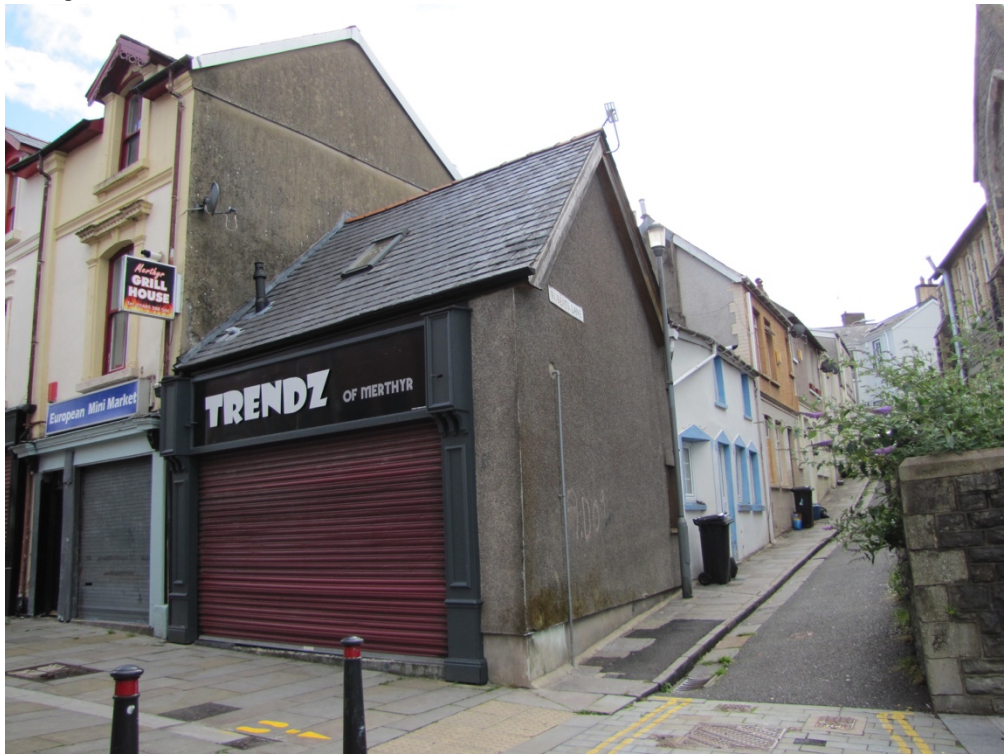
Address	<p>82 High Street</p>

Current use	Trendz barbers
Architectural Description & Condition	<p>Single-storey, so a very human scale, although quite unlike rest of Pontmorlais.</p> <p>Good coarse / heavy natural slate duo-pitched roof.</p> <p>Shuttered shopfront.</p> <p>Pilasters odd with no capitals.</p> <p>Velux-type rooflight facing High Street.</p>
Summary Assessment of Building's Contribution / Significance to the Conservation Area	Positive as a survival of an early low simple domestic-styled commercial property.

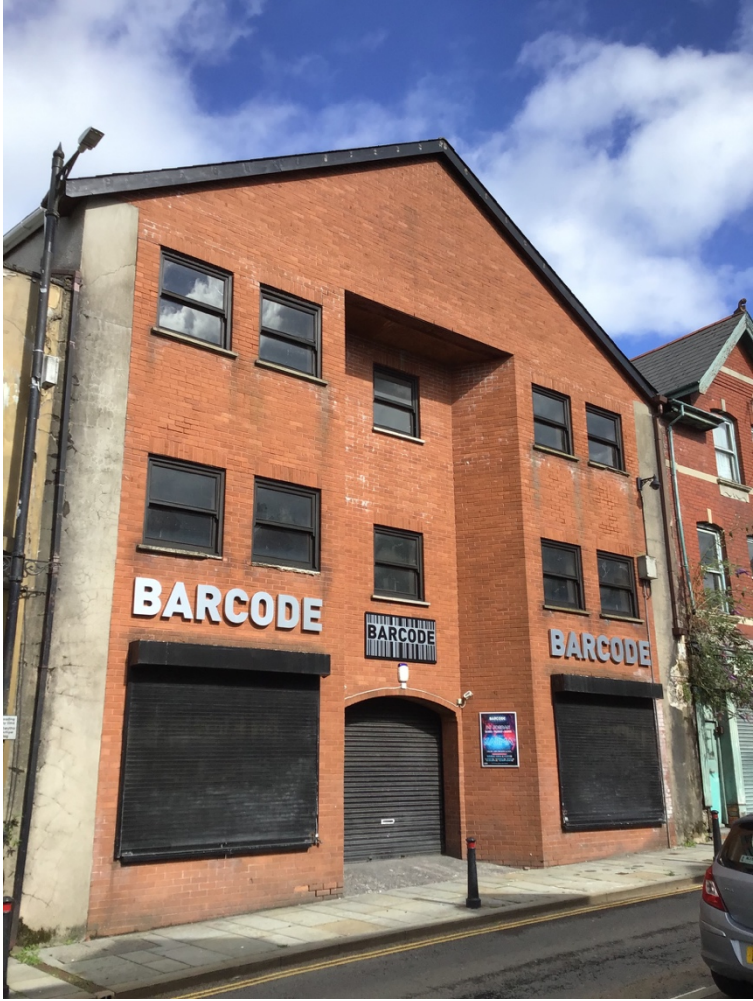
Address	<p>92, 93 & 94 High Street</p>

Current use	Barcode (formerly Walkthrough Bar) night club
Architectural Description & Condition	A modern red brick building.
Summary Assessment of Building's Contribution / Significance to the Conservation Area	None.

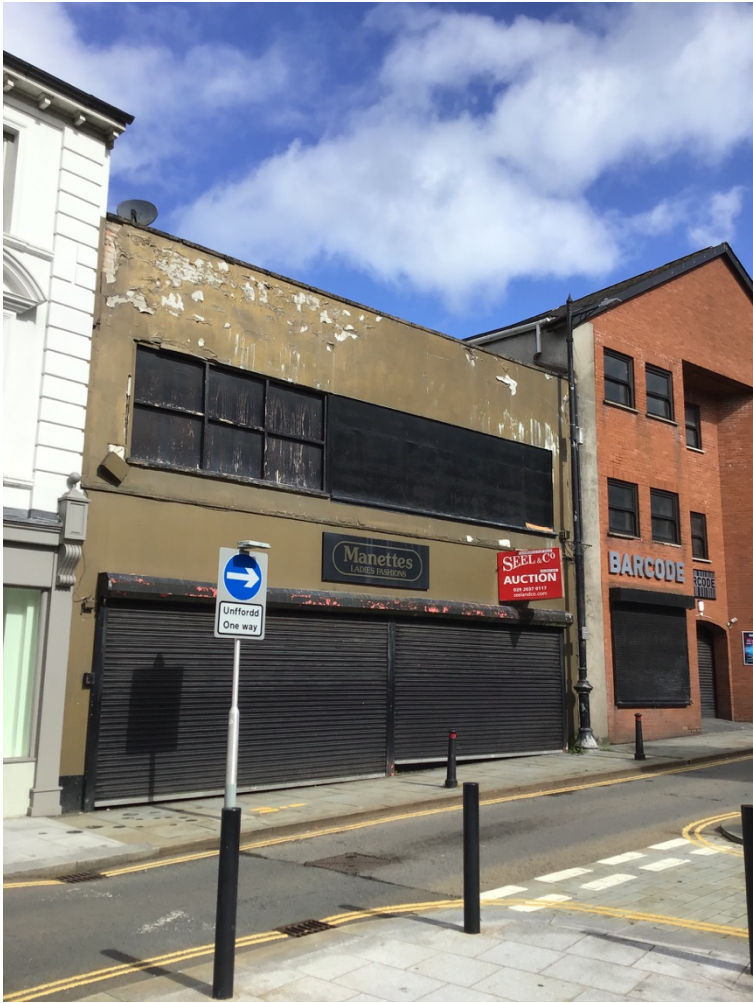
Address	<p>95 & 96 High Street</p>

Current use	Manettes Ladies Fashions (looks shut)
Architectural Description & Condition	<p>Modern parapeted frontage.</p> <p>Roller shuttered ground floor.</p> <p>Two-storeys.</p>
Summary Assessment of Building's Contribution / Significance to the Conservation Area	None.

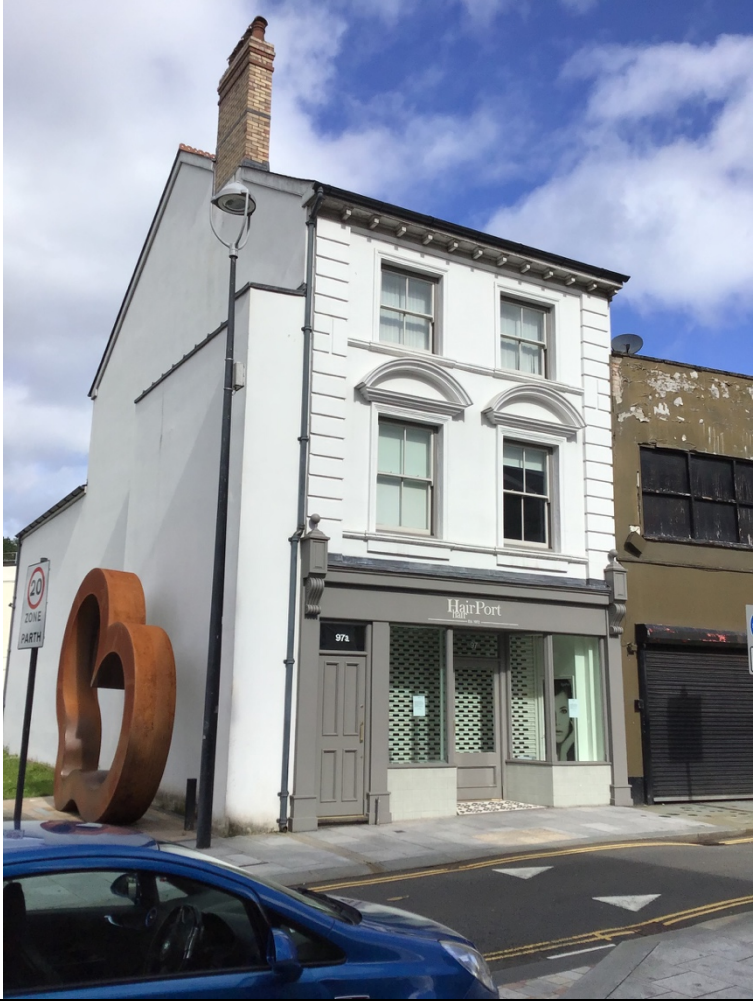
Address	<p>97 High Street</p>

Current use	Barbers
Architectural Description & Condition	Well restored and refurbished in 2016.
Summary Assessment of Building's Contribution / Significance to the Conservation Area	Highly positive.

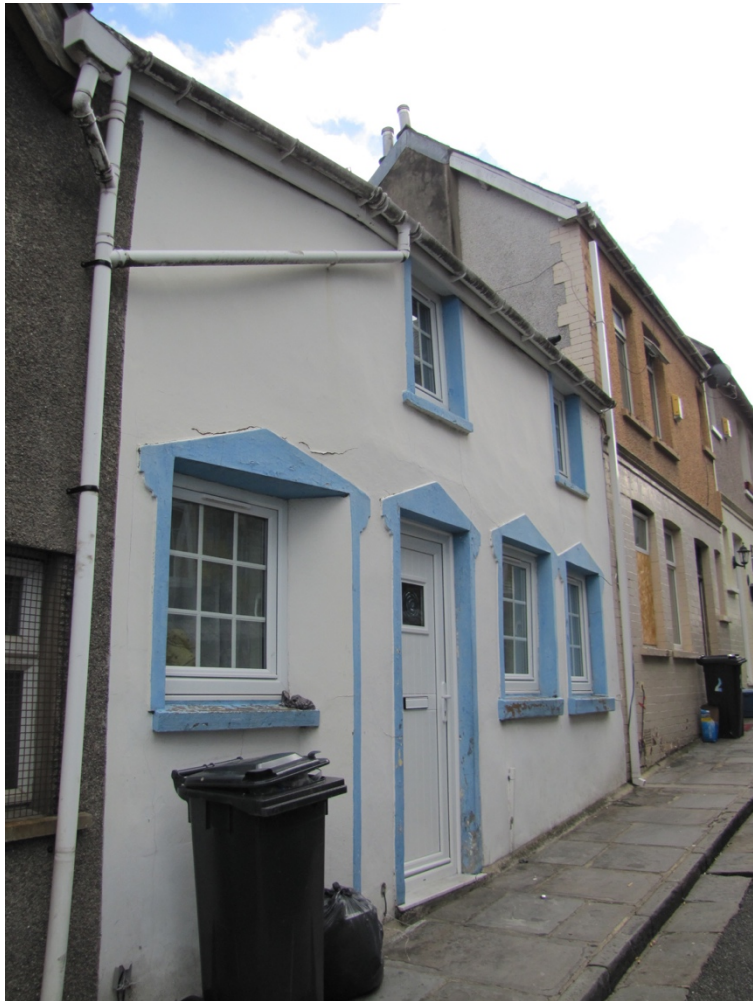
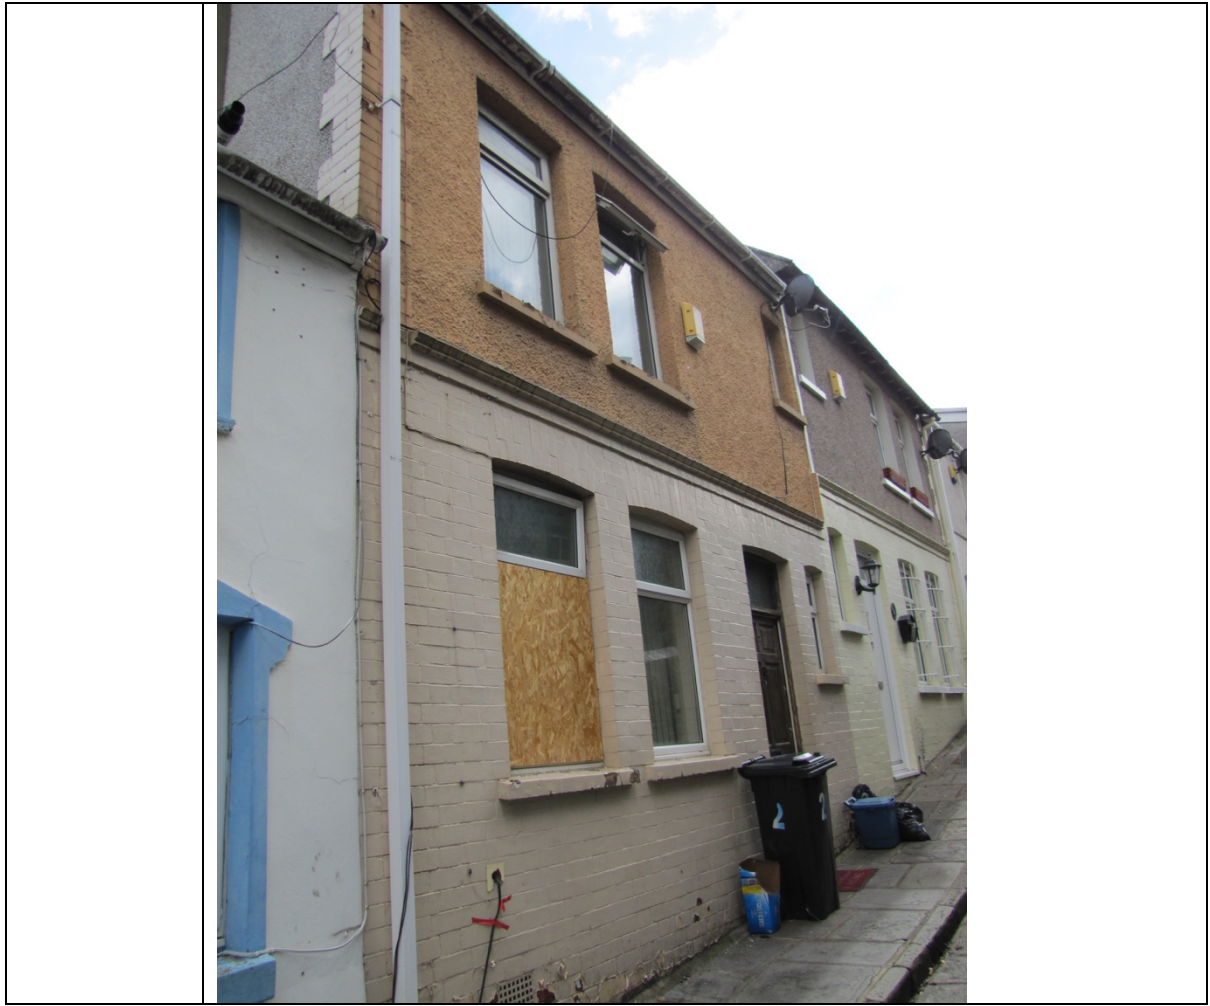
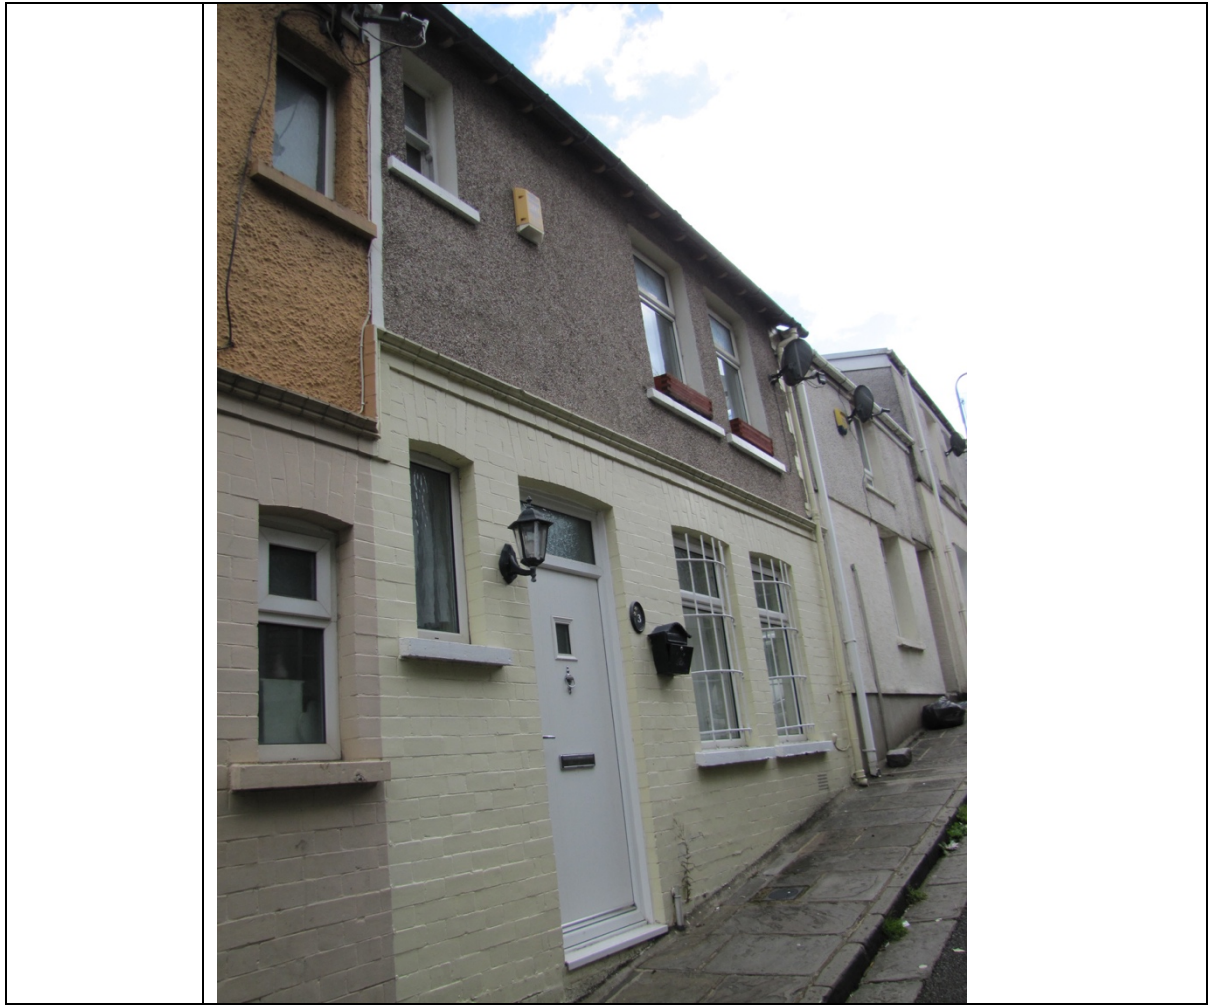
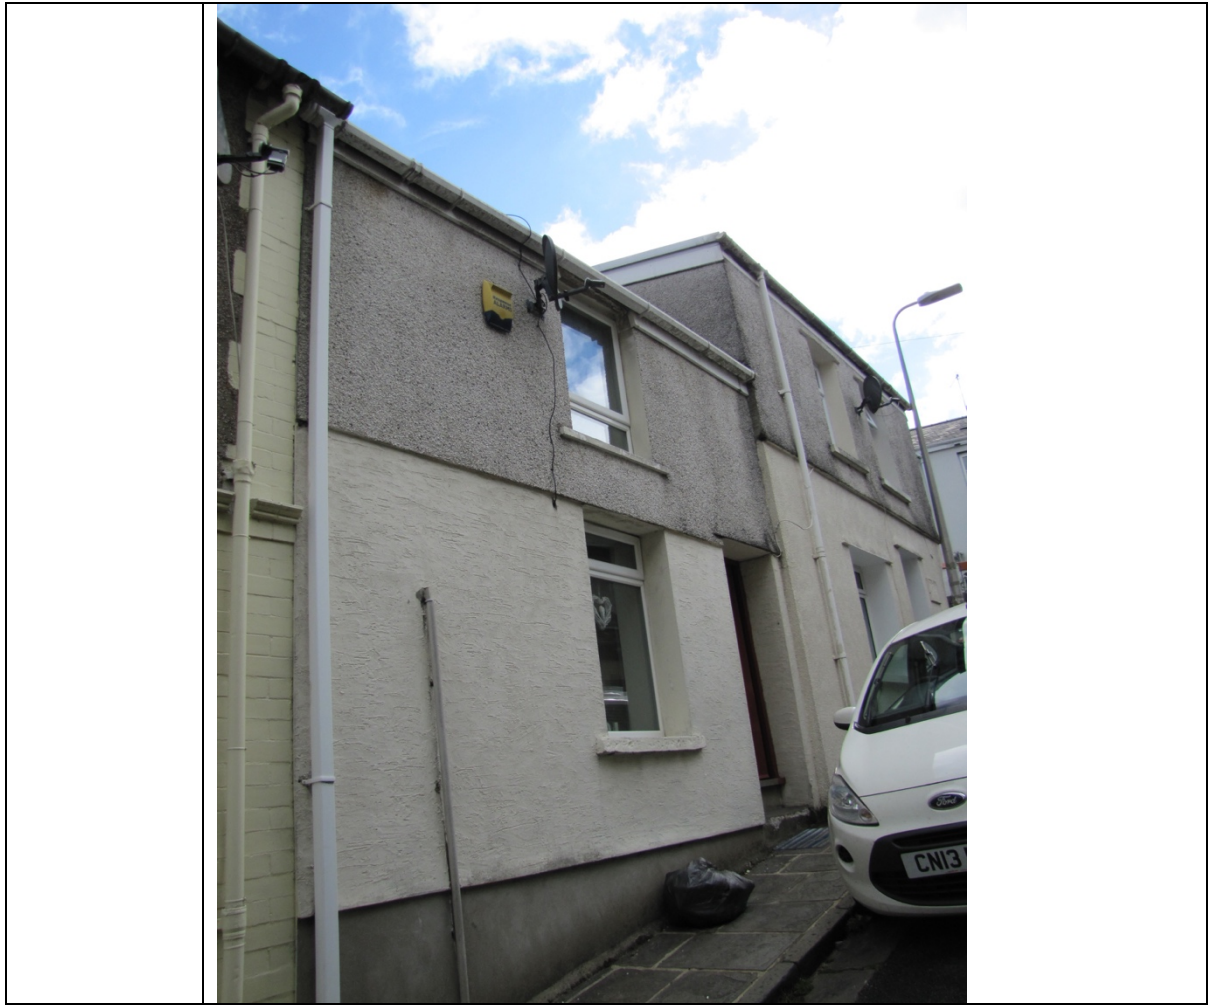
Address	<p>1 to 7 Roberts Lane</p>

Current use	Dwellings.
Architectural Description & Condition	<p>Shown on John Woods' 1836 town map.</p> <p>Attractive low and human scale row of stepped terraced houses.</p> <p>Visually poor modern render, windows and doors to most.</p>
Summary Assessment of Building's Contribution / Significance to the Conservation Area	<p>As one of the few surviving rows of early 19th century worker's dwellings that once proliferated these should have a high significance. The view of them from High Street is also positive.</p> <p>They retain their likely historic form, but their detailing and finishes could be greatly improved.</p>

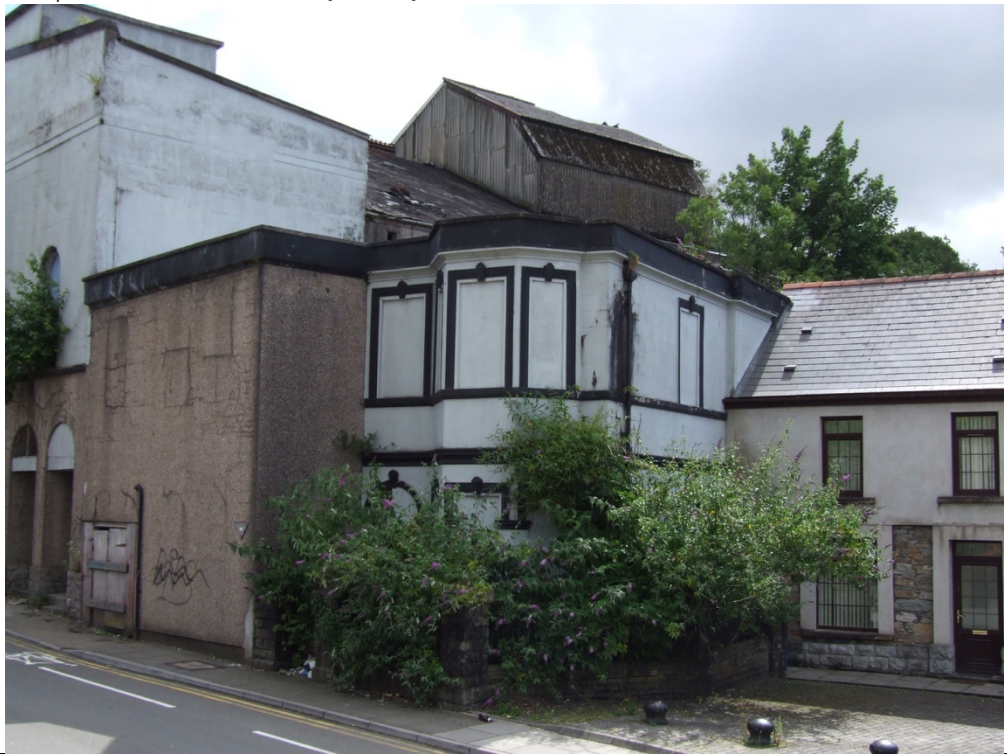
Address	<p>Thespian House at Theatre Royal, Penydarren Road</p>

Current use	Vacant
Architectural Description & Condition	<p>Probably contemporary with Theatre Royal (built 1891).</p> <p>Two-storeys rendered block set back from road and attached to Theatre Royal. Building generally appears to be in poor and neglected condition.</p> <p><u>Front</u> Rendered masonry with splayed bay and decorative mouldings and surrounds to blocked up openings.</p> <p>Flat roof arrangement. Parapet now plain - presumed to have been crenelated previously.</p>
Summary Assessment of Building's Contribution / Significance to the Conservation Area	<p>Some significance, although visually it is very poor.</p> <p>Historic photographs reveal that original crenelations were taken down early on.</p> <p>Window openings infilled & front / entrance projection sadly pebble-dashed.</p> <p>Listed Grade II.</p>

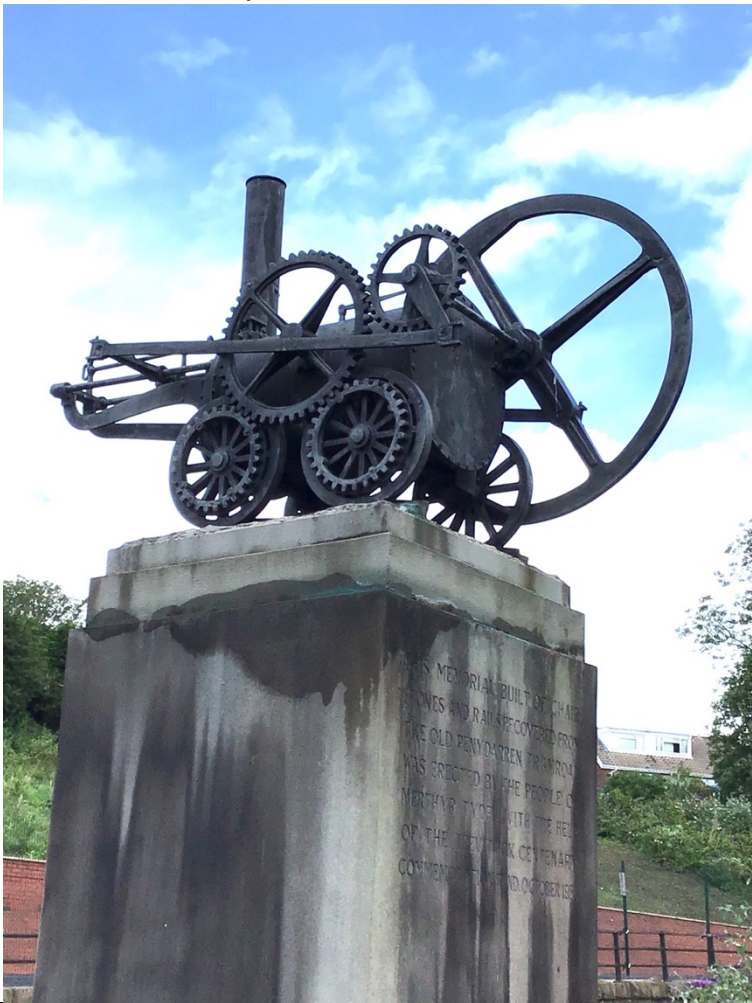
Address	<p>Trevithick Memorial, adjacent to 1 to 3 Gwalia Place</p>

Current use	Open area
Architectural Description & Condition	<p>Trevithick memorial monument made of bronze in the form of the first steam locomotive on stone plinth.</p> <p>Stone paved open area with pennant stone setts between line of pavement and short row of 3 terraced cottages.</p> <p>Coflein (https://coflein.gov.uk/en/site/91516/details/trevithick-memorial-merthyr-tramroad-penydarren-road-merthyr-tydfil) states that:</p> <p><i>'A memorial erected in October 1933 to Richard Trevithick, inventor and builder of the first steam railway locomotive which ran from here along the Merthyr Tramroad... ..to the terminus at Abercynon... ..on 21 February 1804.'</i></p> <p>This was an exceptionally important historic event, although it was largely an experiment partly driven by a bet, and trams continued to be pulled by horses. The first locomotive was used in 1829.</p>

Historic maps show the (Penydarren) Merthyr Tramroad (completed 1802) crossing what is now Penyard Road behind 28 Pontmorlais West to run southwards down Tramroadside North.
Summary Assessment of Building's Contribution / Significance to the Conservation Area	Positive as a small open 'breathing' space after / before the narrow pavement to the north, and that also opens up the street scene and provides opportunities for views of the Theatre Royal. Locally listed. Commemorates an exceptionally important historic event.

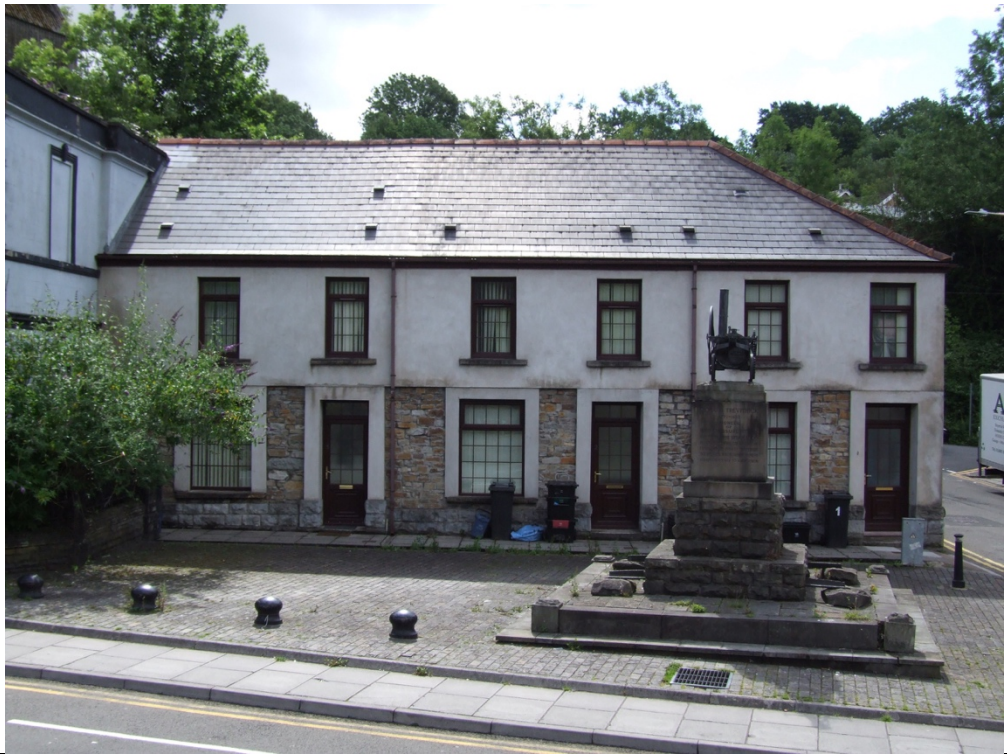
Address	<p>1-3 Gwalia Place</p>

Current use	Residential.
Architectural Description & Condition	<p>Not shown on 1885 Ordnance Survey Map (surveyed 1868-75).</p> <p>Refurbished terrace of 3 cottages abutting Theatre Royal.</p> <p>Slate Roof with red clay ridge and hip tiles with projecting roof vents.</p> <p>Front Pointed random rubble pennant stone to ground floor with rusticated stone plinth. Wide render banding surround to windows and doors. First floor of unpainted render.</p> <p>uPVC windows with double glazing and replica leaded lights.</p> <p>Cast iron or aluminium rainwater goods.</p>
Summary Assessment of Building's Contribution / Significance to the Conservation Area	Some significance, particularly as a backdrop to the Trevithick Memorial, although more refined details could improve the visual appearance.

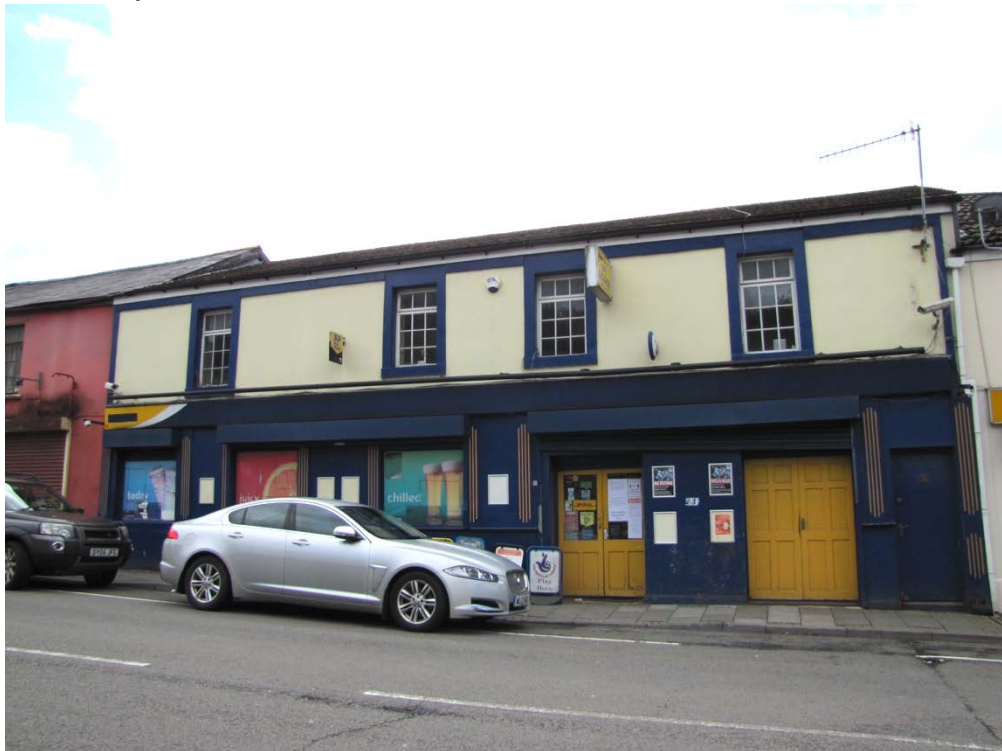
Address	<p>30 & 31 Penydarren Road</p>

Current use	<p>Shop/off-licence to Ground Floor. Presumed residential above. Formerly a public house</p>
Architectural Description & Condition	<p>Whole row is shown on 1885 Ordnance Survey Map (surveyed 1868-75).</p> <p>Mid terrace property.</p> <p><u>Roof</u></p> <p>Modern concrete profiled roof tiles. Modern uPVC fascia & gutters. Chimney stacks removed.</p> <p><u>Front</u></p> <p>Painted render walls to first floor. Relief render window surround to first floor side windows.</p> <p>Poor modern interpretation of traditional shopfront arrangement with modern doors, shop window and stall riser. Old high level relief signage for Fruiterer remains to side gable. External roller shutters to all ground floor doors and windows.</p> <p>First floor casement windows with slim glazing bars – possibly iron windows with painted stone sub-cills.</p> <p>Plethora of modern signage.</p>

Summary Assessment of Building's Contribution / Significance to the Conservation Area	Low, for retaining its form and 1 st floor openings, but its detailing, street frontage and colour scheme could be greatly improved.

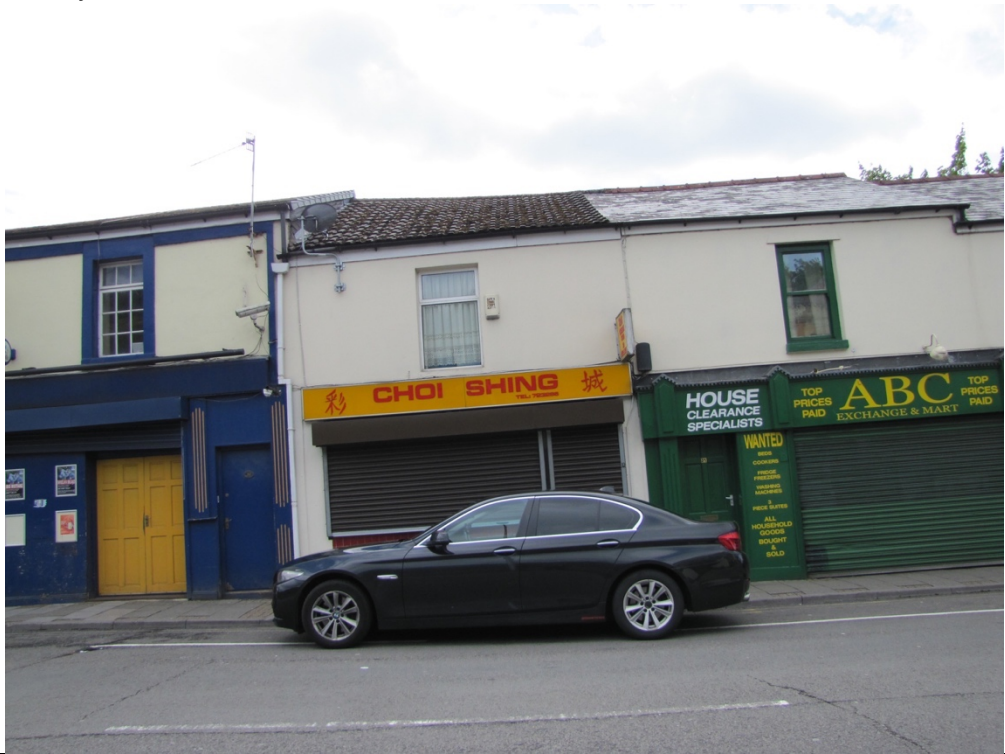
Address	<p>32 Penydarren Road</p>

Current use	Chinese take-away to Ground Floor. Presumed residential above.
Architectural Description & Condition	<p>Whole row is shown on 1885 Ordnance Survey Map (surveyed 1868-75).</p> <p>Mid terrace property.</p> <p><u>Roof</u> Modern concrete profiled roof tiles. uPVC gutters & fascia. Chimney stacks removed.</p> <p><u>Front</u> Painted render walls. Modern Shopfront with external mounted security roller shutters to ground floor. Modern tiled stall riser beneath window. First floor uPVC window – sub-cill removed. Modern signage.</p>
Summary Assessment of Building's Contribution / Significance to the	Low, for retaining its form and 1 st floor opening, but its detailing, street frontage and colour scheme could be greatly improved.

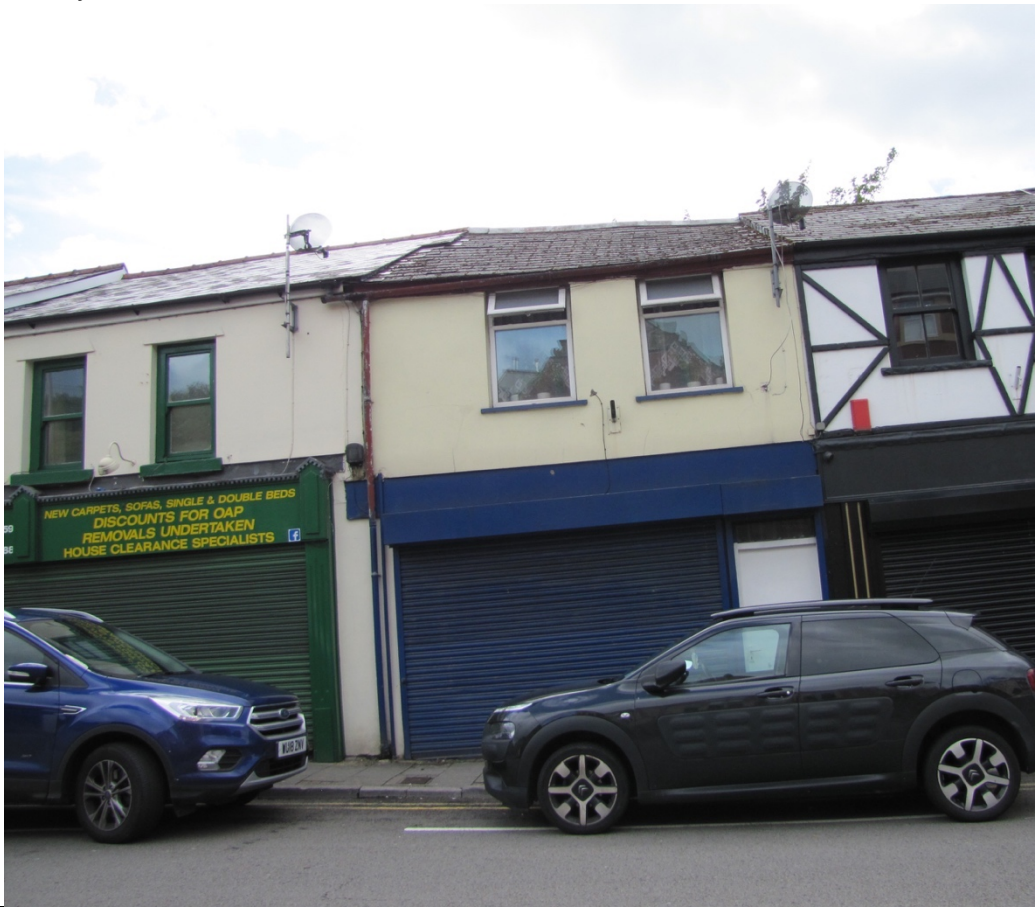
Address	<p>36 Penydarren Road</p>

Current use	<p>Unknown Shop to Ground Floor (possibly vacant). Presumed residential above.</p>
Architectural Description & Condition	<p>Whole row is shown on 1885 Ordnance Survey Map (surveyed 1868-75).</p> <p>Small mid terrace property.</p> <p><u>Roof</u> Slates to roof. uPVC gutters & fascia. Chimney stacks removed.</p> <p><u>Front</u> Painted render walls. Modern Shopfront with external mounted security roller shutters to ground floor. First floor uPVC windows with replacement modern sub-cills. No signage.</p>
Summary Assessment of Building's	<p>Low, for retaining its form and 1st floor openings, but its detailing, street frontage and colour scheme could be greatly improved.</p>

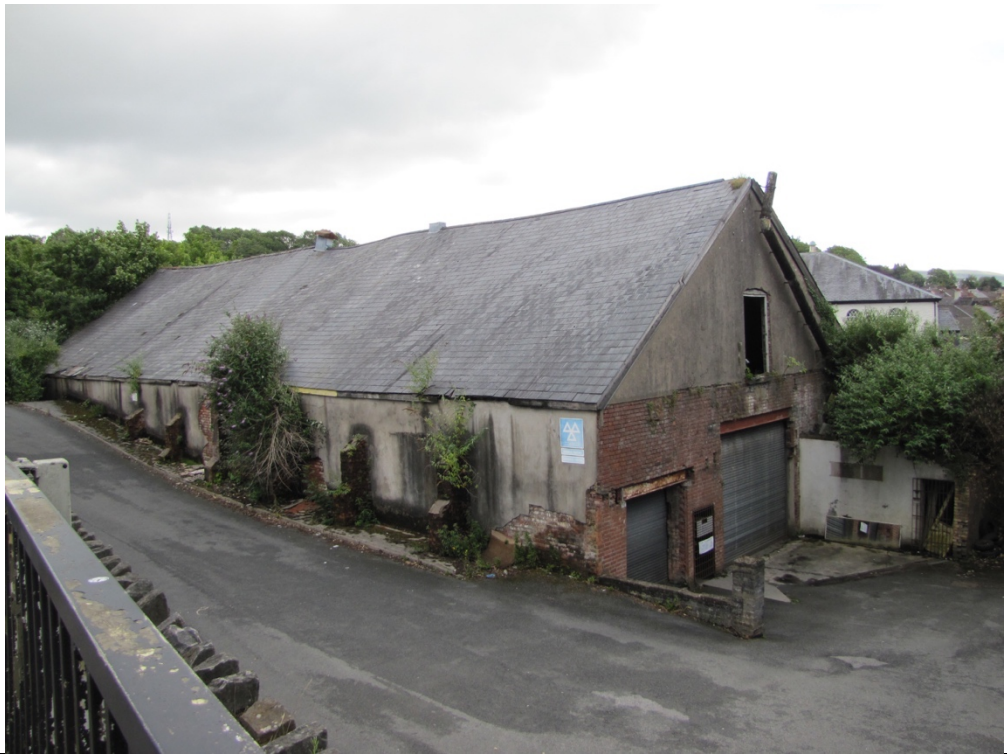
Address	<p>Old Drill Hall, Pontmorlais West</p>

Current use	Garage
Architectural Description & Condition	<p>Brickwork walls with some areas rendered. Steel lintels to the large roller shuttered openings. Tarmacadam hard standings.</p> <p>A large duo-pitched roof with natural slate finish with exposed rafter ends, timber fascia and barges. Lots of distortion in the roof structure.</p> <p>Heavily overgrown along its east elevation overlooking Nant Morlais.</p> <p>Generally in a poor condition.</p> <p>Presumably included in the Conservation Area as a remnant of the sort of activities that went on in the backyards of Pontmorlais.</p> <p>1851 Public Health Map suggests that the lane leading down to the garage is on the line of the former route of the tramroad. The tramroad then ran down to Roberts Bridge passing beneath the line of houses (Newfoundland Road) later built bridging over this tramroad.</p> <p>Drill hall appears to be shown on the 1885 Ordnance Survey plan (surveyed 1868-75).</p>

Summary Assessment of Building's Contribution / Significance	<p>Drill Hall - None, or low (if it has some historical or social significance that comes to light). Its poor condition and low architectural quality reduce its significance, despite the building's size and likely retained historic form.</p> <p>Route of tramroad – Historic significance of this route is very high.</p>

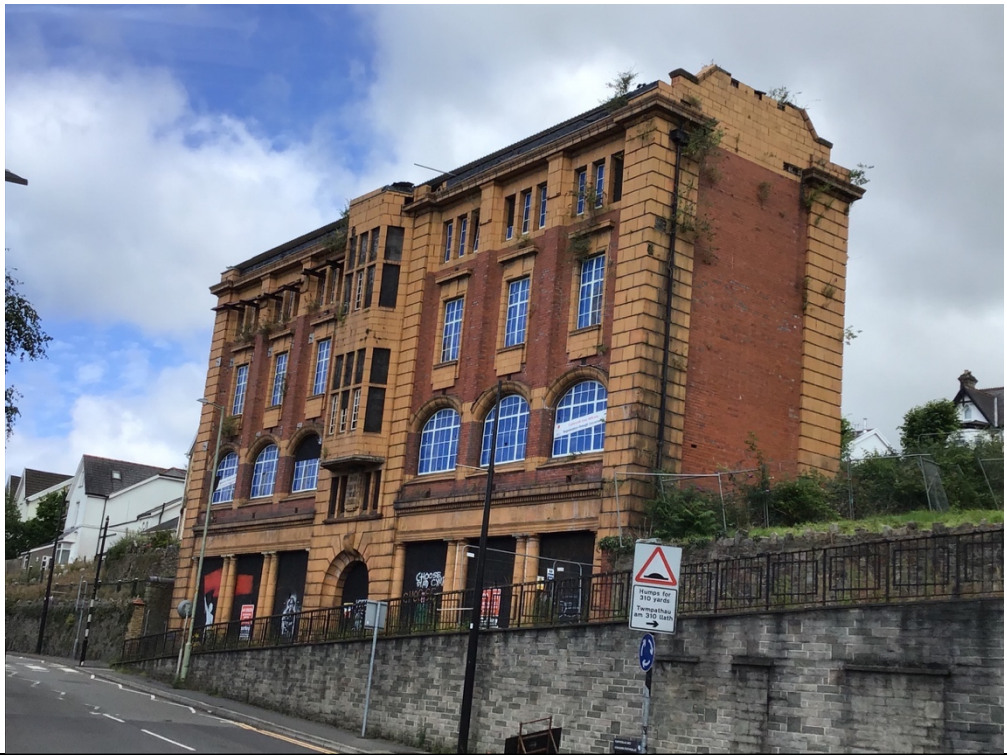
Address	<p>YMCA</p>

Current use	Vacant / derelict
Architectural Description & Condition	<p>Coflein (https://coflein.gov.uk/en/site/31926/details/ymca-buildingdistrict-education-office-pontmorlais-road#site-details) states:</p> <p><i>'1911 Ivor Jones and Percy Thomas [Architects], 4 storey, 7 bay, red brick and ochre tiles. Giant pilasters and crowning cornice.'</i></p> <p>The condition of the YMCA building, particularly visible higher up this road as you approach its northeastern view, is very poor. The rear in particular is severely dilapidated.</p> <p>Steps leading up to Park Terrace pre-date the YMCA.</p>
Summary Assessment of Building's Contribution / Significance to the Conservation Area	<p>High, for its very distinctive design / detailing, scale and prominence.</p> <p>Grade II listed.</p>

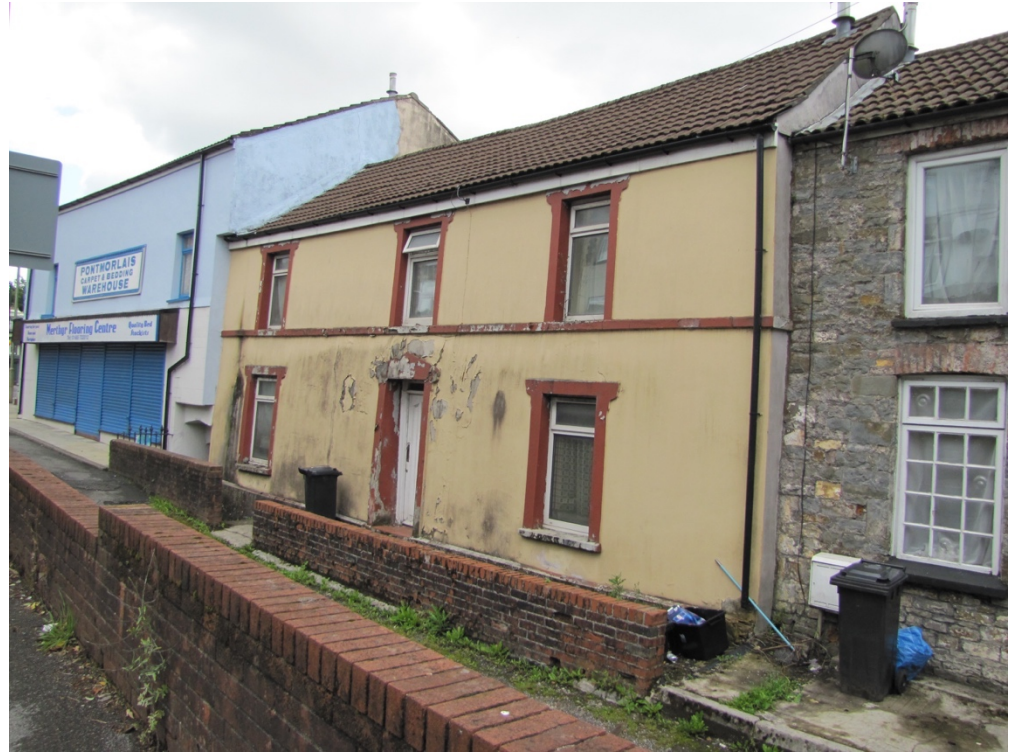
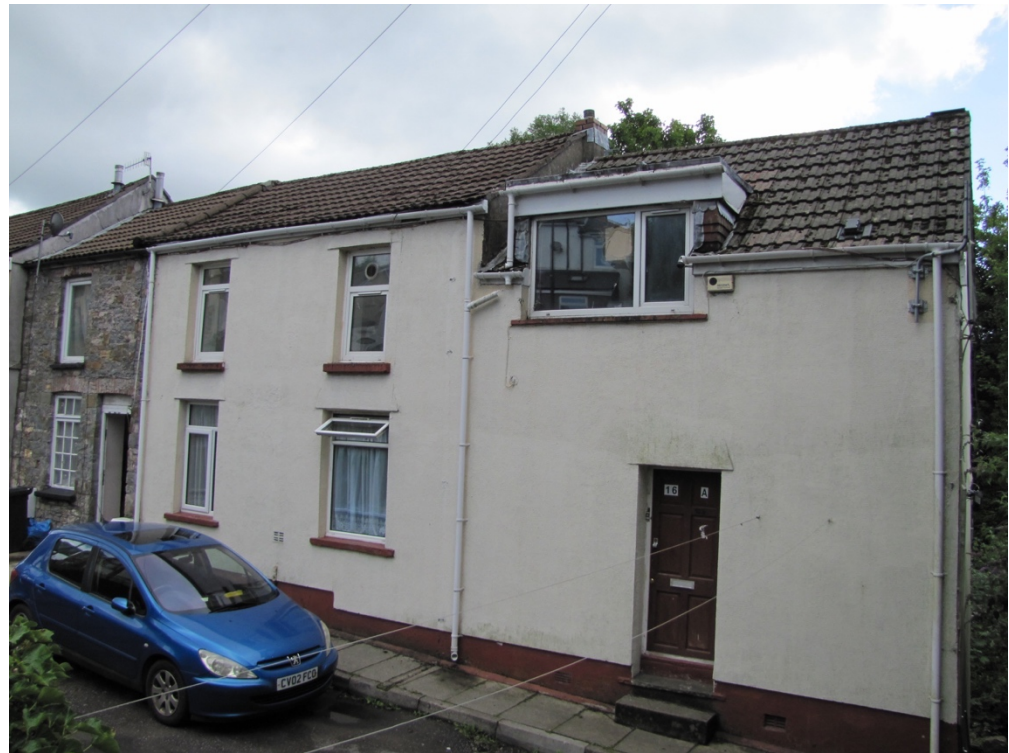
14 to 17 Bolgoed Place

Architectural Description & Condition	<p>Westernmost end of terrace present on John Woods' 1836 town map.</p> <p>Double-fronted eastern end of terrace is shown on 1851 Public Health Map.</p> <p>1851 Public Health Map shows the earliest tramway passing immediately in front of this terrace and leading down to a new bridge over the River Taff. Presumably this bridge would have been built c.1794 primarily for the tramway to access the new Glamorganshire Canal.</p> <p>Humble dwellings, greatly altered in terms of details and finishes.</p> <p>Concrete tiled duo-pitched roofs.</p> <p>Plastic rainwater goods.</p> <p><u>16a & 17 Bolgoed Place</u></p> <p>Modern front door to no.16a at southernmost end. No front door to the next part, so these properties may have been converted into one property.</p> <p>No.17 is the lowest of the duo-pitched roofed dwellings, with an odd central doorway.</p> <p>The modern rendered wall finish continues onto the adjacent house, which has a slightly higher roof and a very small chimney.</p> <p>Plastic windows.</p> <p>Small modern dormer window, although it might be of some age.</p> <p><u>15 Bolgoed Place</u></p> <p>Render has been hacked off, exposing stone walls and some brick soldier-course headed openings.</p> <p>Modern, timber windows and a modern front door.</p> <p><u>14 Bolgoed Place</u></p> <p>Slightly higher roof with a lot of distortion in the roof.</p> <p>Slightly battered front wall with render finish with lots of peeling paint.</p> <p>Simple rendered window surrounds.</p> <p>Small yard with a modern brick wall.</p>
