APPENDIX B - BUILDING-BY-BUILDING ASSESSMENT (2020)

1 LOWER HIGH STREET SQUARE, ST.TYDFIL'S CHURCH & COURT STREET

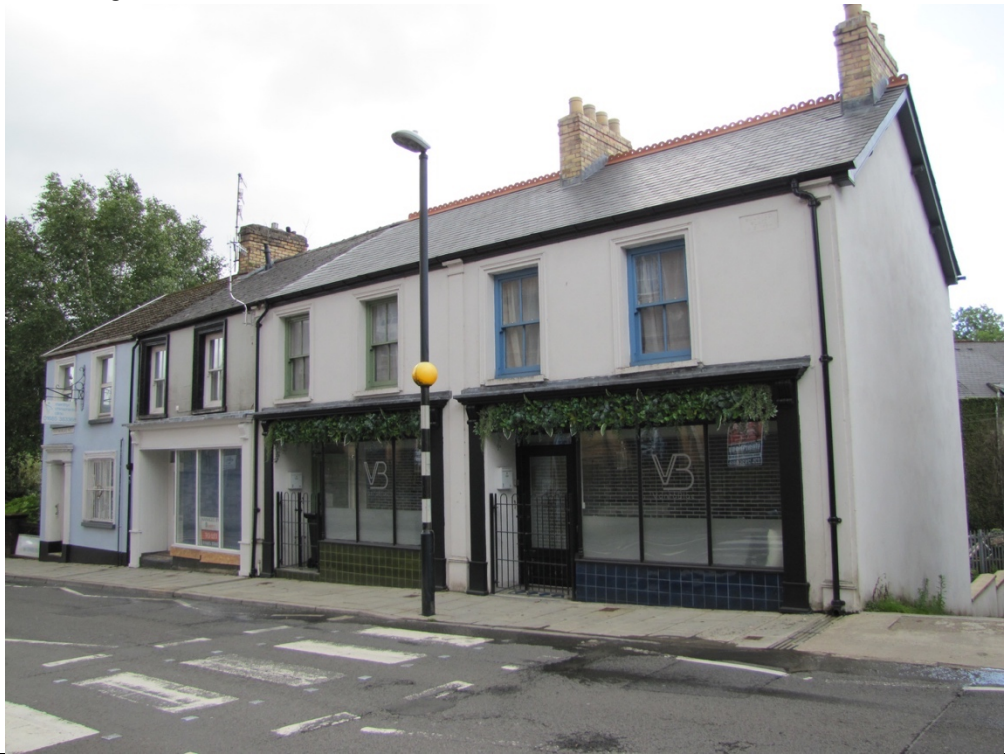
Address	<p>1 to 4 Bolgoed Place</p>

Current use	Vantablac Barbers (Nos. 1 & 2), Liberty Properties (letting agents) (No.3) & chiropractic clinic (No.4)
Architectural Description & Condition	<p>Shown on John Woods' 1836 town map.</p> <p><u>1 & 2 Bolgoed Place</u></p> <p>Recently restored to front and rear.</p> <p>Modern painted timber frontage with tiled stall-riser, tiled recessed and gated entrances.</p> <p>1st floor has 2-over-2 modern, but traditionally styled, timber sash windows.</p> <p>Two buff clay brickwork chimneystacks.</p> <p>Natural slated duo-pitched roof.</p> <p>Modern crested ridge tiles.</p> <p>Rendered walls with render moulded 1st floor window surrounds.</p> <p><u>3 Bolgoed Place</u></p> <p>Fibre-cement slate duo-pitched roof with central buff clay brick chimneystack.</p> <p>Rendered walls (stucco lines struck) with render moulded 1st floor window surrounds.</p>

<p>Traditional highly glazed (obscured glass) shop front with old traditional scroll capitals to pilasters, lead weathered fascia and recessed entrance.</p> <p><u>4 Bolgoed Place</u></p> <p>Concrete tiled duo-pitched roof.</p> <p>Rendered walls with render moulded window surrounds.</p> <p>Front door rendered surround with dentilled cornice.</p> <p>Plastic windows and front door.</p> <p>Modern signage and modern metal grille to ground floor window.</p>
Summary Assessment of Building's Contribution / Significance to the Conservation Area	<p>As one of the early 19th century commercial / domestic rows, and for retaining their historic form and good restored details, these should have a high significance.</p>

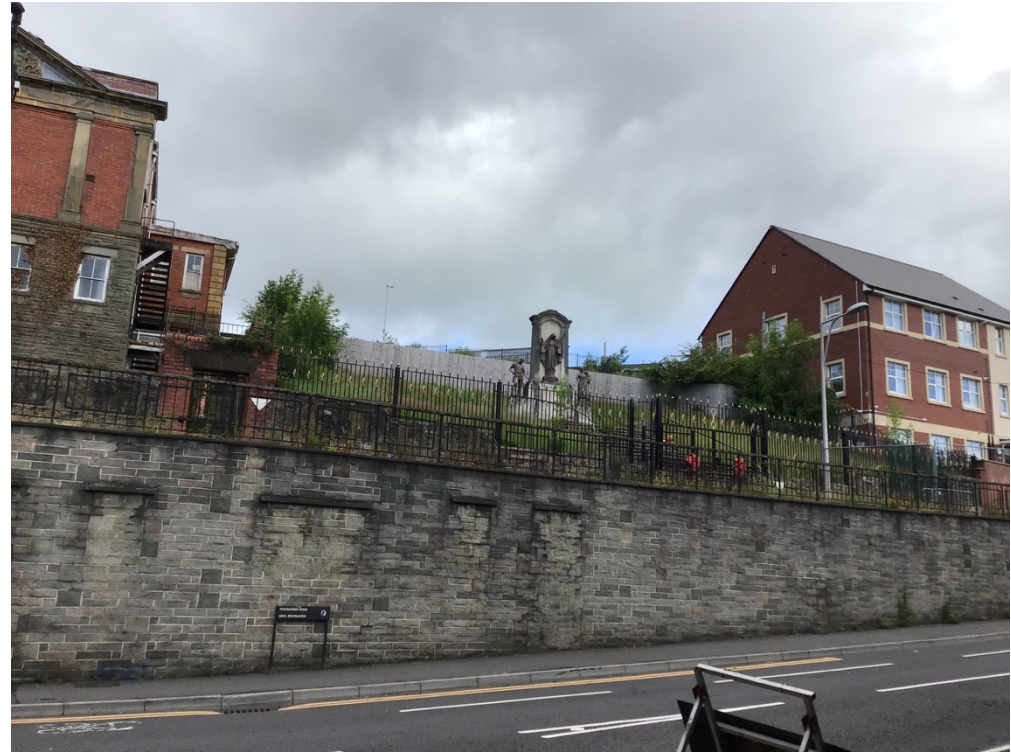
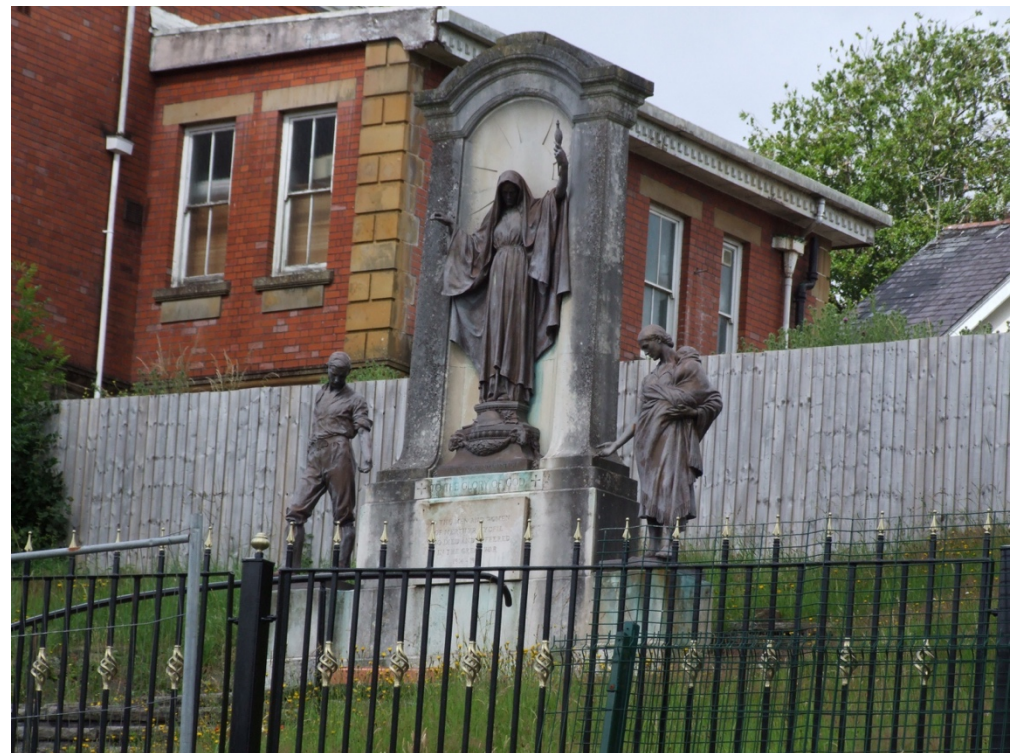
War Memorial

Architectural Description & Condition	<p>Set on terraced hillside above main road junction at Pontmorlais Circus.</p> <p>Cadw's listed building description states:</p> <p><i>'ca 1930. Bronze figures by L S Merrifield, 1931; cast by A B Burton, founder of Thames Ditton.</i></p> <p><i>Tall Portland stone niche with moulded arched capping, tapering sides and stepped plinth with flanking pedestals. Central bronze, mythological figure of one of the Three Fates bearing (or measuring) the Web of Life. War trophy to swagged pedestal. To sides are standing figures of a miner and a female carrying a child.</i></p> <p><i>Arrangement of curved flight of steps leads down to ca 1930 bronze guardrail with classical torch motif. Ironwork urns on front wall.'</i></p>
Summary Assessment of Building's Contribution / Significance to the Conservation Area	<p>Whilst, due to its small scale and siting, it doesn't have much physical 'presence' in the Conservation Area, as a Grade II listed structure it is of great significance.</p>

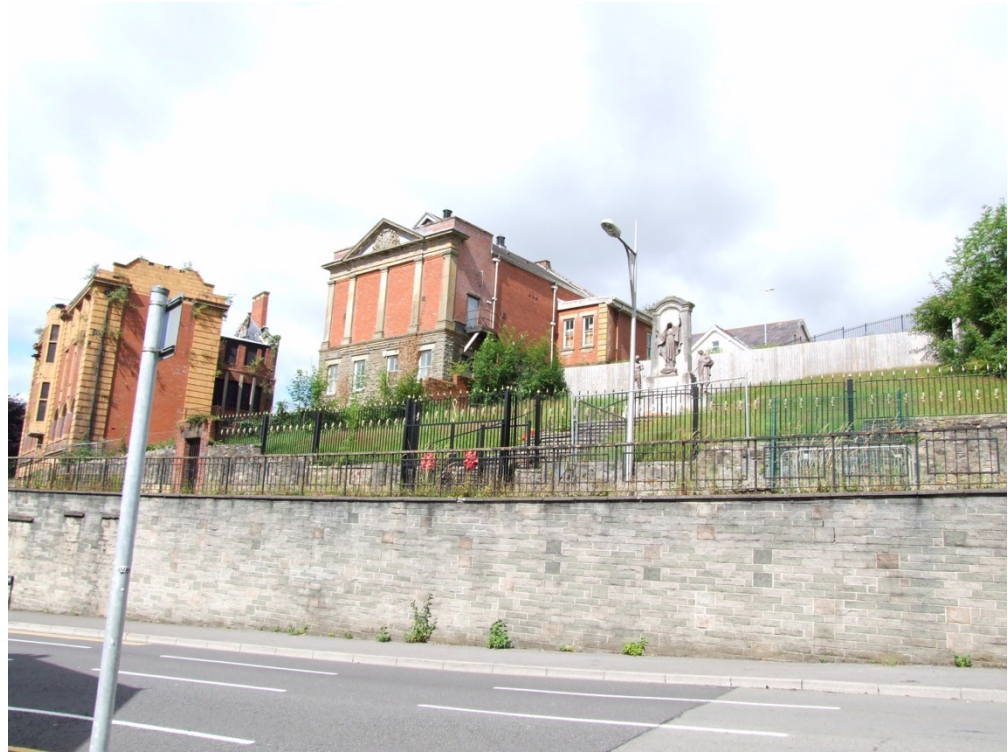
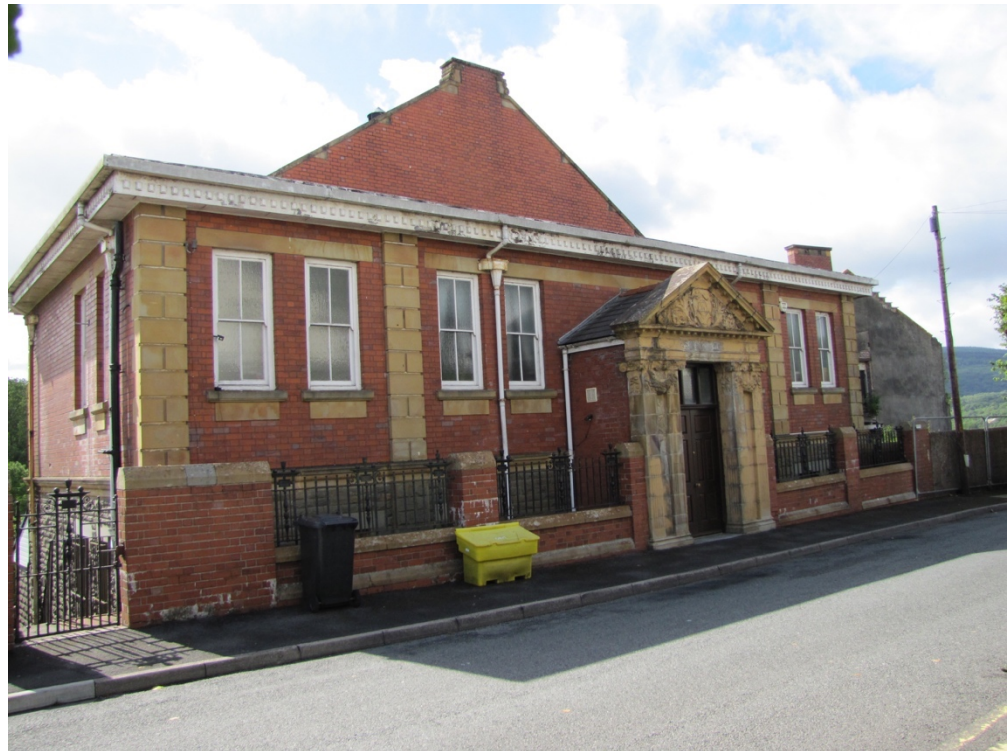
Masonic Temple

Architectural Description & Condition	<p>Red clay facing brickwork walls; Bathstone pilasters and pediment to its south (rear) elevation; 2 over 2 timber sash windows.</p> <p>Purpose-built 1910-12.</p>
Summary Assessment of Building's Contribution / Significance to the Conservation Area	<p>Significant as a dominant feature in the Conservation Area.</p> <p>Locally listed.</p>

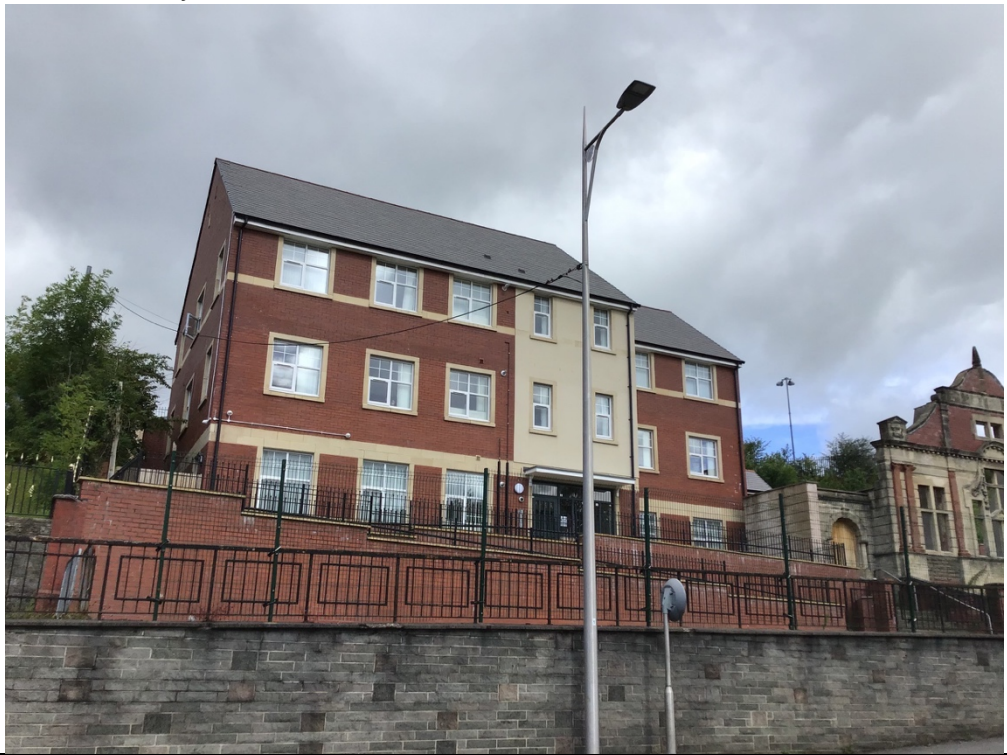
Address	<p>Flats immediately to the north of War Memorial</p>

Current use	Residential
Architectural Description & Condition	<p>New (built c.2017) three-storeys.</p> <p>Facing brickwork and rendered walls.</p> <p>This adds to belittle the War Memorial although the War Memorial was never that dominant.</p>
Summary Assessment of Building's Contribution / Significance to the Conservation Area	None.

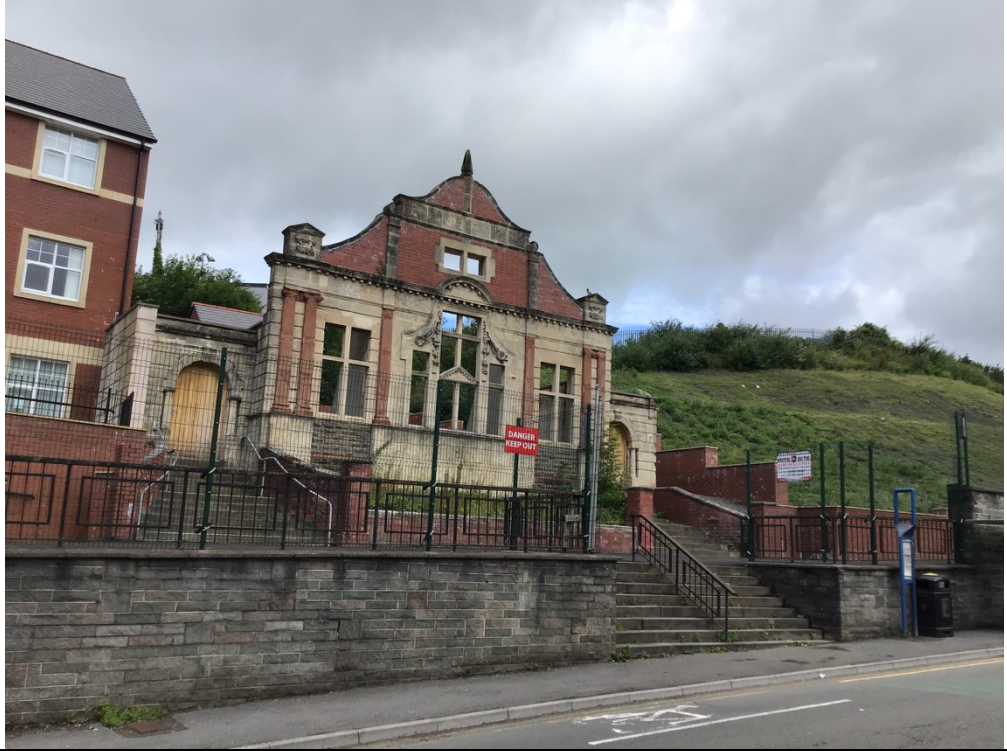
Address	<p>Former Employment Office / Labour Exchange (originally built in 1907 as Tydfil Hall Forward Movement Chapel)</p>

Current use	None (façade only)
Architectural Description & Condition	<p>Red clay facing brickwork and bathstone dressings.</p> <p>Façade has been retained and is now free standing.</p>
Summary Assessment of Building's Contribution / Significance to the Conservation Area	<p>Only some significance since all that remains is the entrance façade.</p> <p>Locally listed.</p>

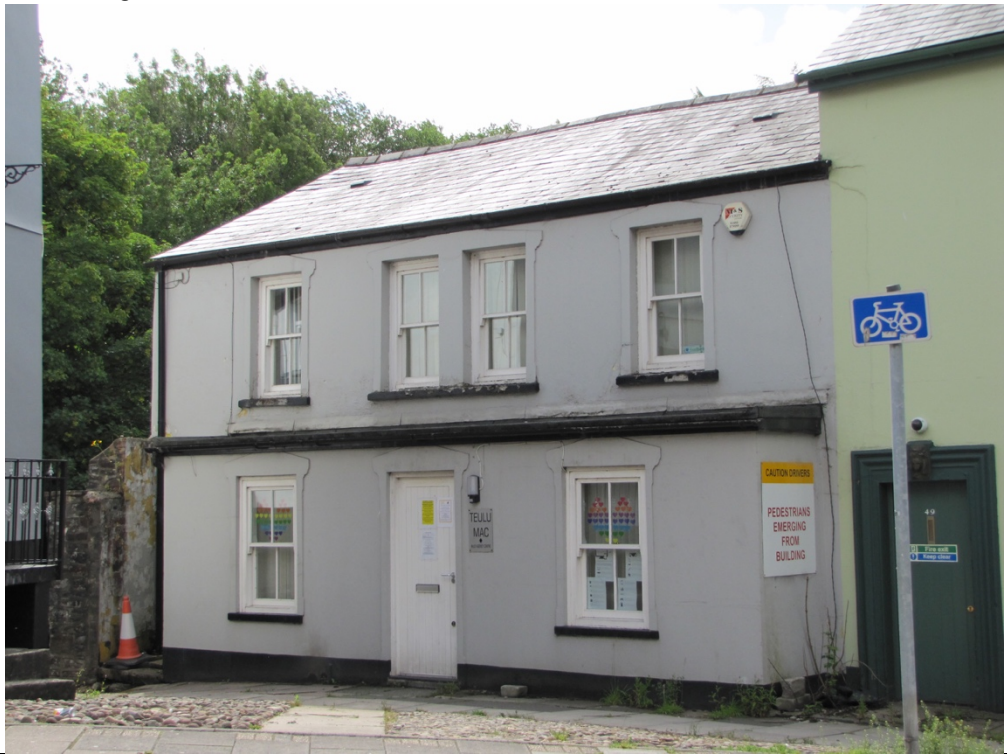
Address	<p>47 & 48 High Street, Pontmorlais</p>

Current use	Teulu Mac (charity offices)
Architectural Description & Condition	<p>Shown on 1851 Public Health Map.</p> <p>Painted rendered walls.</p> <p>Mineral felt flat roof to single-storey extension.</p> <p>Modern, painted timber sash windows to 1st floor.</p> <p>Low-pitched slated duo-pitched roof.</p>
Summary Assessment of Building's Contribution / Significance to the Conservation Area	Moderate significance, for retention of its historic form and 1 st floor window details.

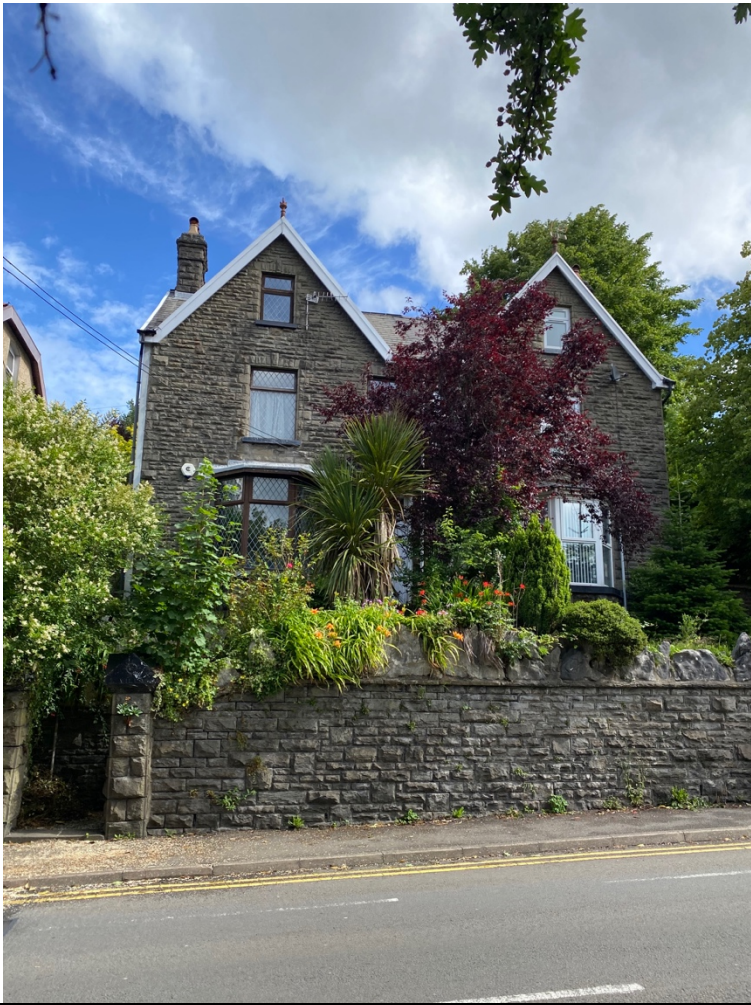
Address	<p>Gavenny Villa & Usk Villa – 3 High Street</p>

Current use	Dwellings (semi-detached)
Architectural Description & Condition	<p>Designed as one of a grouping of three large villa properties set above the road with raised gardens behind pennant stone boundary wall. This property is now 2 semi-detached dwellings.</p> <p>Not shown on 1901 Ordnance Survey map (although survey was 1897-98)).</p> <p><u>Front</u></p> <p>Two-storey with attic rooms. Regular coursed pennant stone wall. All plastic windows (including bay to ground floor) and front door to right hand dwelling. Stained timber casements to left hand dwelling with mock diamond leaded glass (including ground floor bay). uPVC fascias, bargeboards and rainwater goods. Fairly plain stone window cills.</p>

<p>Slate roof covering with clay ridge & hip tiles. Imposing pennant stone chimney stacks.</p> <p><u>Side (Lane)</u></p> <p>Side elevation to west side has been rendered. East side concealed by trees.</p> <p>Part of a group of attractive properties set above road. Part of the northernmost properties within the current Conservation Area boundary.</p>
Summary Assessment of Building's Contribution / Significance to the Conservation Area	<p>Very low, because their inclusion in a town centre Conservation Area is questionable on account of their physical remoteness from the town centre and their different character to it.</p>

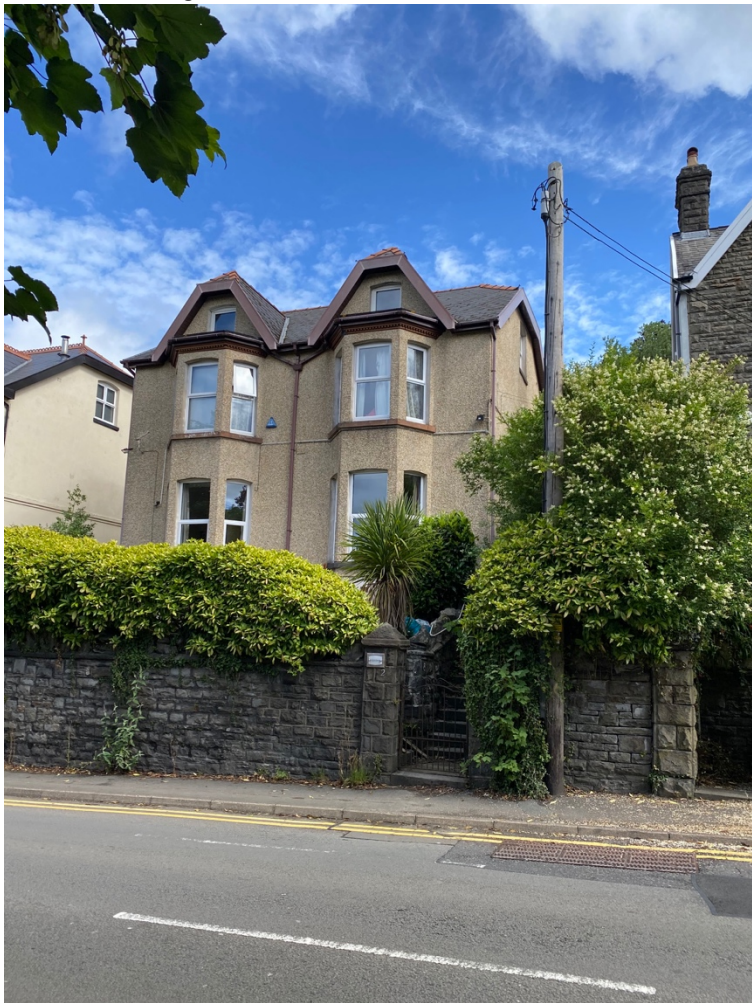
Address	<p>Hazeldean - 2 High Street</p>

Current use	Dwelling
Architectural Description & Condition	<p>Designed as one of a grouping of three large villa properties set above the road with raised gardens behind pennant stone boundary wall. This property is now believed to be a single dwelling.</p> <p>Not shown on 1901 Ordnance Survey map (although survey was 1897-98)).</p> <p><u>Front and side elevations</u></p> <p>Two-storey with attic rooms. Pebble dashed wall finish. All plastic windows (two double bays) and front door to side of property. Brown uPVC fascias, barges and rainwater goods. Fairly plain stone window cills. Fibre cement slate roof covering with clay ridge & hip tiles. Chimney stacks removed.</p>

Part of a group of attractive properties set above road. Part of the northernmost properties within the current Conservation Area boundary.
Summary Assessment of Building's Contribution / Significance to the Conservation Area	Very low, because its inclusion in a town centre Conservation Area is questionable on account of its physical remoteness from the town centre and its different character to it.

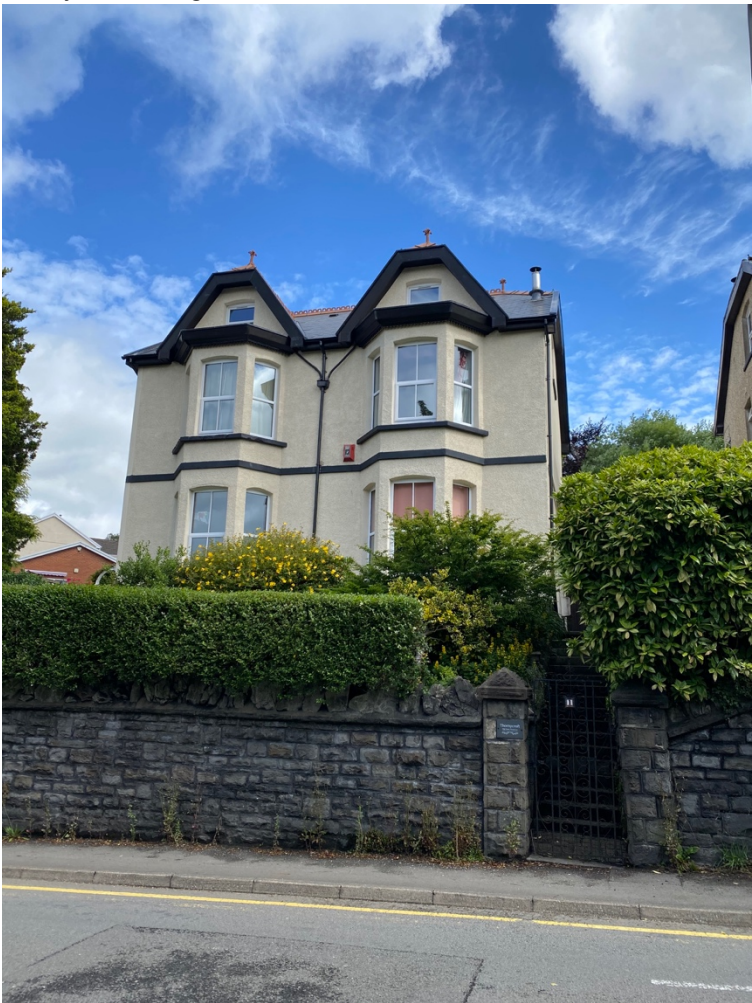
Address	<p>Thornycroft - 1 High Street</p>

Current use	Dwelling
Architectural Description & Condition	<p>Designed as one of a grouping of three large villa properties set above the road with raised gardens behind pennant stone boundary wall. This property is now believed to be a single dwelling.</p> <p>Not shown on 1901 Ordnance Survey map (although survey was 1897-98)).</p> <p><u>Front and side elevations</u></p> <p>Two-storey with attic rooms. Painted render finish with banding. Painted timber modern sash windows (two double bays) with uPVC windows to attic storey. uPVC windows to side elevations. Painted modern plain timber fascias and barges. Aluminium rainwater goods generally with lead pipework from bay flat roof. Fairly plain stone window cills. Fibre cement slate roof covering with crested red clay ridge & hip tiles. Chimney stacks removed.</p>

Part of a group of attractive properties set above road. Part of the northernmost properties within the current Conservation Area boundary.
Summary Assessment of Building's Contribution / Significance to the Conservation Area	Very low, because its inclusion in a town centre Conservation Area is questionable on account of its physical remoteness from the town centre and its different character to it.

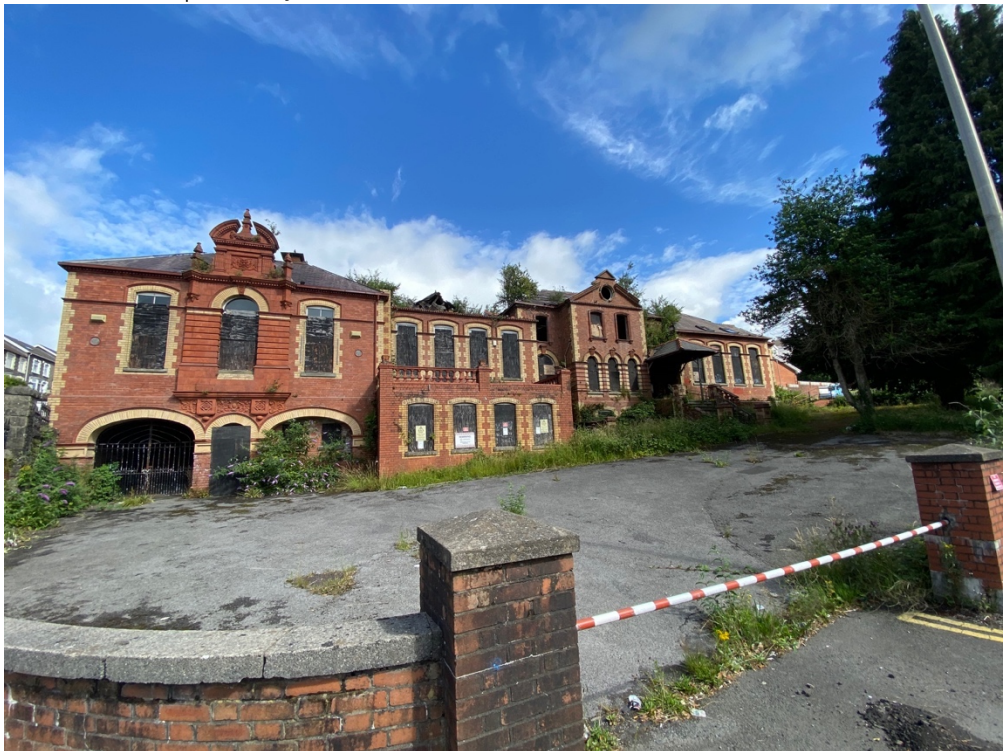
Address	<p>Old General Hospital, Penydarren Road</p>

Current use	Vacant
Architectural Description & Condition	<p>Substantial building set back from main road with fine and varied architectural features.</p> <p>Natural Welsh slate roof (red/ purple) coverings with crested ridge tiles and lead covered hips (lead substantially missing). Remains of adapted roof vents.</p> <p>Walls generally of red brick with yellow brick quoins and surrounds to windows. Decorative terracotta (faience) projections, detailing and pediments along with yellow faience fluted tympanum to arched openings. Remains of terracotta balusters to south projection.</p> <p>Windows generally boarded over. Visible sections indicate uPVC replacement to principal openings.</p> <p>Modern aluminium square box section gutters and round downpipes generally with modern uPVC SVP's.</p> <p>Boundary walls partially of original pennant stone with remains of fine decorative railings to west side. Modern replacement brickwork boundary wall generally to south, partially collapsed. Macadam surfaced frontage, badly overgrown.</p> <p>As a building that has been vacant for a number of years, the condition is clearly deteriorating quickly. Action will be required to save this building that has a significant amount of character, located in a prominent position.</p> <p>Built 1888.</p>

<p>A bronze statue, sculpted by Sir Thomas Brock, commemorating Sir W. T. Lewis' elevation to peerage by King George V was erected outside the Old General Hospital c.1911. This has been relocated to Aberdare Park.</p>
<p>Summary Assessment of Building's Contribution / Significance to the Conservation Area</p>	<p>A substantial and attractive building with significant potential for sympathetic refurbishment however its poor condition, physical remoteness from the town centre and its differing character to the town centre buildings means it is of low significance to the Town Centre Conservation Area.</p> <p>Clearly a potentially positive building but its inclusion within a town centre Conservation Area somewhat incongruous with its location.</p>

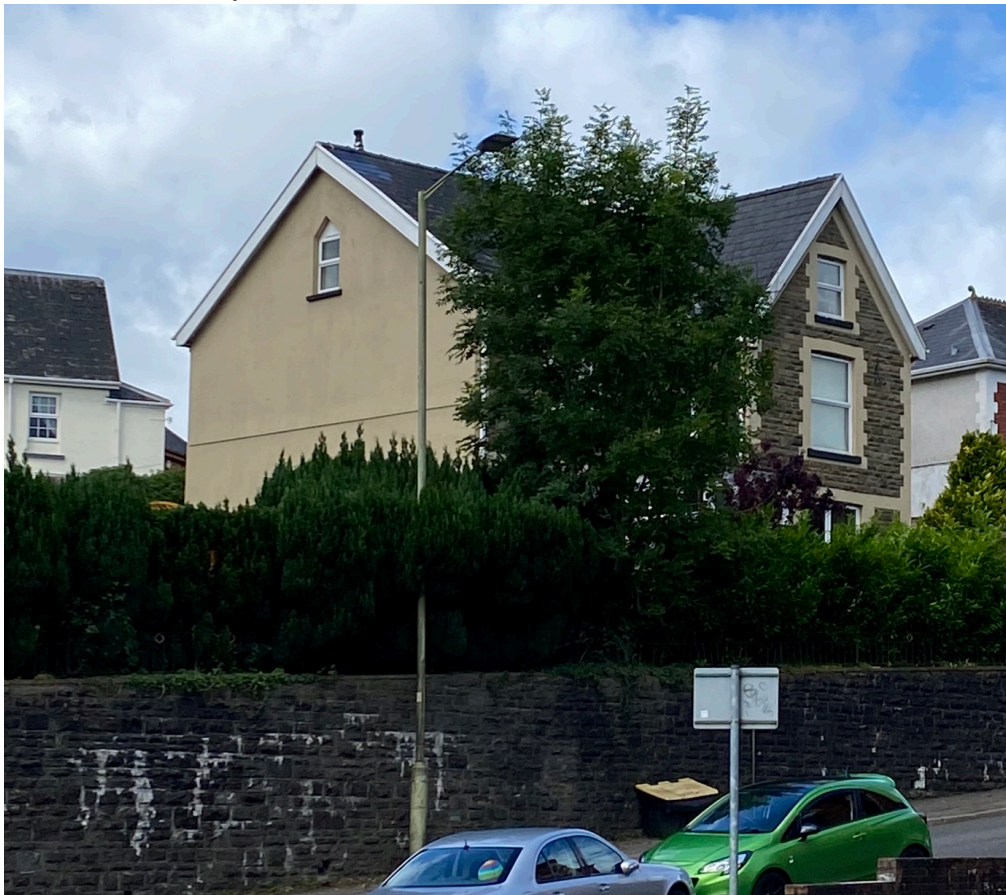
Address	<p>Oaklands – Gwaelod y Garth Road</p>

Current use	Dwelling
Architectural Description & Condition	<p>Designed as a single detached impressive dwelling set up above the street level on raised ground with substantial pennant stone retaining wall and metal railings. Substantial planting conceals much of the building from meaningful views.</p> <p><u>Front</u> Two-storey with attic rooms and gabled frontage. Regular coursed pennant stone wall with painted stone quoins and banding. All plastic windows generally. Flat roofed porch to front believed to be of painted timber with dentilled and profiled eaves and leaded lights to windows. uPVC fascia, barges and rainwater goods. Fairly plain stone window cills. Slate roof covering with clay ridge & hip tiles. Imposing pennant stone and buff brick chimney stacks.</p> <p><u>Sides</u> Side elevations rendered and painted. East side concealed by trees.</p> <p>Appears to be shown on 1901 Ordnance Survey map.</p>

<p>Summary Assessment of Building's Contribution / Significance to the Conservation Area</p>	<p>Attractive detached villa dwelling, but located high above the streetscene such that it plays little part in it. Seemingly incongruous to a town centre Conservation Area.</p> <p>Very low, because its inclusion in a town centre Conservation Area is questionable on account of its physical remoteness from the town centre and its different character to it.</p>

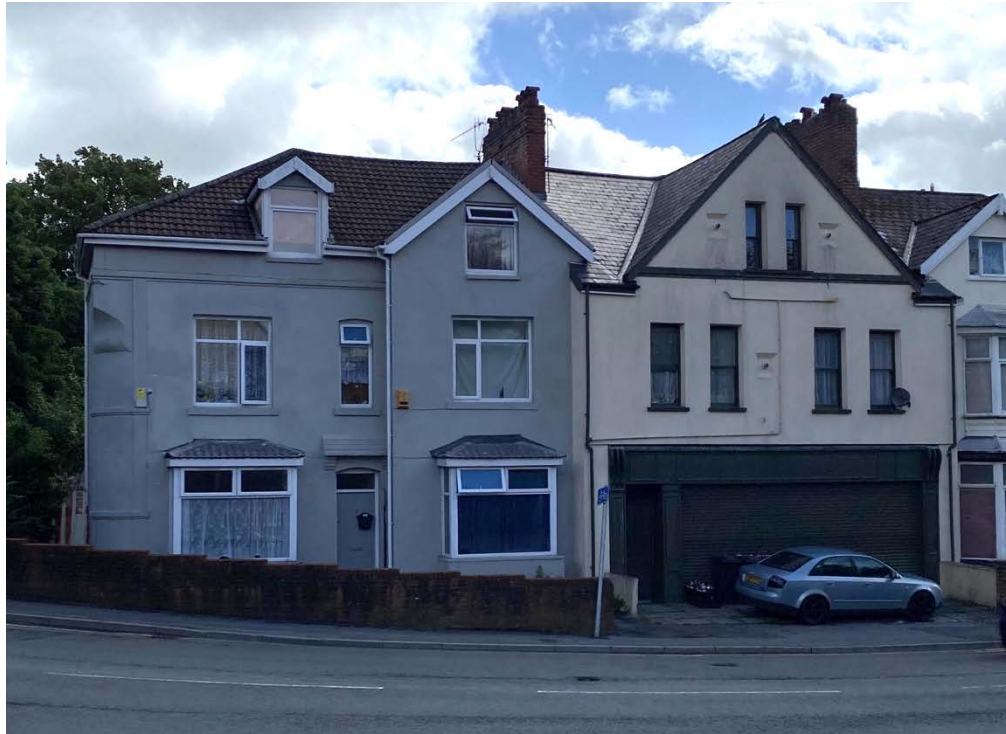
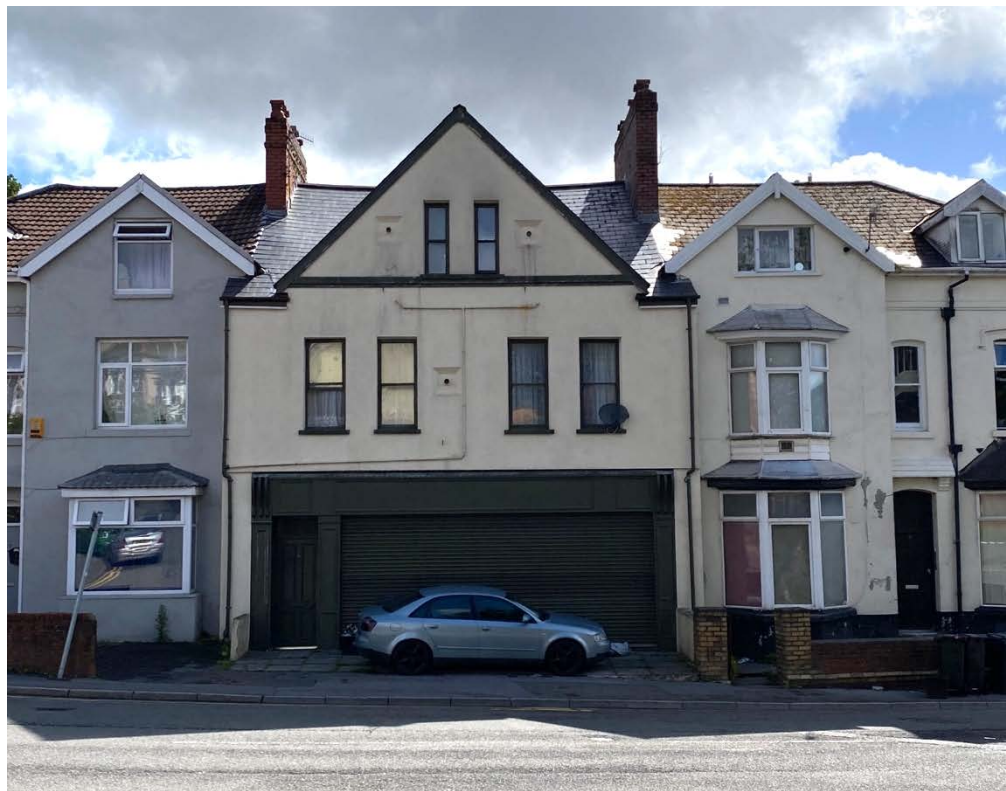
5-7 Garth Villas, Penydarren Road

Current use	Domestic (with possible shop to ground floor of no. 6). Presumably sub-divided into flats / bed-sits.
Architectural Description & Condition	<p>Cartographic evidence suggests that this row dates from the turn of the 20th century, although a building has been on this site (to a slightly different orientation) since the early 19th century. It would be interesting to know more about the construction of this building to see whether an earlier date is possible.</p> <p>Close proximity and the formal design suggests the original building may have been associated with the Penyardren Ironworks, perhaps for employees.</p> <p>Large painted rendered block of three two story properties with attic rooms including gables frontages and dormers.</p> <p>Originally designed as a single block with symmetrical arrangement. Subsequent ownership variable ownership has resulted in various changes to the principal front elevation that detracts from the original design intent.</p> <p>Close proximity and the formal design suggests this may have been associated with the Penyardren Ironworks, perhaps for the highest status employees.</p> <p><u>Front</u> Roof is now a mix of inappropriate red concrete tile and fibre cement slate (older and more recent). 2 large red brick chimney stacks on party wall lines. Painted smooth render finish generally to walls with rounded corners and banding. Windows replaced with mixture of painted timber casements and uPVC to no's 5 & 7. No. 6 retains painted sash windows to upper floors with a ground floor shopfront and integrated roller shutter. No. 5 (right hand side) retains the original bay window projections and forms along with entrance door and corbelled slate door canopy, but alterations to the frontage of no. 7 has done away with these.</p> <p><u>Sides & rear</u> The side and rear elevations have been substantially altered and extended. No features of merit to note from street scenes.</p>

Summary Assessment of Building's Contribution / Significance to the Conservation Area	Not unattractive group of buildings that are not particularly significant, but with potential for improvement. Do not seem to belong in the Town Centre Conservation Area.

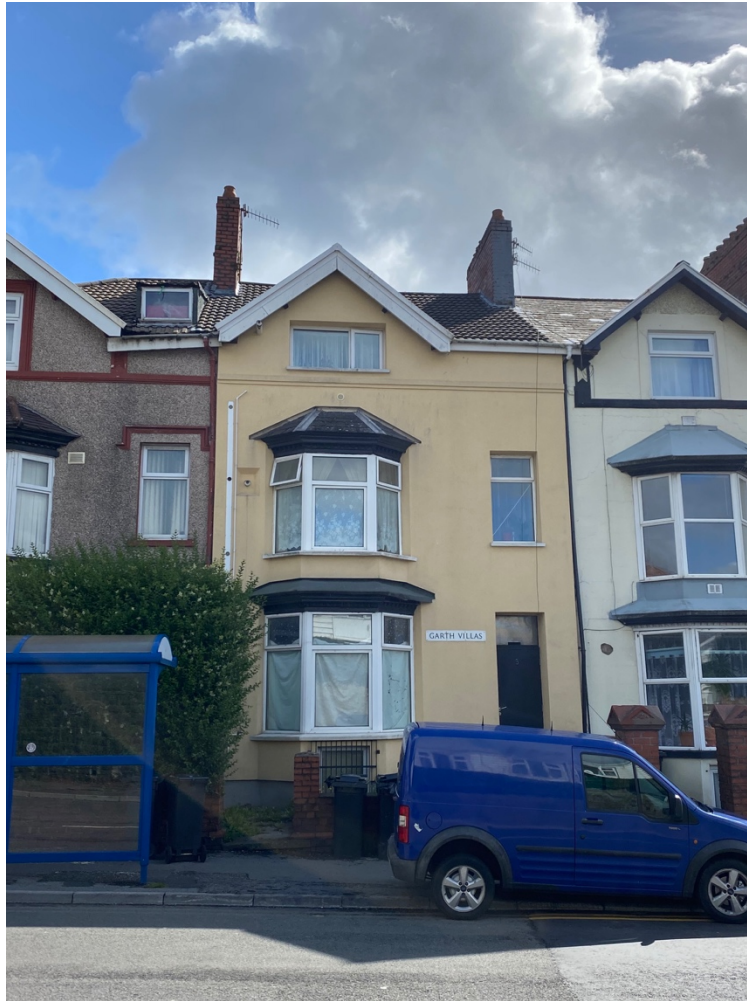
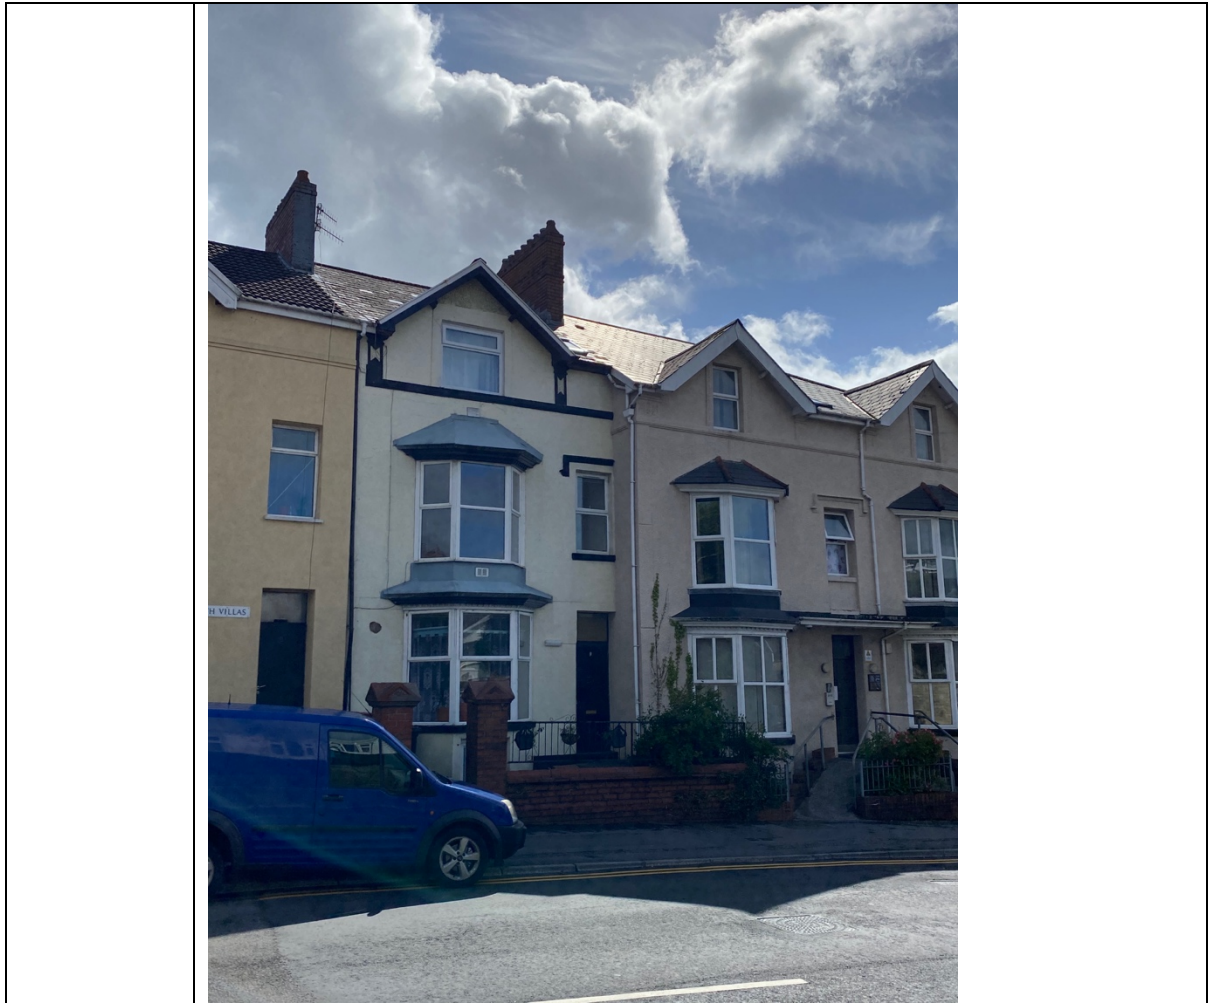
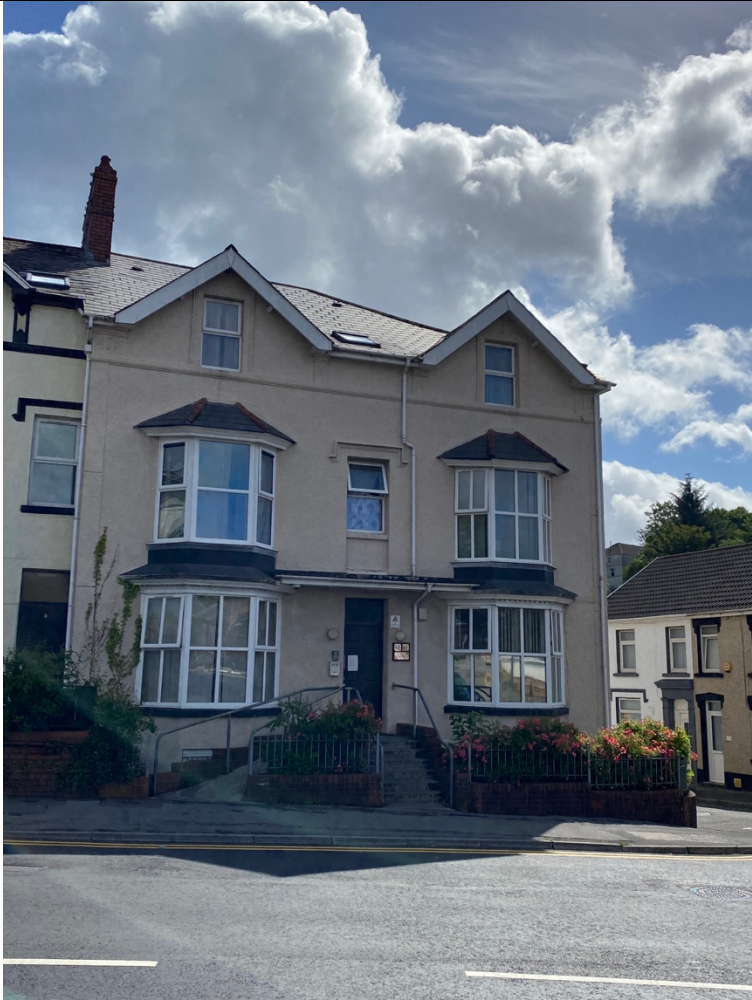
1-4 Garth Villas, Penydarren Road

Current use	Dwellings – most appear to have been sub-divided into HMO's.	
Architectural Description & Condition	<p>A building has been on this site since the early 19th century, although the date of this building is not clear. It would be interesting to know more about the construction of this building to see whether an earlier date is possible.</p> <p>Close proximity and the formal design suggests the original building may have been associated with the Penydarren Ironworks, perhaps for employees.</p> <p>Large painted rendered block of four two story properties with full attic rooms including gabled frontages.</p> <p>No. 1 to south end is double fronted.</p> <p><u>Front</u></p> <p>Roof is now a mix of inappropriate concrete tile (no's 3 & 4) and fibre cement slate.</p> <p>Large imposing red brick chimney stacks on party wall lines.</p> <p>Double bays to each property (slated hipped roof coverings to all except no. 2 seemingly covered with modern membrane). Remains of dentilled decorative timber fascia to most bays.</p>

<p>Mixture of modern pebble dash and painted smooth or roughcast render finish generally to walls with high level string course to attic storey. Windows replaced with white uPVC.</p> <p><u>Sides & rear</u> The side and rear elevations do not impact on views of the Conservation Area. No features of merit to note from street scenes.</p>
Summary Assessment of Building's Contribution / Significance to the Conservation Area	<p>Potentially not unattractive group of buildings that are not particularly significant. Do not seem to belong in the Town Centre Conservation Area.</p>

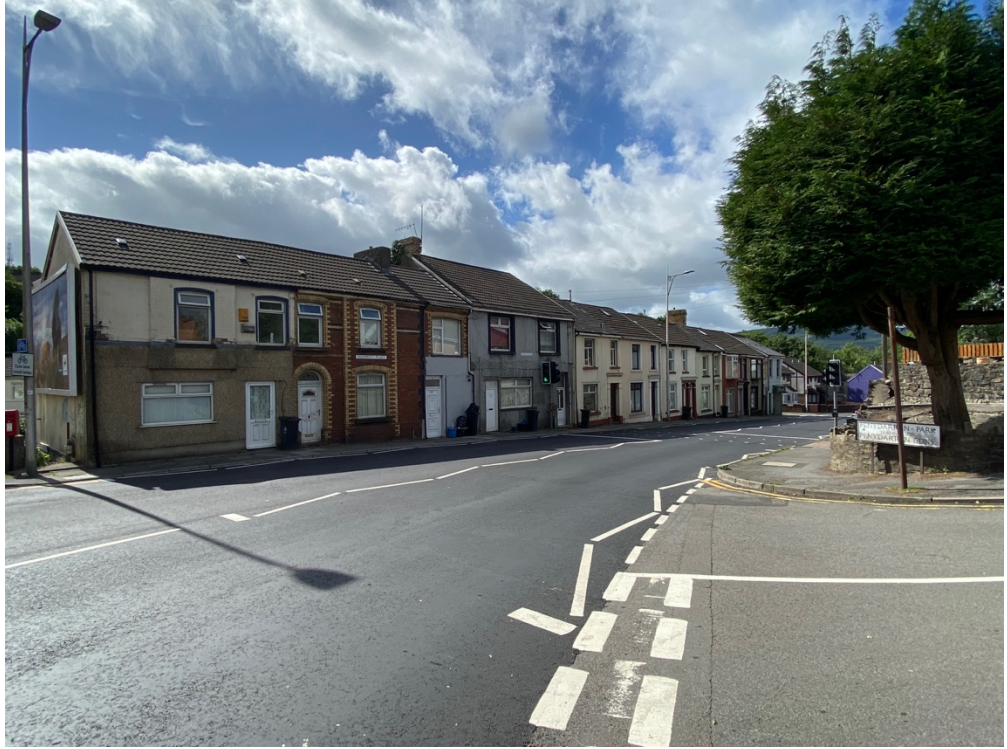
Address	Prospect Place, Penydarren Road

Current use	Dwellings
Architectural Description & Condition	<p>Terrace of typical smaller single fronted properties, common to valleys towns.</p> <p>Most have been substantially altered over the years. Most now have profiled concrete tiled roofs, though two retain slates. Few chimney stacks remain.</p> <p>The majority now have rendered frontages (mixture of painted render and dashed finishes). No's 20-25 have smooth rendered finishes; some retain the cut coursing to replicate ashlar with classical influenced door and window surrounds. No. 28 retains a fine red brick elevation with buff/yellow brickwork detailing at arched window and door heads and quoins.</p> <p>All doors and windows have been replaced with modern uPVC.</p>
Summary Assessment of Building's Contribution / Significance to the Conservation Area	A typical terraced arrangement, common to the approaches of Valleys towns. Little in the way of significance and would not seem to belong to the Town Centre Conservation Area.

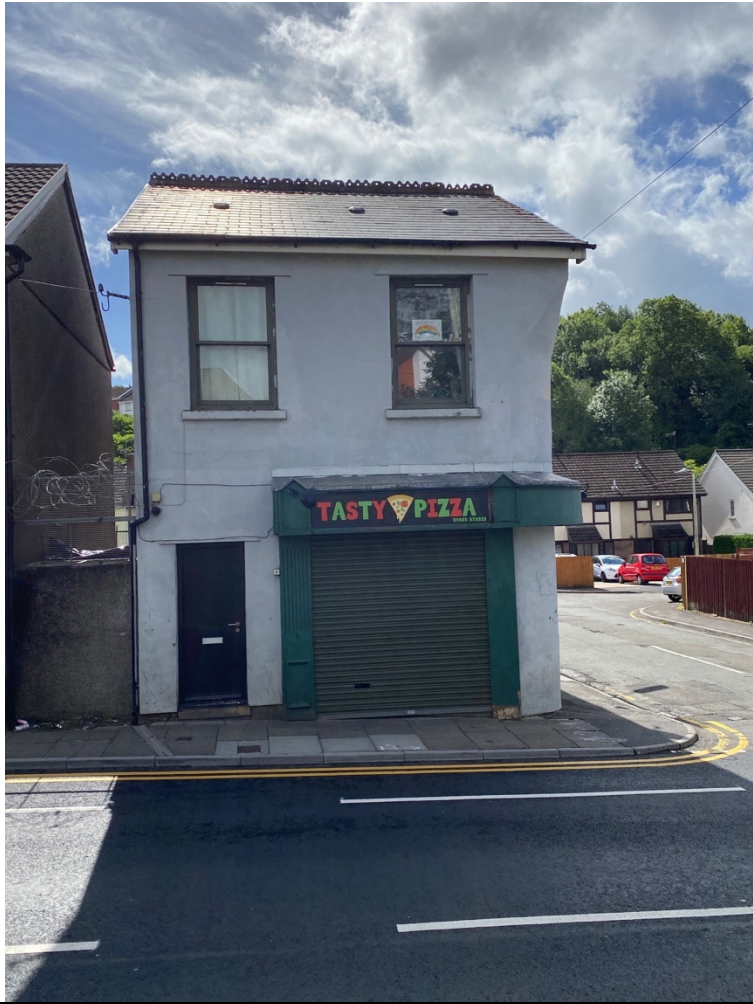
Address	19 Park Place, Penydarren Road

Current use	Take Away with flat above (currently Pizza)
Architectural Description & Condition	<p>Two storey detached sited close to the terrace of Prospect Place. Reads in street scene as part of the terrace.</p> <p><u>Roof</u> Slate roof with red clay ridge & hips (crested)</p> <p><u>Front & Side</u> Painted smooth render with rounder corner. Ground floor shop-front – modern interpretation of traditional frontage with external roller shutters. Modern timber sash windows to first floor.</p>
Summary Assessment of Building's Contribution / Significance to	Whilst this property may contain a commercial unit, it has little in the way of historic significance and is remote from the town centre.

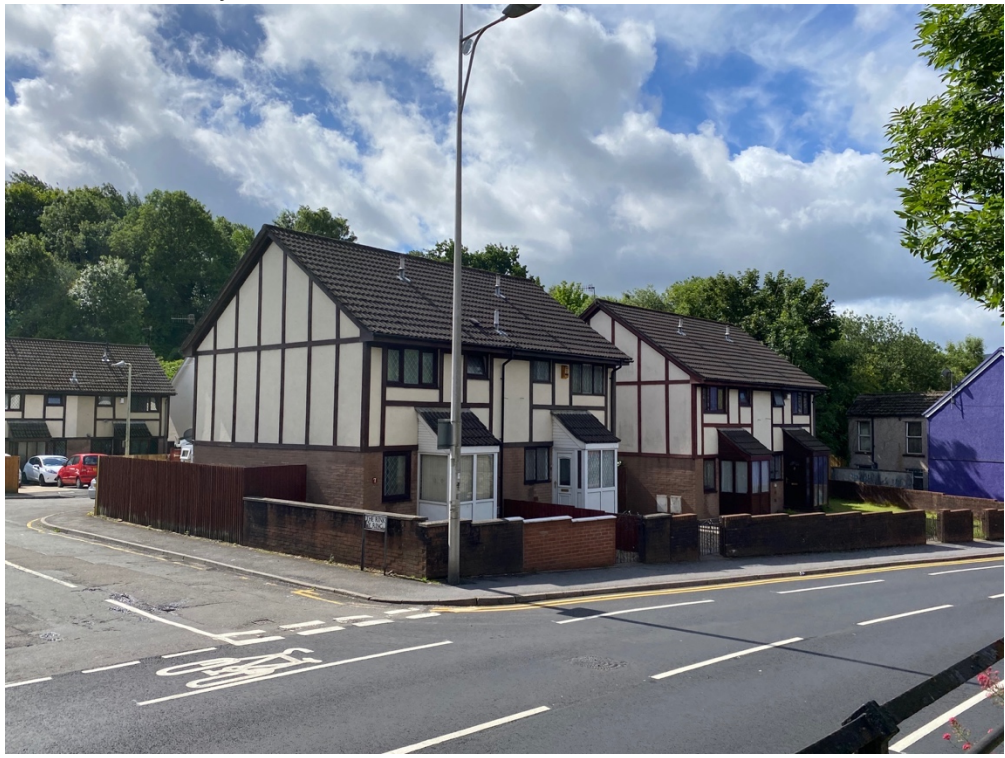
Address	<p>4 to 7 The Rink, Penydarren Road</p>

Current use	Dwellings
Architectural Description & Condition	<p>Two pairs of modern semi-detached dwellings</p> <p>Likely late-20th century building, set back from road. Concrete profiled roof tile with part-timbered painted render to first floor. Concrete bricks to ground floor walls. Modern uPVC windows and projecting porches.</p> <p>Modern paved enclosed front gardens</p>
Summary Assessment of Building's Contribution / Significance to the Conservation Area	None.

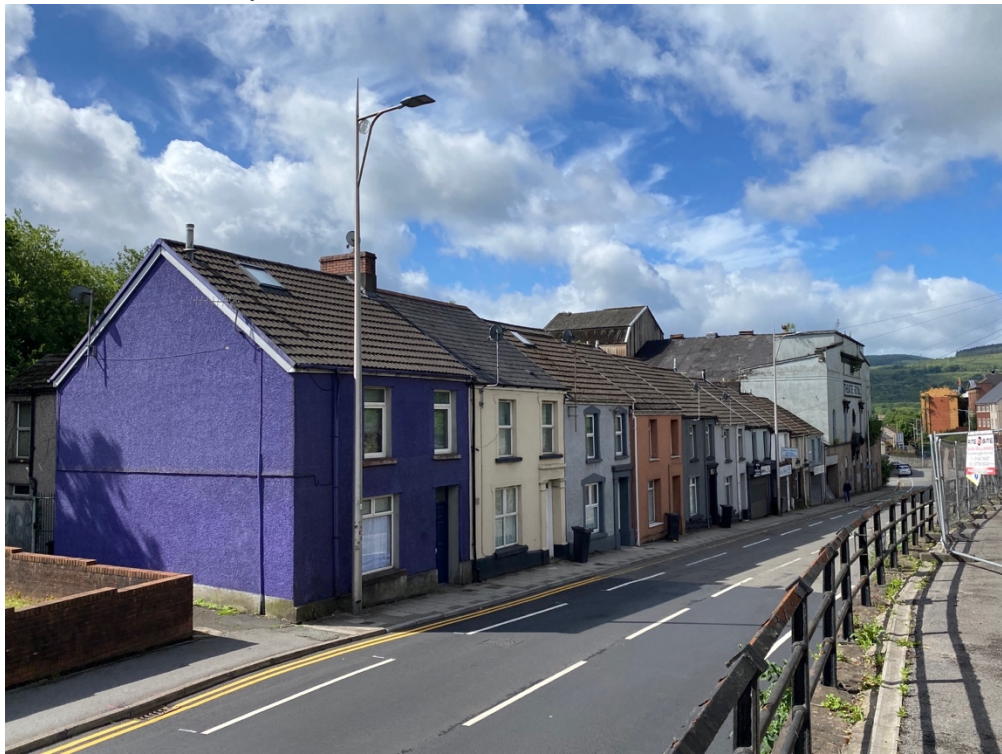
Address	<p>5 to 15 Park Place, Penydarren Road</p>

Current use	Mixed use - Predominantly residential with 3 no. commercial ground floor units (no's 6, 8 & 9).
Architectural Description & Condition	<p>Stepped terrace of typical smaller single fronted properties, common to valleys towns.</p> <p><u>Roof</u> Modern concrete tiles to virtually all properties with isolated fibre cement slates to one.</p> <p><u>Front</u> Painted rendered elevations. Isolated remains of decorative painted (presumably stucco) door surrounds to no's 11 & 13. No. 13 also retains rendered surround to windows.</p> <p>uPVC replacement windows to all properties except first floors to no's 8 & 9 that retain painted timber sash arrangements to first floor.</p> <p>Ground floor shop-fronts to no's 6, 8 & 9 – some elements of modern interpretation of traditional frontages remain with roller shutters and modern plastic signage. Replacement uPVC rainwater goods generally.</p>

Summary Assessment of Building's Contribution	Very little of historical significance remains of this terrace. It does provide a framing quality of views down Penydarren Road adjacent to the Theatre Royal and also contains the first grouping of commercial units that could claim to be a part of the town centre.
