South Wales Metro

Hoover Geotechnical Desk Study

July 2018

Transport for Wales

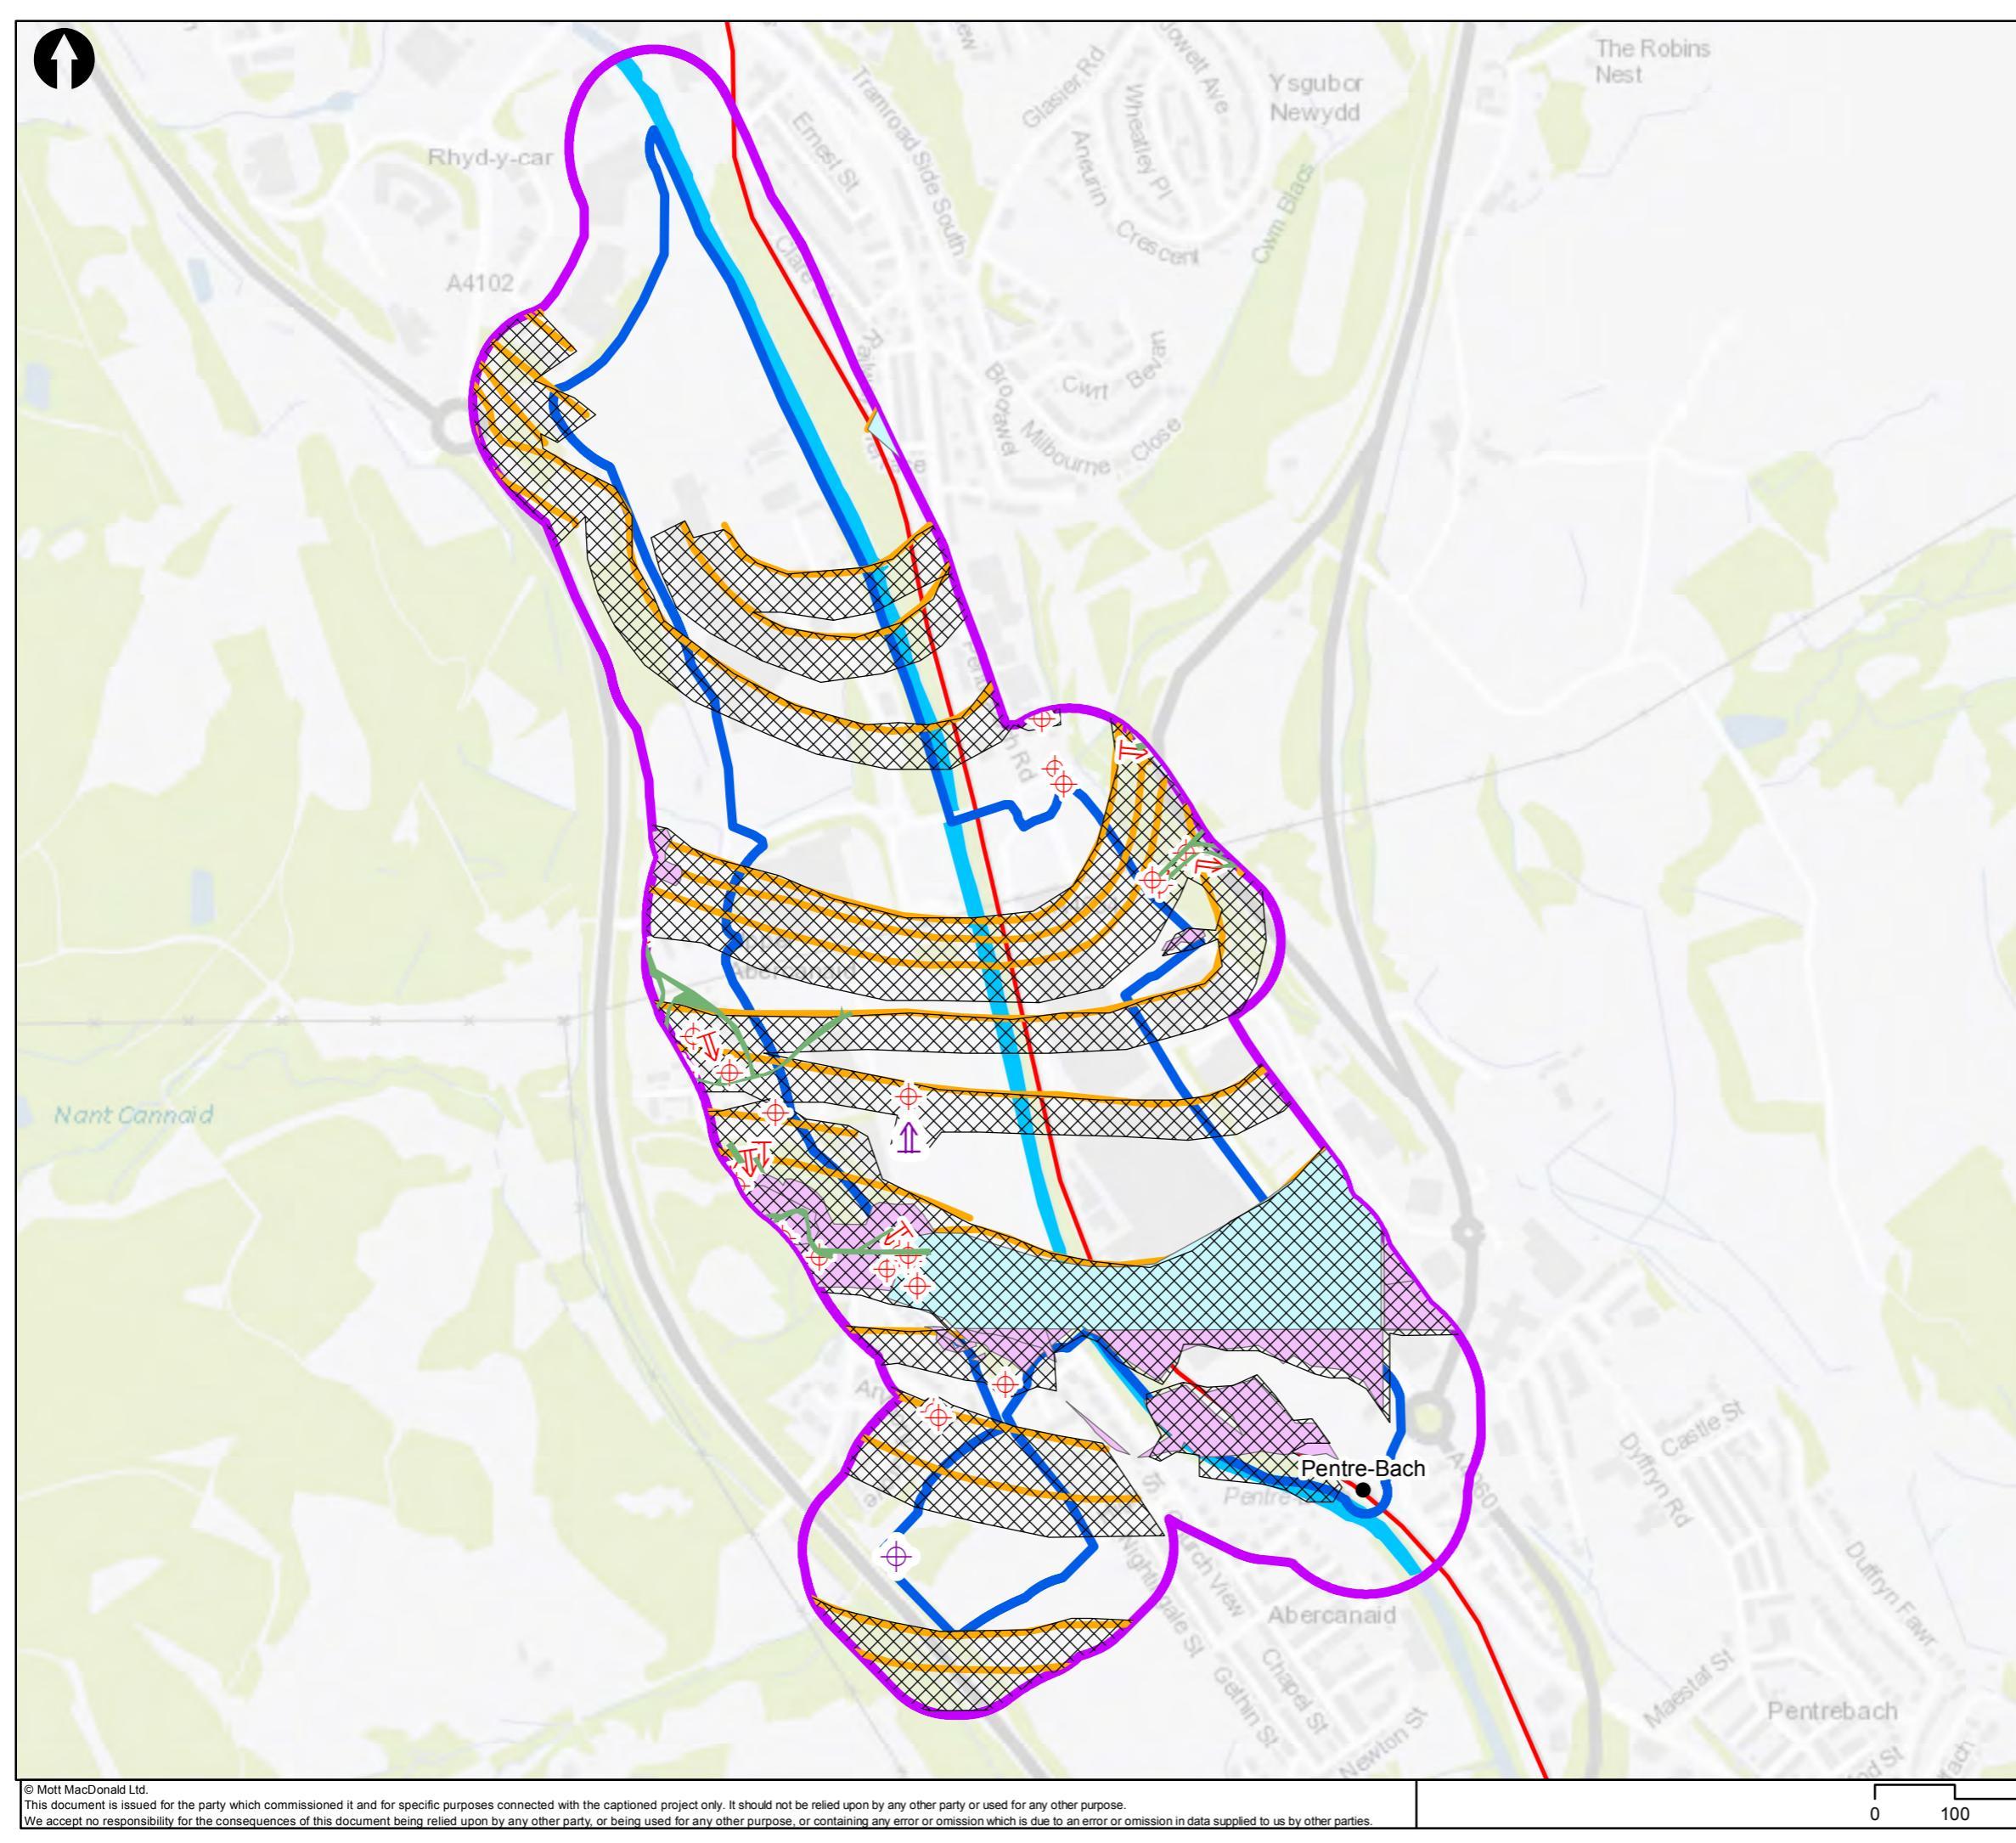
A.10 Drawing 367590-MMD-44-DR-GIS-C-0010 – Associated Mining Risk Plan

-		_							
	4	→ s	haft						
	Mine Entries with Unknown Capping Details								
	-	} €	Shaft	t					
	1	1 4	Adit						
		<u> </u>	coal	Outcro	ps				
- / -		P	roba	able M	ine Wo	rkings			
1		K	now	n Sha	llow Mi	ne Working	js		
		5 	inalio liab	Diek D	ne Roa	ias mont			
	Note	s –	iigii		evelop	ment

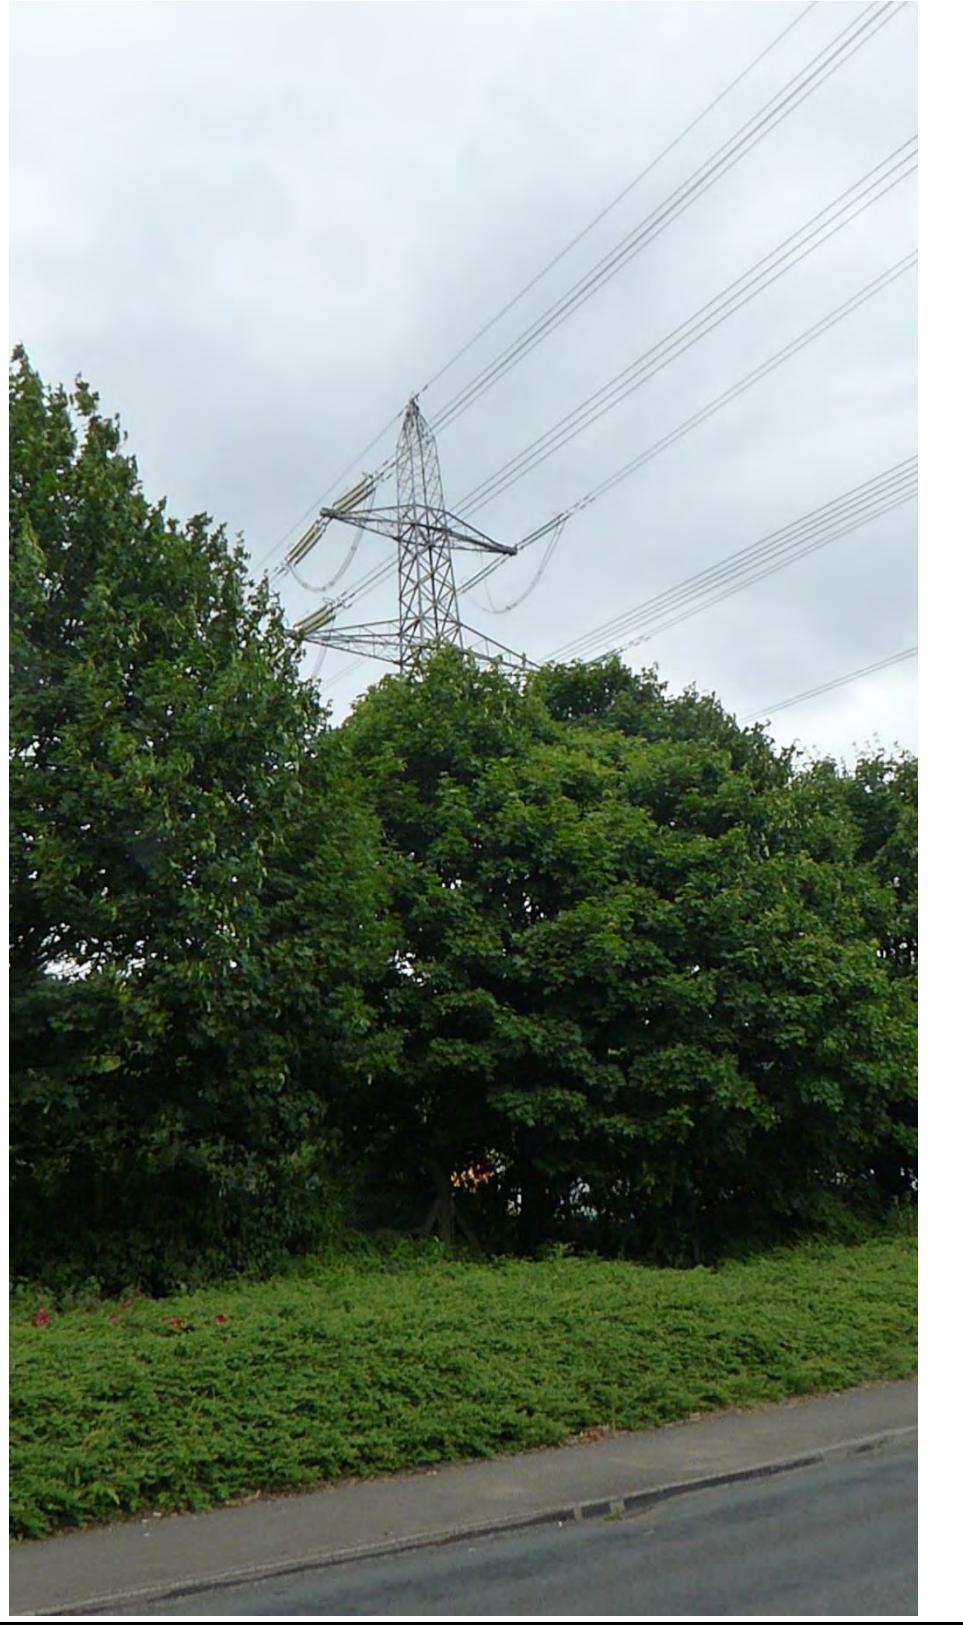
Power cable mast within eastern section of site on eastern side of Merthyr Road

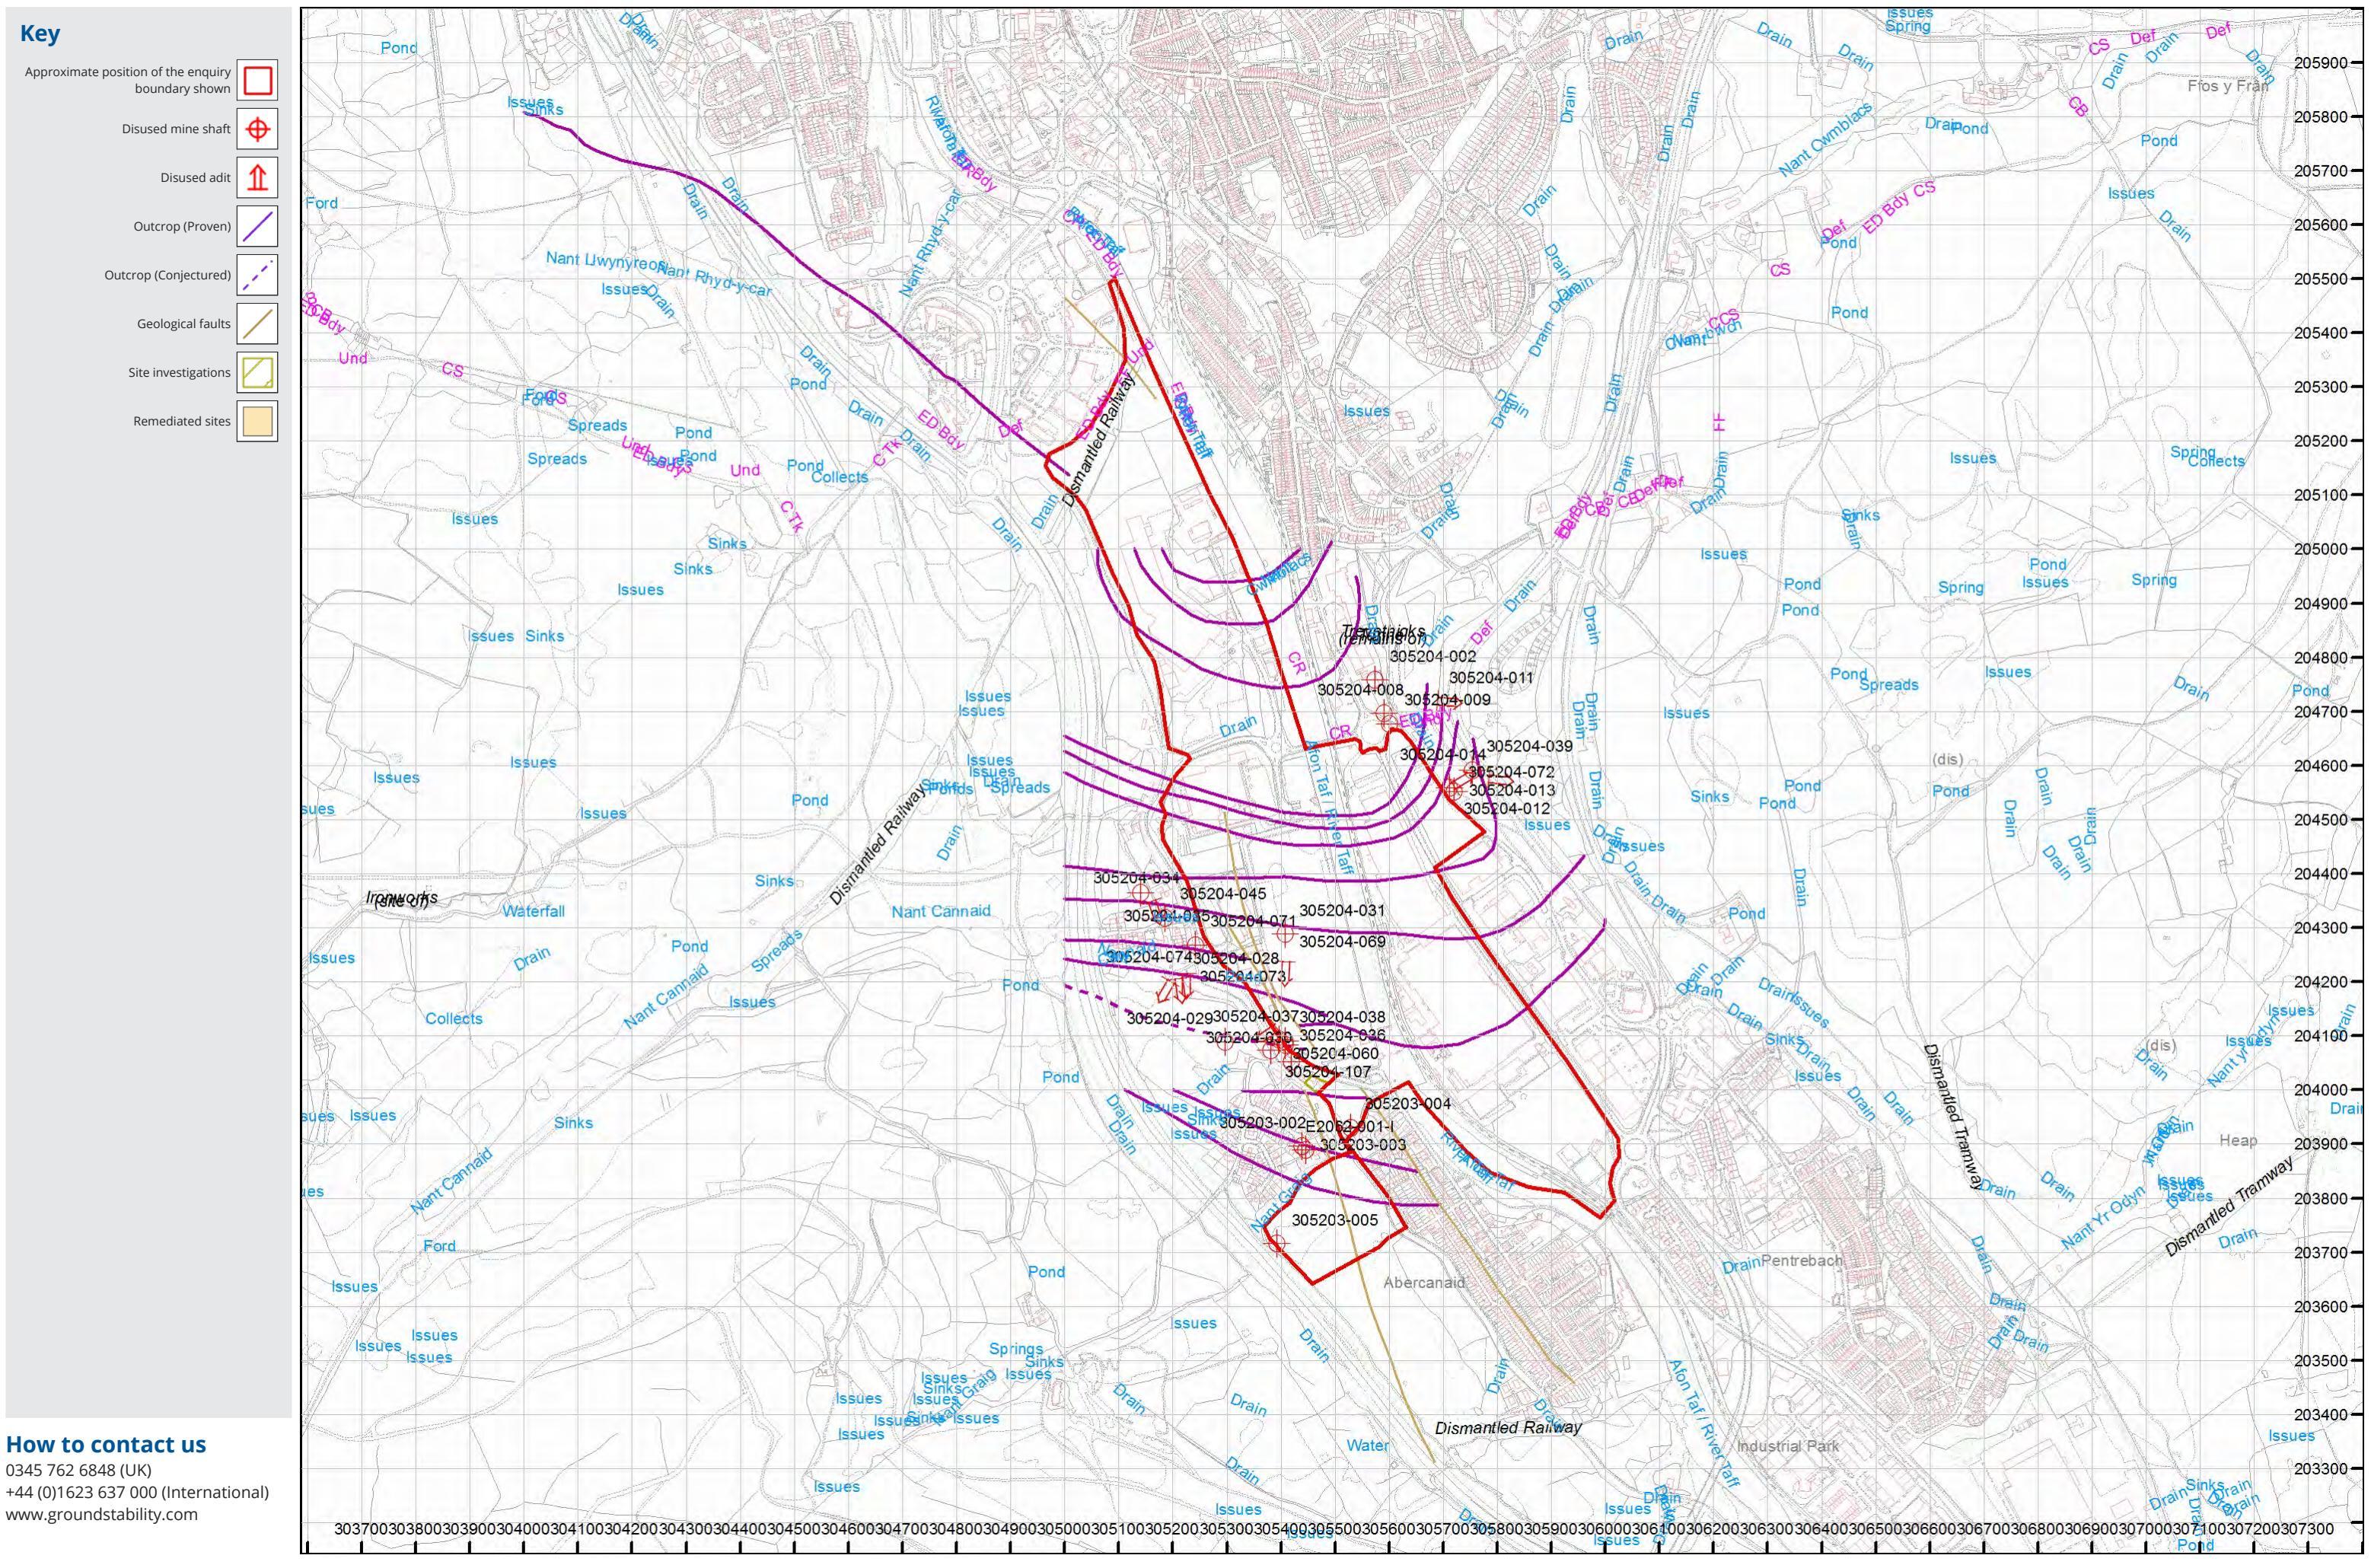
Summary of findings

The map highlights any specific surface or subsurface features within or near to the boundary of the site.

Please refer to the 'Summary of findings' map (on separate sheet) for details of any geological faults, fissures or breaklines either within or intersecting the enquiry boundary.
