APPENDIX C - DETAILED CONSERVATION AREA ASSESSMENT (2020)

1 LOWER HIGH STREET SQUARE, ST.TYDFIL'S CHURCH & COURT STREET

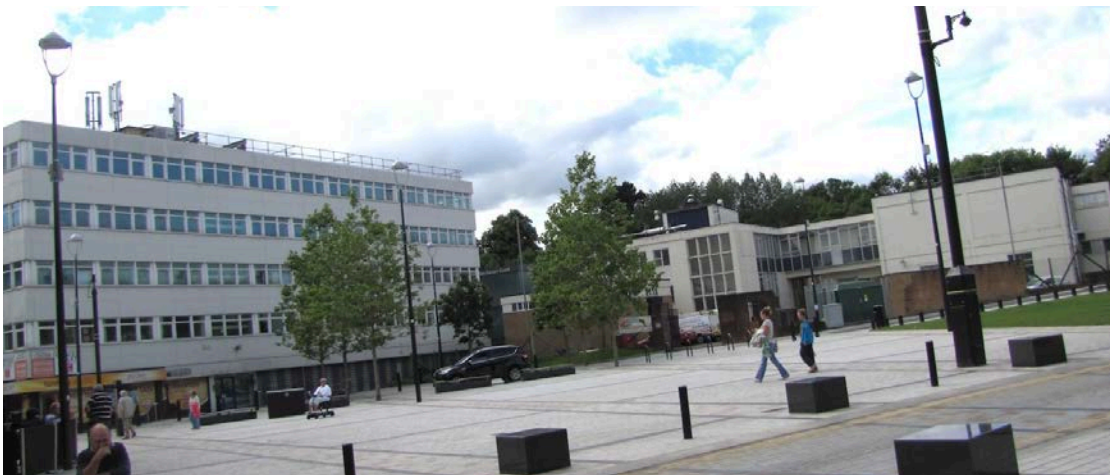
One minor downside in forming Penderyn Square is that the demolition of the cinema opened up a view of the utilitarian telephone exchange building to the northwest and also of the multi-storey 'Oldway House' to the southwest of the square.

Poor view of telephone exchange building to west side of Penderyn Square

The view of the telephone exchange building to the west of the pedestrianized square is poor, and ideally should be visually screened (e.g. by a line of trees etc.) when viewed from the Old Town Hall in particular. This screening might also extend to screen the ground floor of the multi-storey building to the southwest corner of the square.

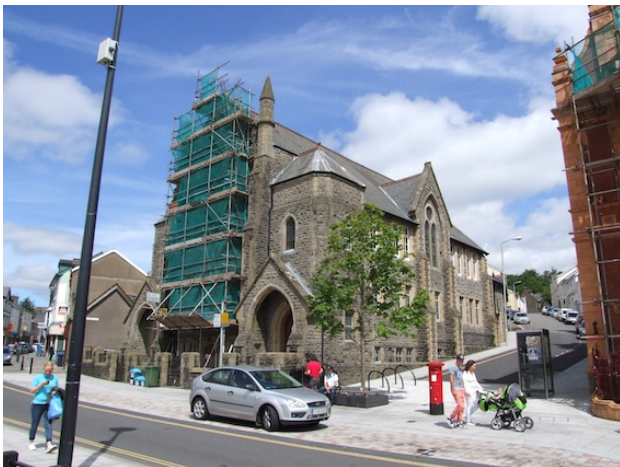
Hope Church has a stripped-down / functional Victorian Gothic appearance and uses the local snecked, rock-faced stone for walling with freestone or buff brick surrounds to the openings; the ironwork railings to the perimeter wall have been replaced with simple mild steel versions but the substantial piers and low wall with chamfered copings remain; the slate roof has clay ridge tiles but the central turret vent has not survived.

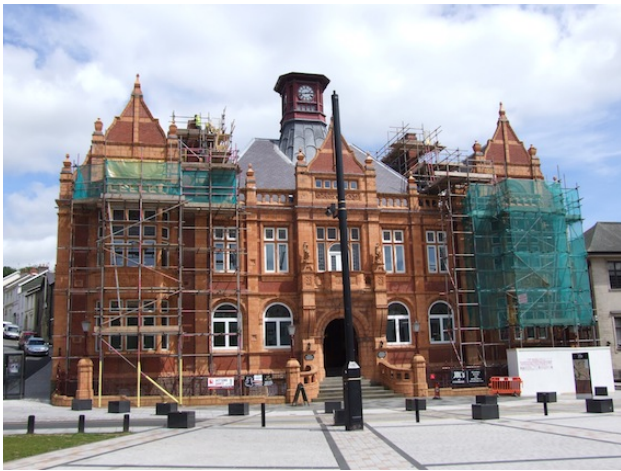
at the YMCA building, Pontmorlais Circus) are combined to create a lively Jacobethan exterior to all elevations with elaborate gables, turrets and parapets, surmounted by a steep slate roof with lead ridge rolls and capped by a clock turret placed centrally on the west elevation; the cupola over the clock tower has been removed and some of the chimneys have been rebuilt in plain brickwork rather than restoring the original terracotta details.

The Old Town Hall has recently been renovated and is now in use as a venue for creative arts industries.

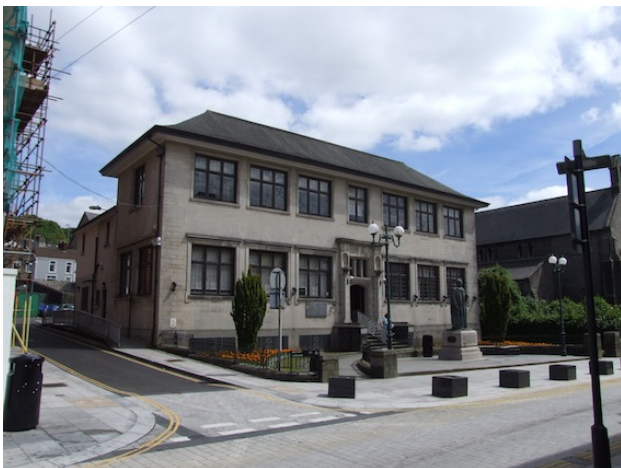
Carnegie Library

The Library is a simple and sparingly detailed pale concrete-faced block, built 1935-36, with wide, overhanging eaves and a hipped (Westmorland) slate roof, laid in diminishing courses, that is quite uncharacteristic of the area and gives the building a fresh and distinctive identity. Designed by Councillor T Edmund Rees (of Messrs Johnson, Richards & Rees, architects of Merthyr).

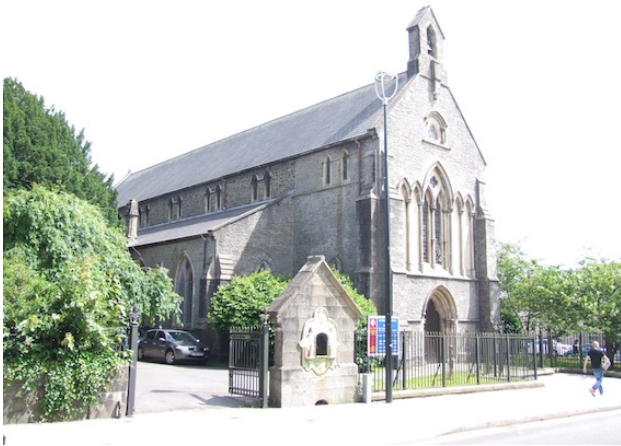
St.David's Church

St David's Church was built 1846-7 and was designed by the highly respected T H Wyatt and D Brandon Architects (London). This uses a similar palette of materials to Hope Chapel, however the simple gothic detailing is more typically 'English Gothic' in character.

, squeezed between the church and the tramroad on the eastern edge of the site. This follows the same theme as the church building itself although later additions have a rendered finish to the external walls to the rear.

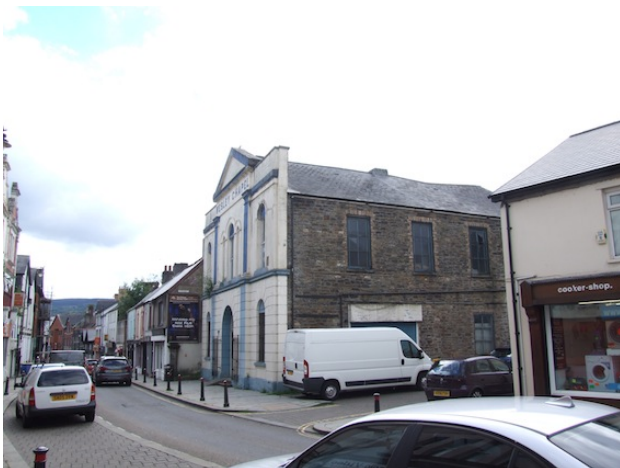
Wesley Chapel is slightly stepped back from the general building line to present an imposing late-classical rendered façade of a generous scale. The site of an earlier building to the north of the chapel has been cleared in the past to form a small car parking area. This gap means the rubble stonework side elevation of the chapel is visible. This 'unfinished' elevation was not originally meant to be seen.

Wesley Chapel with ad-hoc car park alongside where a building once stood

lastly been used as a second-hand furniture shop. The condition and appearance of Wesley Chapel are suffering due to lack of use and maintenance.

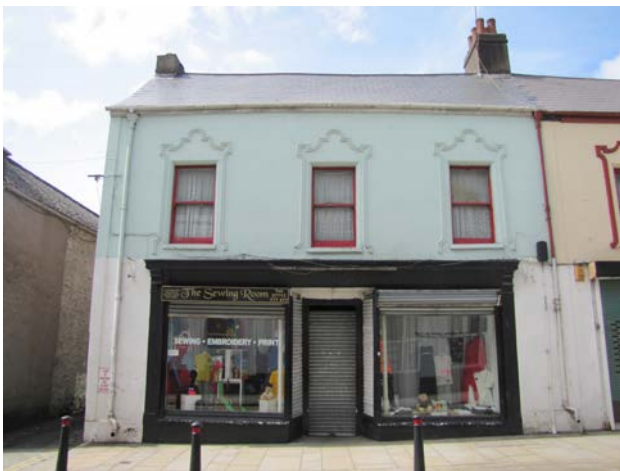
Most of the historic ground floor shopfronts and street frontages have been replaced during the 20th century so that only a few details have survived. 9 Pontmorlais may be the best example, and the pilasters subdividing 1-6 Morlais Buildings retain some very good examples of sculptural stone corbels.

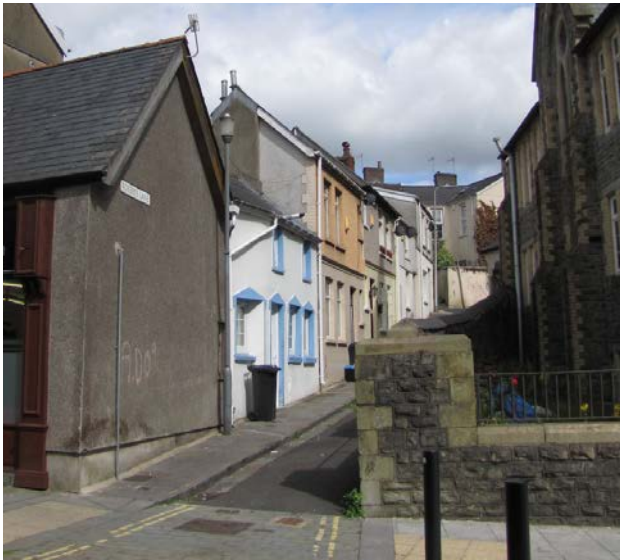
Roberts Lane

Roberts Lane, off the east side of the High Street, has a short, narrow stepped terrace of small, two-storey dwellings on its north side. The materials and finishes have been extensively altered but the terrace's compact scale and topography remain and provide visual interest. The character of the lane is more intimate and domestic, and a pleasant contrast to the commercial High Street.

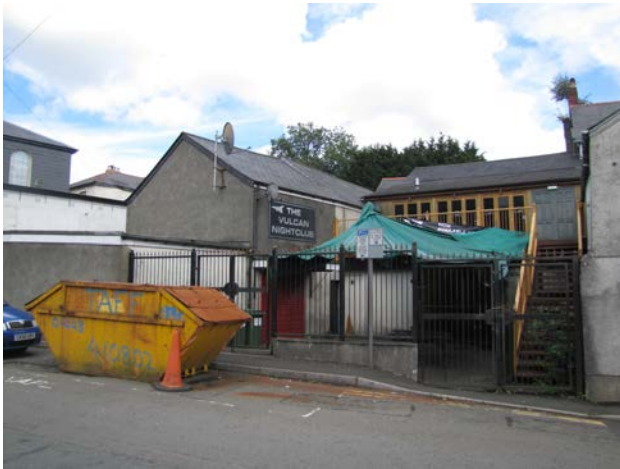
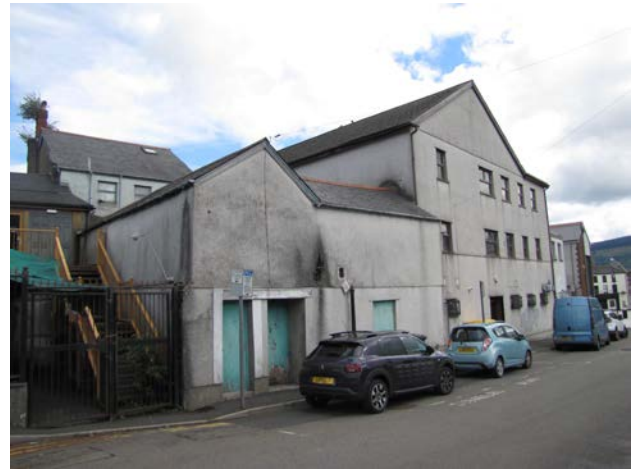
The rear elevations of the High Street properties visible from Tramroadside North retain little evidence of 19th century materials or details apart from the occasional, dilapidated natural slate roof and / or derelict outbuilding. The situation seems better to the west side of the upper length of High Street Pontmorlais where several outbuildings and former workshops appear to have survived probably because of the physical restrictions of limited access along narrow, private lanes and alleyways. These structures are generally of rubble walling, sometimes lime-washed, with brick surrounds to openings and natural slate or later replacement corrugated sheet roofs. Castle Yard has unfortunately not fared so well and suffered from the widespread application of modern sand/cement renders, assumed construction of significant infills or extensions, and loss of all visible historic details.

Poor appearance of buildings along Castle Yard

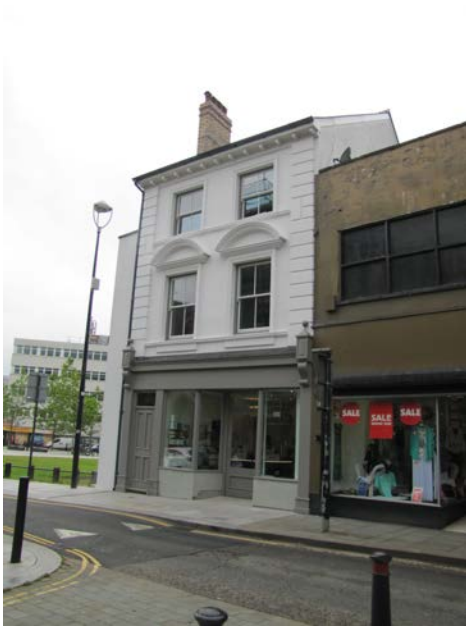
97 High Street (THI works recently completed)

- new and lower key / more appropriate signage;
- reinstating the generally historical vertical emphasis in the elevation;
- retention and repair of existing historic details;
- reinstatement of missing historic details;
- removal of accretions and/or inappropriate claddings/materials;
- re-building of missing chimneystacks.

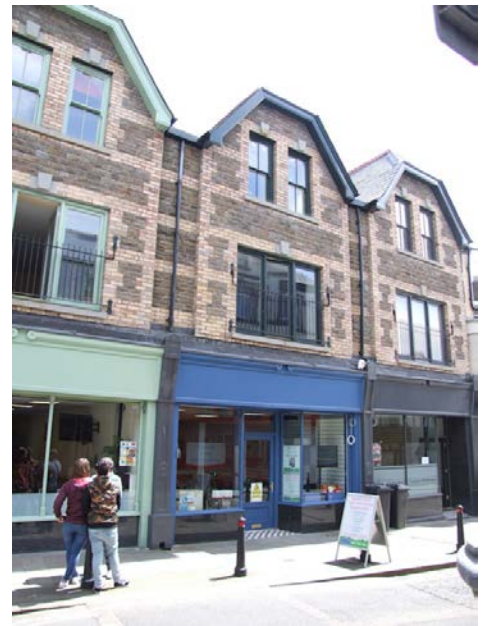
93 to 95 Pontmorlais (THI works recently completed)

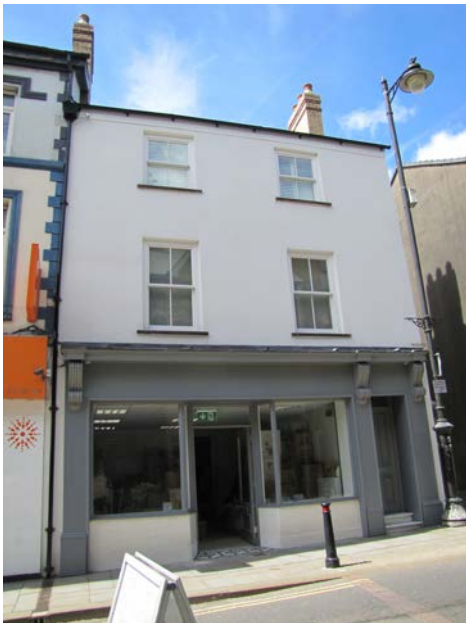
5 Pontmorlais (THI works recently completed)

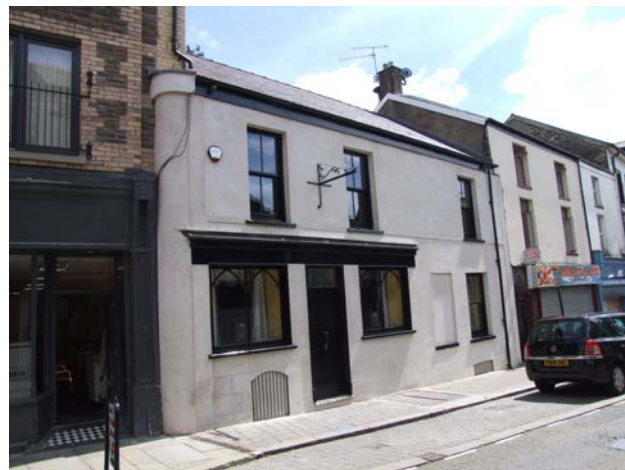
96 Pontmorlais (Anchor Inn) (THI works recently completed)

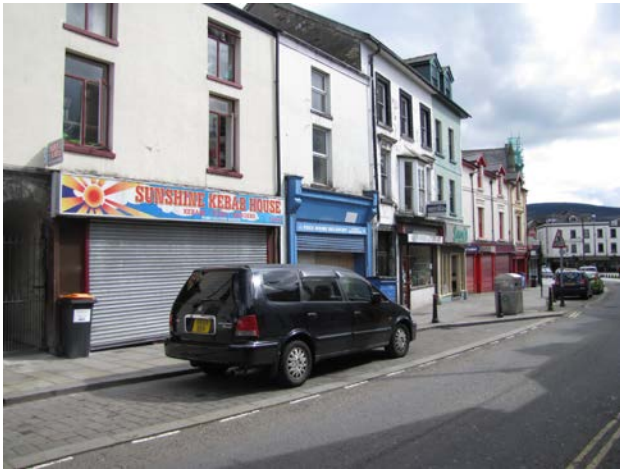
The concentration of take-away food outlets along High Street Pontmorlais contributes little to daytime activity and accentuates the poor mix of uses in this commercial area.

Concentration of (externally) shuttered fast-food outlets
towards southern end of High Street

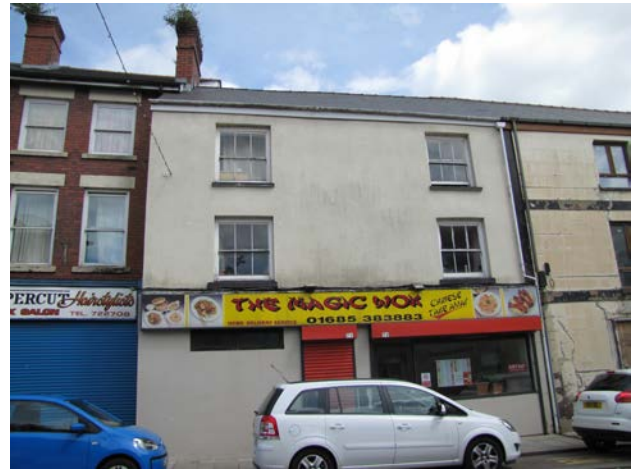
Typical example of dominating fast-food signage

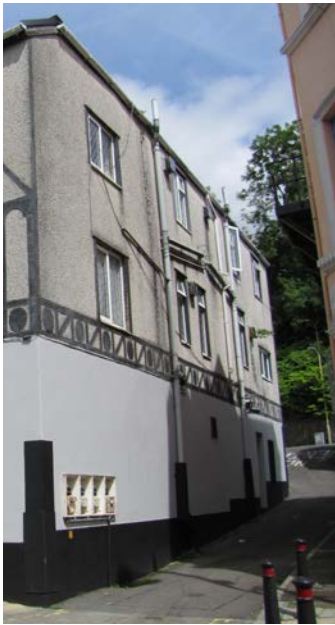
Proliferation of un-coordinated services

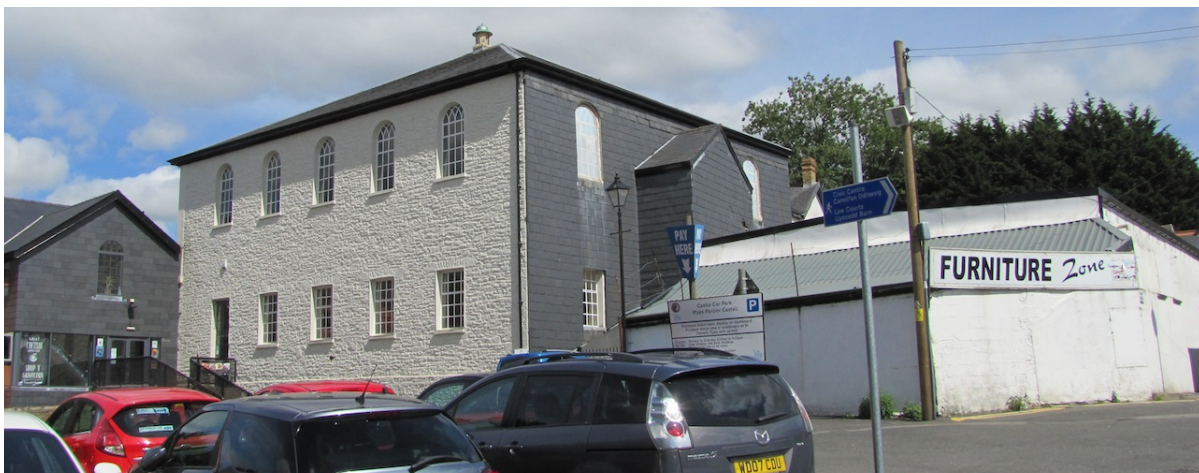
Adjacent buildings visually poor on important approach to Chapel Soar (Theatr Soar)

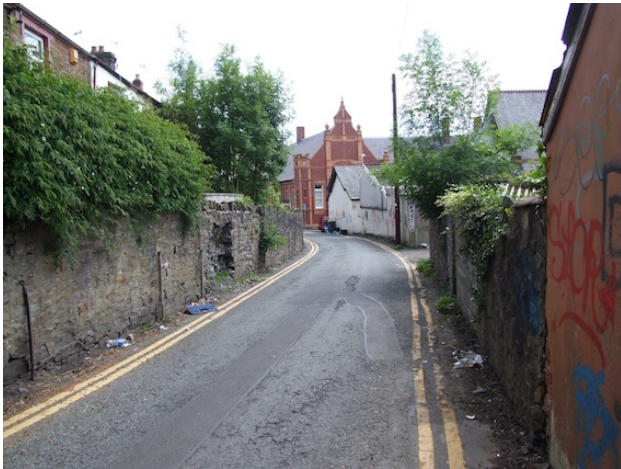
Tramroadside North is generally in fairly good condition although the rear elevations of some of the High Street buildings are visually poor in some instances and there are occasionally poor views into unkempt yards, a few filled with rubbish.

Typical view of Tramroadside North Pontmorlais

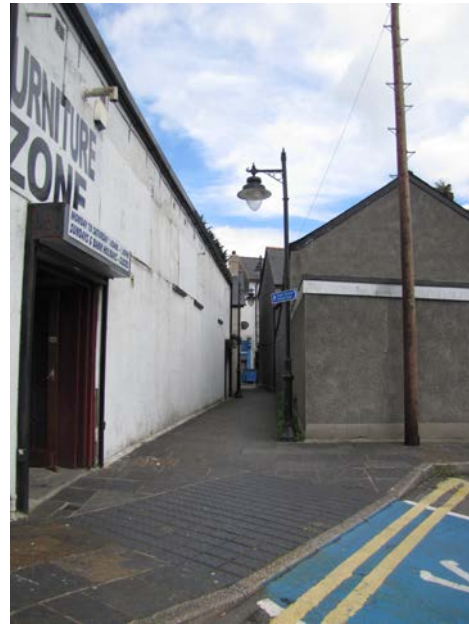
Some old boundary walls along the west side of the Tramroadside North have been lost. This has lost definition and revealed the unkempt rear of some properties, some harbouring a lot of rubbish. Consideration needs to be given to how maintenance and cleaning / clearing of privately owned areas like this can be encouraged and / or enforced since they are detrimental to the appearance and character of the Conservation Area. Residents should continue to be encouraged to keep these areas maintained, clean and tidy or to reinstate missing historic stone boundary walls, not least to screen untidy areas. Graffiti has also been a visual problem along Tramroadside North, although this isn't as noticeable as it was in 2016.

Lane access to High Street, alongside The

Missing boundary walls exposing unkempt areas to some properties along Tramroad Side North

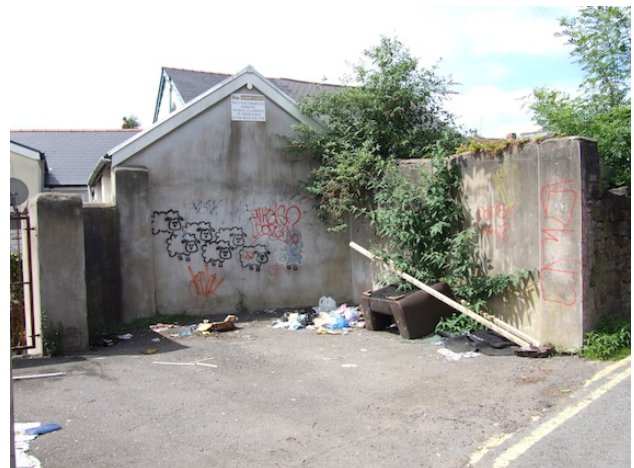
Typical graffiti to walls / properties along Tramroadside North

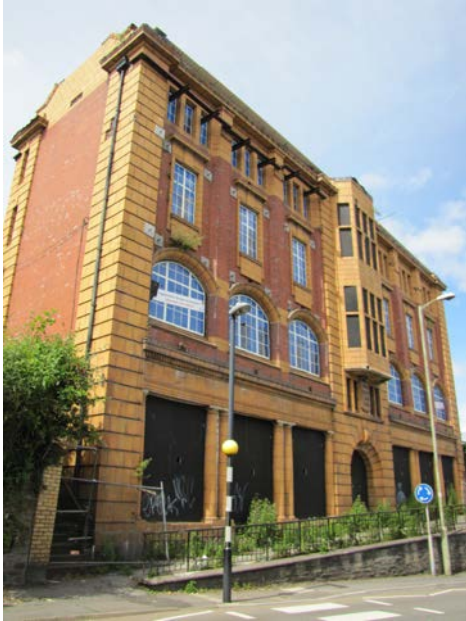
Unfortunately, the YMCA building is currently derelict and the openings are temporarily sheeted. The original pitched roof and many of the roof level details have clearly been missing for many years. A temporary metal sheet over-roof has been installed as part of the 'holding-works' completed as part of the first phase of THI works. We understand there are still efforts being made to restore it and bring it back into use, and this opportunity should be greatly encouraged.

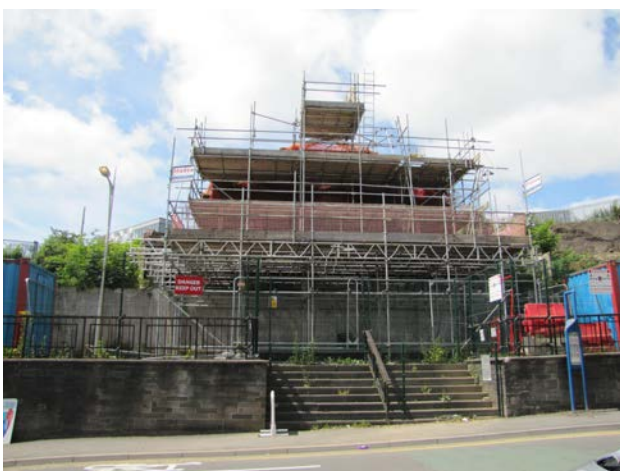
The central main entrance façade of the former Labour Exchange has (somewhat incongruously) been retained as part of the development of the land behind, for affordable housing. Whilst the retention of the façade retains some visual and evidential heritage and architectural value for the Conservation Area there is no denying that the former Labour Exchange building, a former chapel, has gone.

Main entrance of former Labour Exchange building behind scaffold

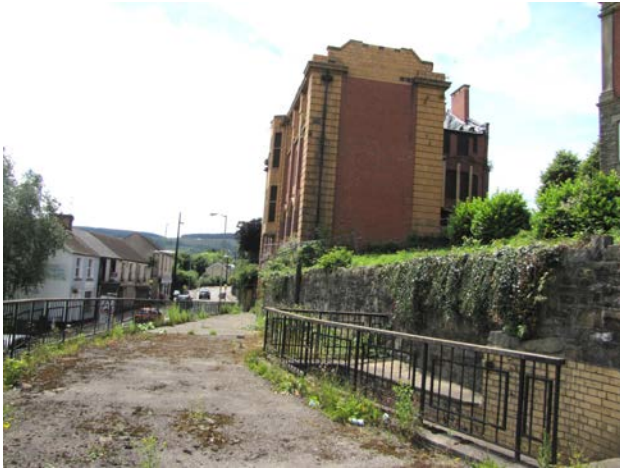
Unkempt 'Promenade'

Adjacent to the mini-roundabout / road junction there is a flight of steps leading up to the raised terrace area (known locally as The Promenade). The Promenade, originally the route of the first tramroad, later provided elevated and ramped pedestrian access between the YMCA building, past the war memorial and beyond the labour exchange to the north. Access along the raised Promenade has now been blocked off for several years.

Public convenience openings, beneath The Promenade, were infilled, probably during the late-20th century, and the whole wall appears to have been clad with pre-cast concrete facings. Historic photographs show that the original balustrade arrangement has been replaced, probably at the same time.

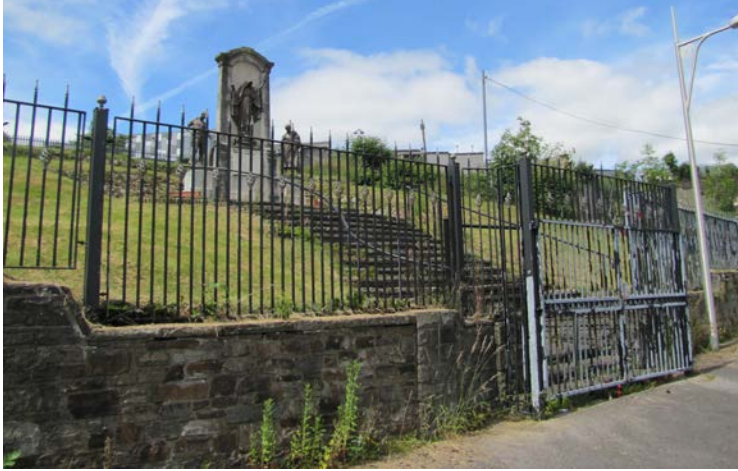
War Memorial, gates and railings

The War Memorial appears to be permanently locked-up although the sloping grassed areas around it are clearly being maintained.

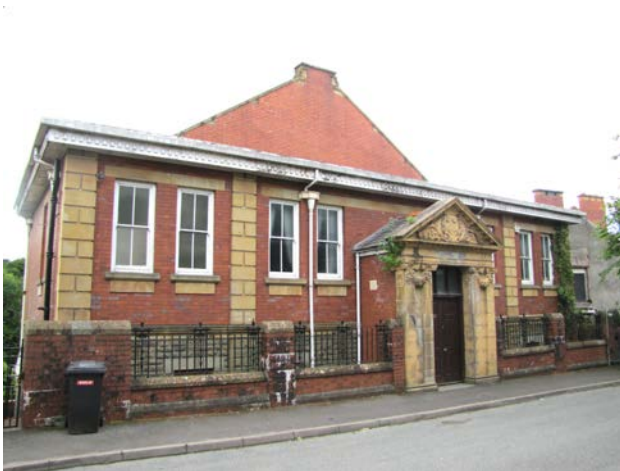
The Masonic Temple is a substantial formal building. Whilst it does not appear to be architecturally significant externally it retains some good iron railings to its front elevation on Park Terrace. It is also positive in that it is still in regular use, and for its original purpose, so it appears to be in fairly good condition because of this.

Masonic Temple front elevation on Park Terrace

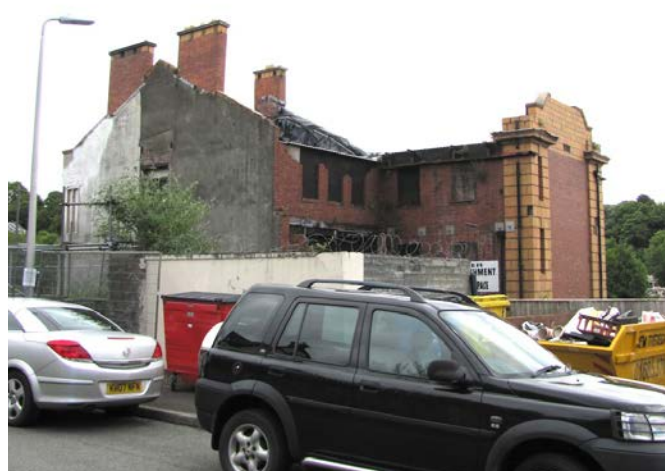
There is some good quality original ironwork existing along the forecourt of the Masonic Temple on Park Terrace. The YMCA's Park Terrace boundary is currently defined by temporary Herras type fencing. The view of the dilapidated YMCA building from Park Terrace is a depressing sight and a clear indication of how much needs to be done there to bring the building back into use.

View of YMCA rear, from Park Terrace

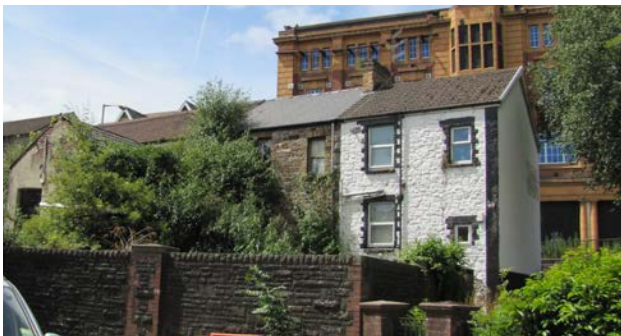
Unkempt rear elevations of 1 to 3 Bolgoed Place, and badly extended 2 Bolgoed Place
